## ASSIGNMENT

To Inspect Vehicle No: SLU 8913K

**Full Report**  
**Registration: SLU8913K**  
**Printed: 02/09/2021 12:07 PM**

# SINGAPORE ACCIDENT STATEMENT

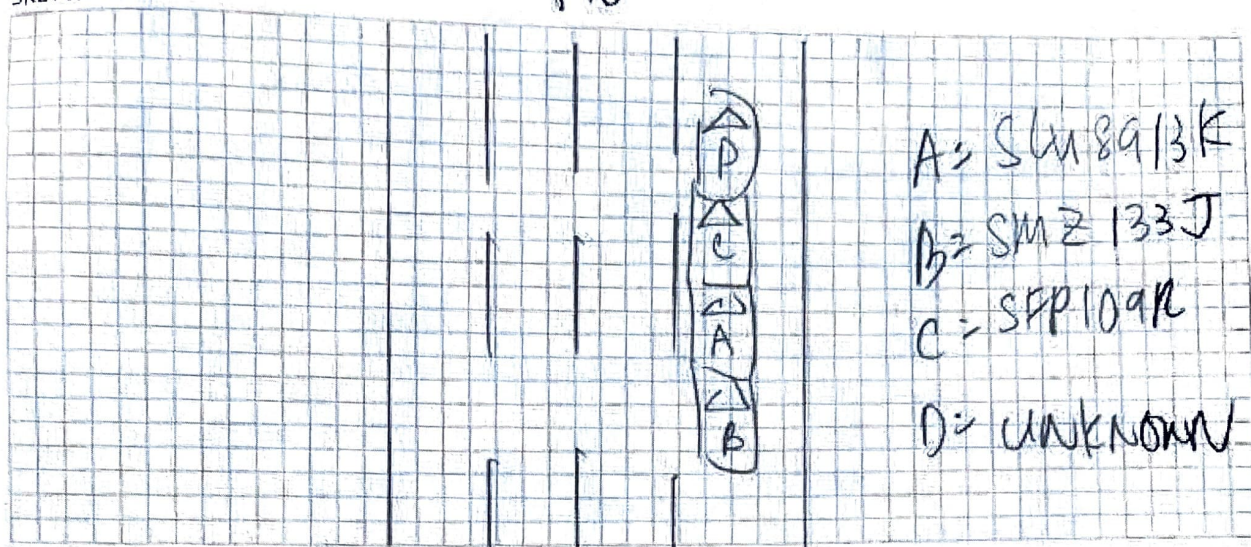
## SKETCH PLAN

ON 27/08/2011 at 1600hrs, I was travelling along PIE Tnds Mas, I was in the first lane when the vehicle in front brake. I follow suit. Moments later I felt an impact from the rear and realized vehicle B had collided onto my vehicle.

I wish to state that the impact caused by vehicle B had pushed me forward to hit vehicle C and vehicle C hit onto vehicle D. It was a 4 cars collision.
