ADJUSTMENT ON REPAIR COST FOR VEHICLE NO. SGW 4128K

PHOTOGRAPHS FOR VEHICLE NO. SGW 4128K

INSPECTION

RE-INSPECTION

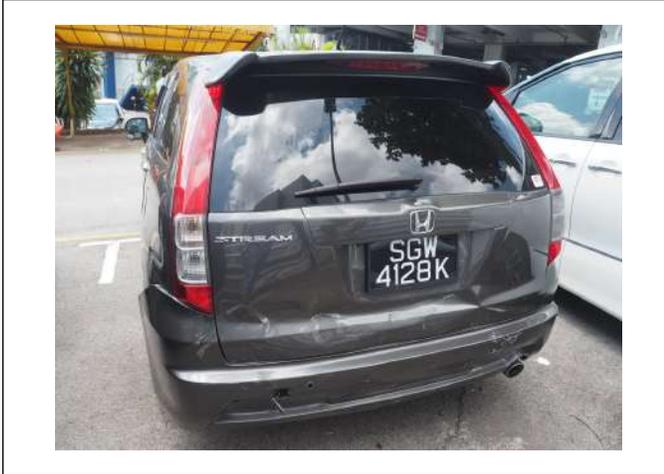
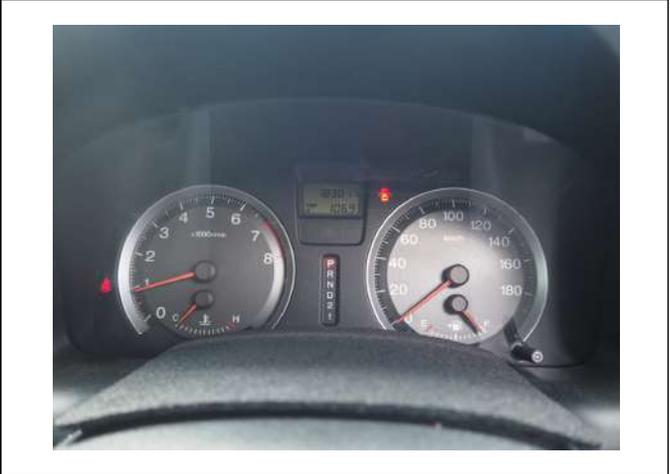
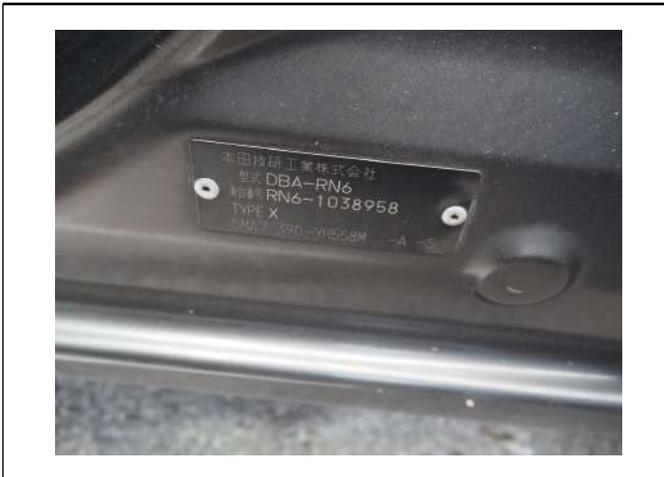
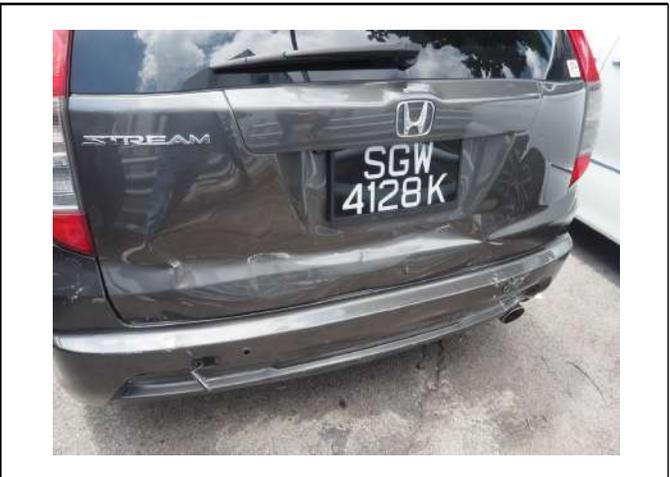
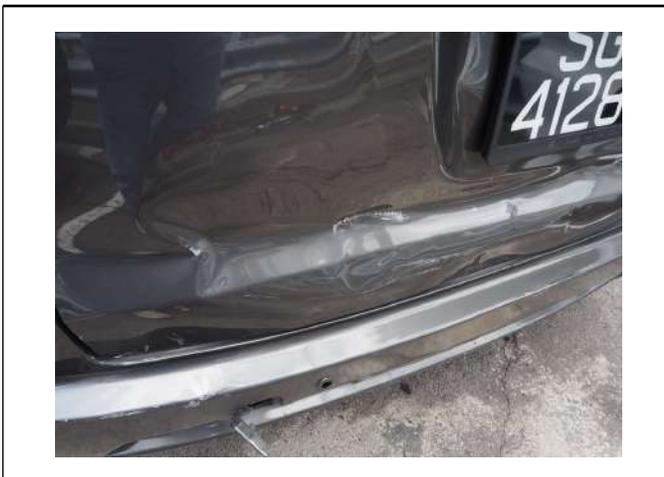
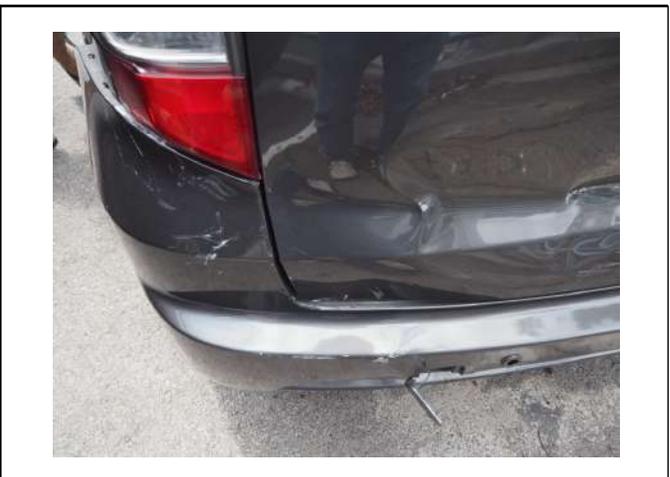
THE VEHICLE SUSTAINED DAMAGES AT THE REAR PORTION.
DAMAGES SEE DETAILS.

Qty	Description of Parts	Condition	Estimate By Workshop (\$)	Our Adjusted (\$)
<u>REPLACEMENT OF PARTS</u>				
1	TAILGATE	DENTED	1,250.30	903.00
1	TAILGATE LOGO	NOT NECESSARY	62.00	-
1	TAILGATE EMBLEM 'STREAM'	NECESSARY	55.00	55.00
1	TAILGATE INNER LOCK	DISTORTED	194.60	194.60
1	TAILGATE WEATHERSTRIP	CUT	157.80	157.80
1	TAILGATE INNER BOARD	CRACKED	211.00	211.00
1	TAILGATE WINDSCREEN MOULDING	NECESSARY	133.00	133.00
1	REAR BUMPER	DEFORMED	633.20	633.20
1	REAR BUMPER TOWING COVER	DEFORMED	50.00	50.00
2	REAR BUMPER SIDE RETAINER @\$62.40	NECESSARY	124.80	124.80
1	TAILLAMP LH	CRACKED	412.00	358.00
1	REAR FENDER INNER TRIM LH	CRACKED	466.80	285.00
1	REAR END PANEL	DENTED	580.00	580.00
1	REAR END PANEL TOP GARNISH	CRACKED	160.00	160.00
	LESS 20% DISCOUNT		-898.10	-769.08
			3,592.40	3,076.32
<u>SPECIAL NETT ITEMS</u>				
1	REAR NUMBER PLATE (SN)	NOT NECESSARY	50.00	-
1	SET REAR BUMPER CLIPS (SN)	NECESSARY	20.00	20.00
