Affiliated to Federation Internationale Des Experts En Automobile				
LONPAC INSURANCE BHD 300 BEACH ROAD #17-04/07 THE CONCOURSE SINGAPORE 199555			Ref: CC4/LPC21009648/Vpa3q2	
			Date: 29/12/2022	
			Code: LPC2

ADJUSTMENT ON REPAIR COST FOR VEHICLE NO. SHD 3181A

PHOTOGRAPHS FOR VEHICLE NO. SHD 3181A

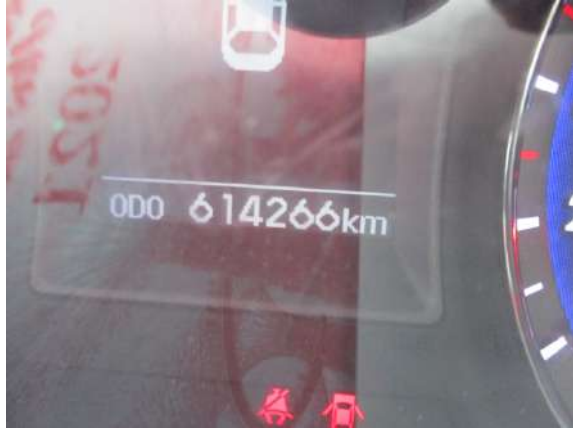
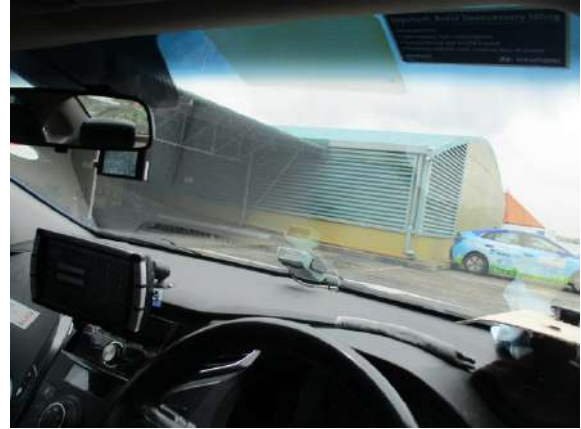
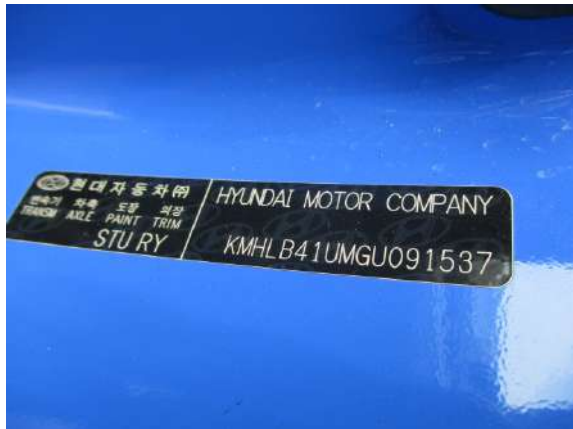
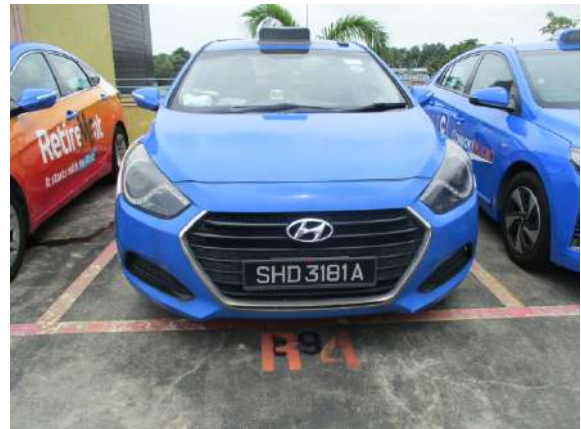
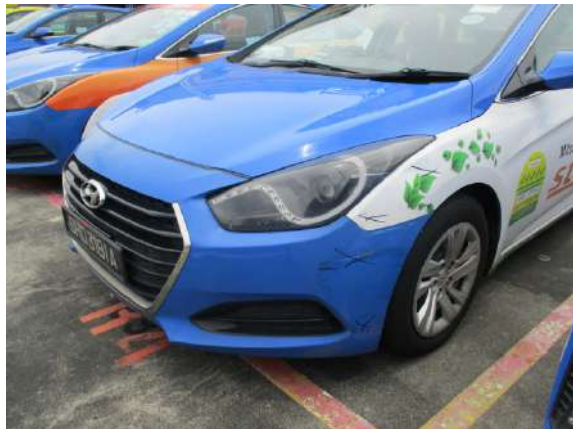
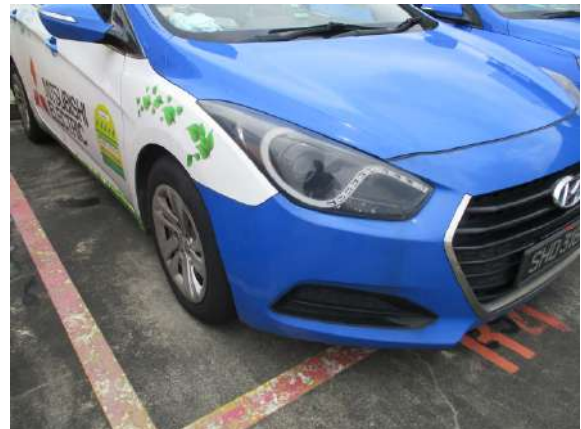
4. Description of Damages				
THE VEHICLE SUSTAINED DAMAGES AT THE FRONT PORTION AND N/S BODY. DAMAGES SEE DETAILS.				
5. General Information				
Accident Date	13/09/2021	Inspection Date	14/09/2021	
Survey held at	COMFORTDELGRO ENGINEERING PTE LTD 59 LOYANG DRIVE SINGAPORE 508969			
5a. Remarks				
A)THE INSPECTION WAS CONDUCTED ON A"WITHOUT PREJUDICE" BASIS. B)IN ACCORDANCE TO YOUR INSTRUCTIONS, WE HAVE NOT AUTHORISED REPAIRS.				
5b. Estimate Days of Repair				
ESTIMATED NORMAL PERIOD FOR REPAIR:			3 Working Days
