1. Policy Particulars :- THIRD PARTY CLAIM

2. Vehicle Particulars & Condition

4. Description of Damages

ADJUSTMENT ON REPAIR COST FOR VEHICLE NO. GX 836X

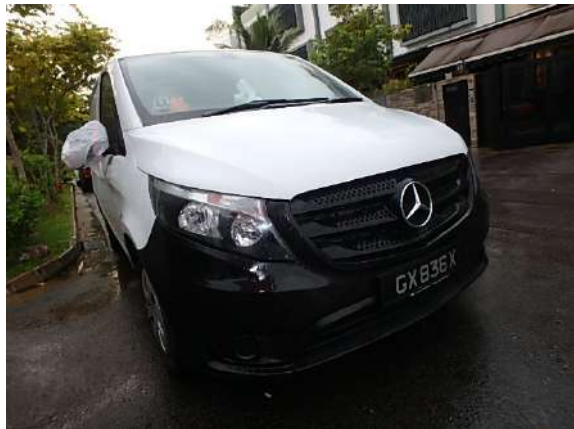
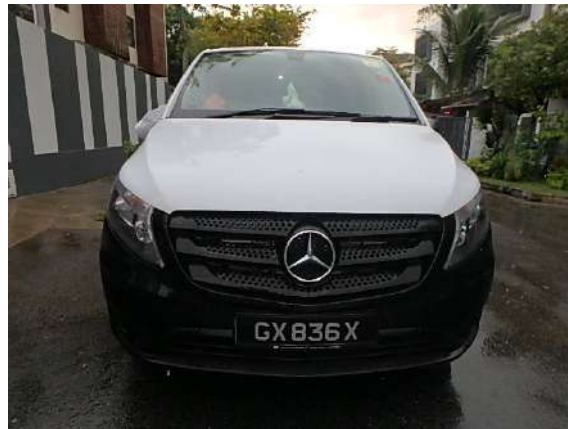
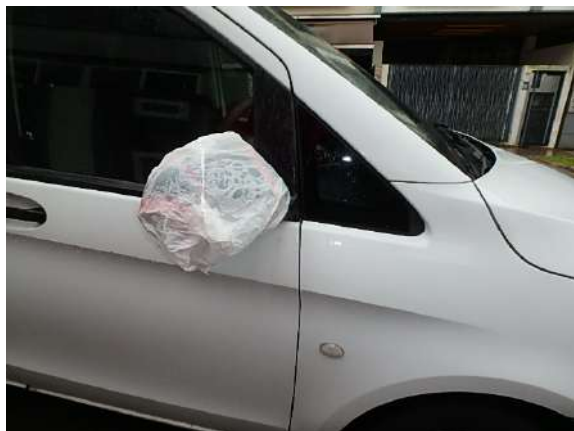
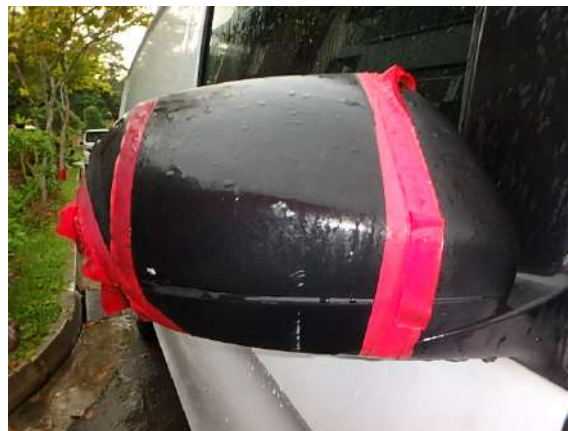
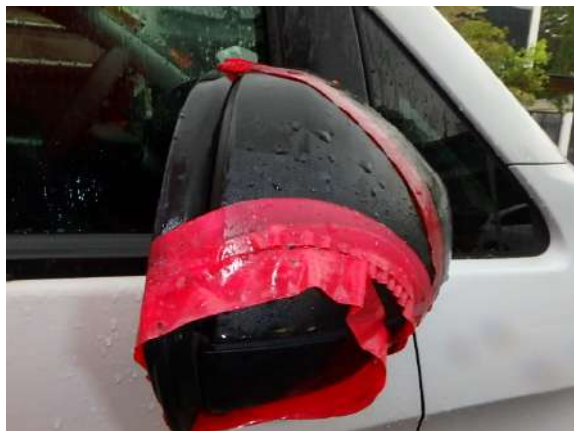
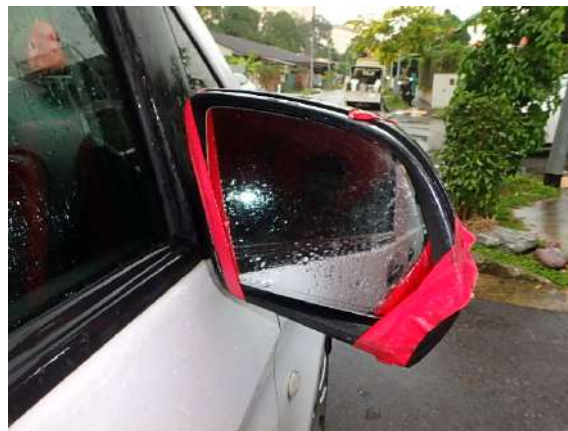
INSPECTION

THE VEHICLE SUSTAINED DAMAGES AT THE FRONT O/S DOOR MIRROR.

Qty	Description of Parts	Condition	Estimate By Workshop (\$)	Our Adjusted (\$)
	<u>REPLACEMENT OF PARTS</u>			
1	FRONT RH SIDE MIRROR	CRACKED	1,250.00	1,250.00
1	FRONT RH SIDE MIRROR COVER	DENTED	96.00	96.00
1	FRONT RH SIDE MIRROR GLASS	SERVICEABLE	101.00	-
	LESS 10% DISCOUNT		-144.70	-134.60
			1,302.30	1,211.40
	<u>LABOUR</u>			
	REMOVE & REFIX FRT RH SIDE MIRROR & RESET SYSTEM.		100.00	60.00
			100.00	60.00
	GRAND TOTAL		1,402.30	1,271.40
RECOMMENDED COST OF REPAIRS				1,271.40
