ACCIDENT INVOLVING MOTOR VEHICLES NO. YQ2593G & LP226036E ALONG 750 ESR BIZPARK@ CHAI CHEE ON 07.08.2021 AT ABOUT 1900 HOURS.

Re: Third Party Claim For Vehicle Registration No. **YQ2593G**

VEHICLE INSPECTION REPORT

The impact of the collision has damaged / affected the o/s front windscreen pillar, front door, side gate, rear floor bed, and etc...

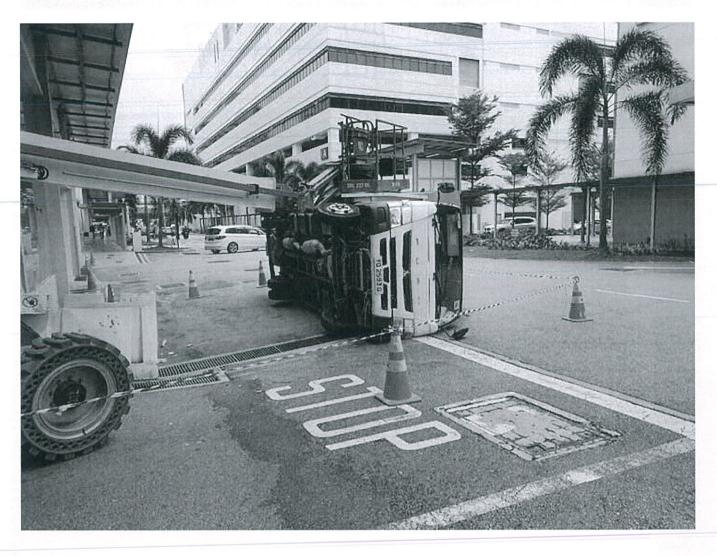
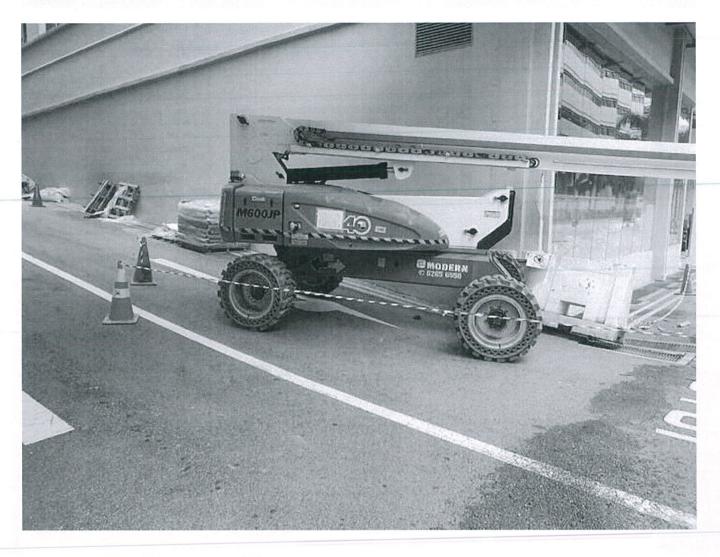
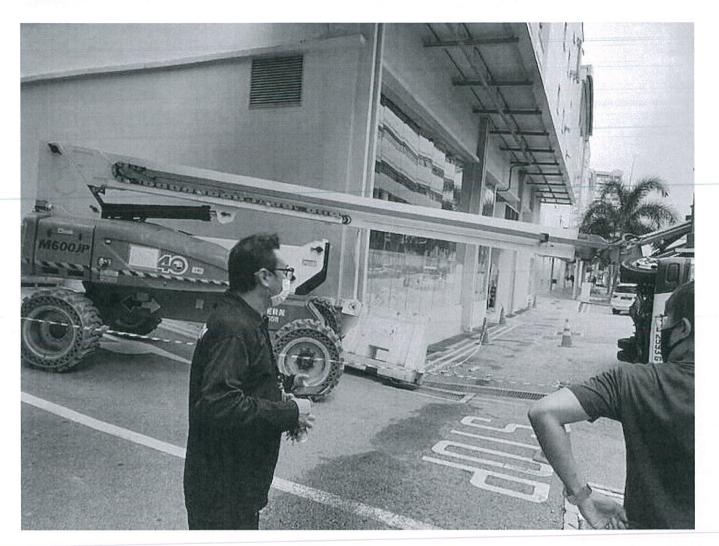
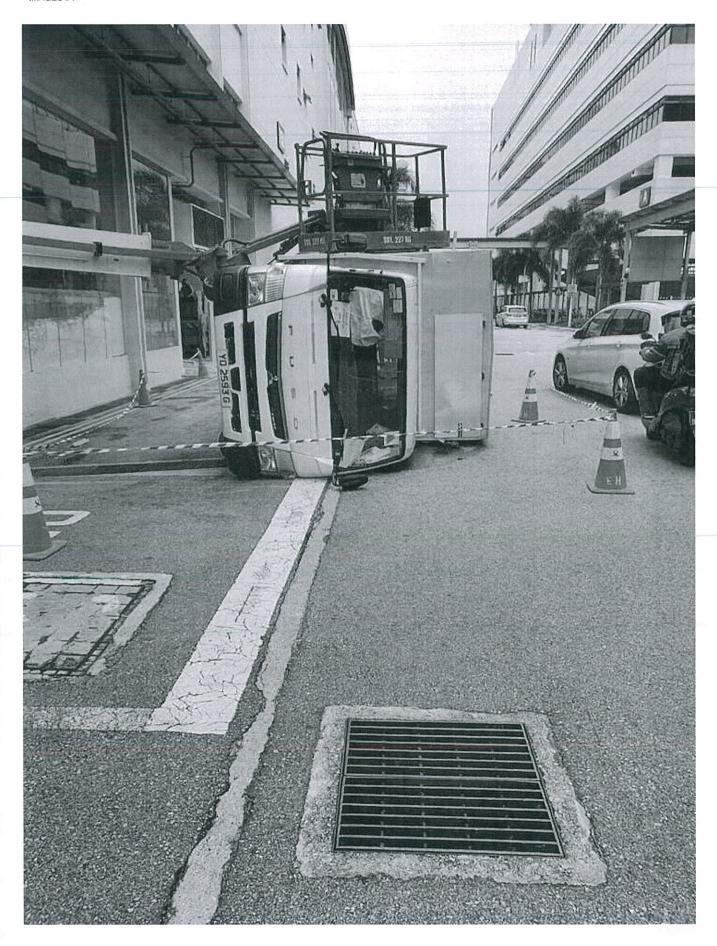
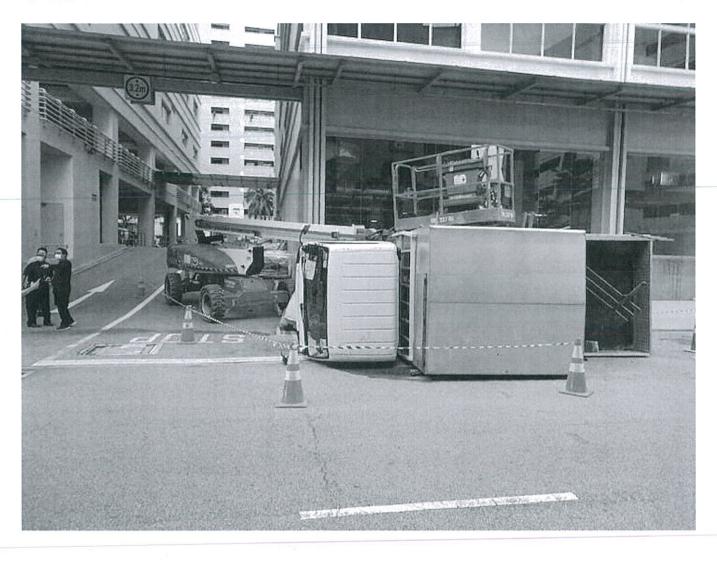
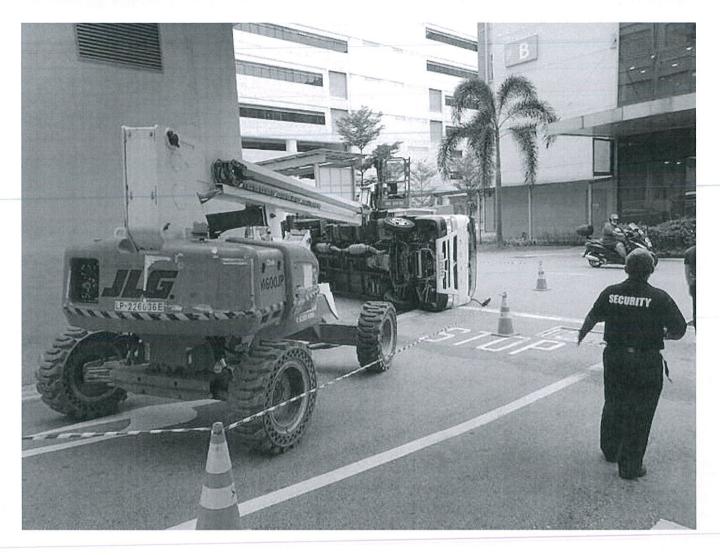
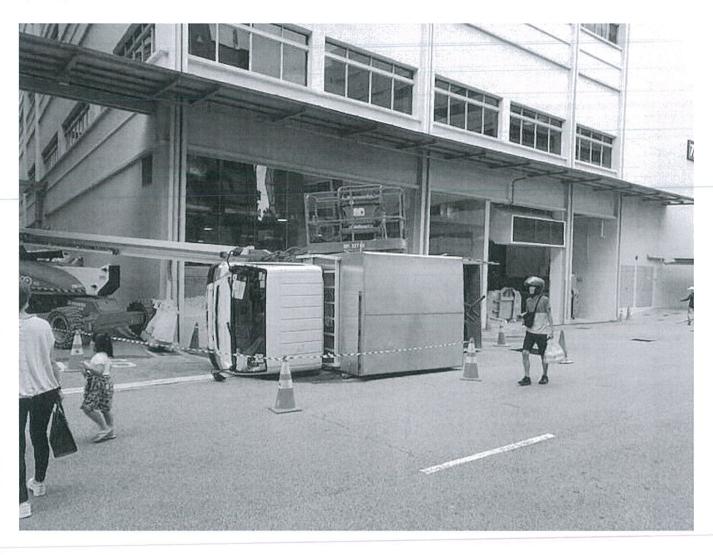
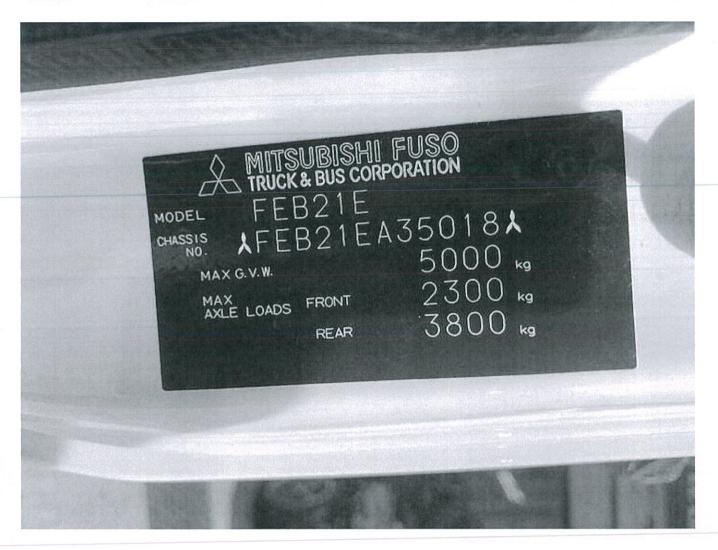
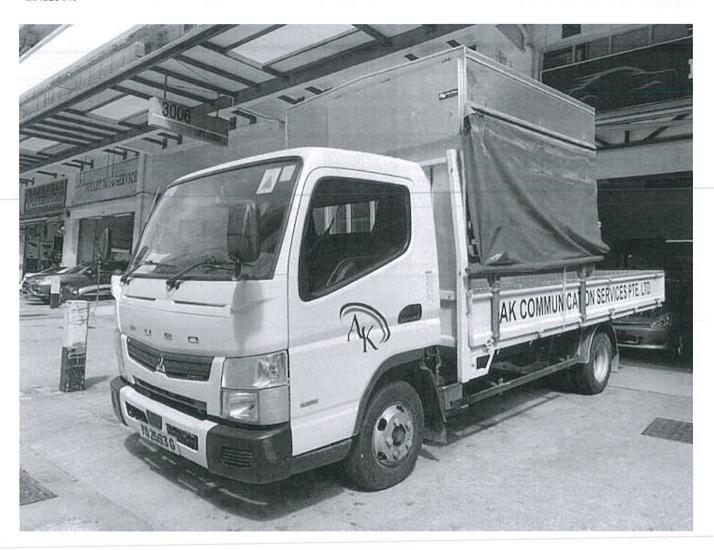
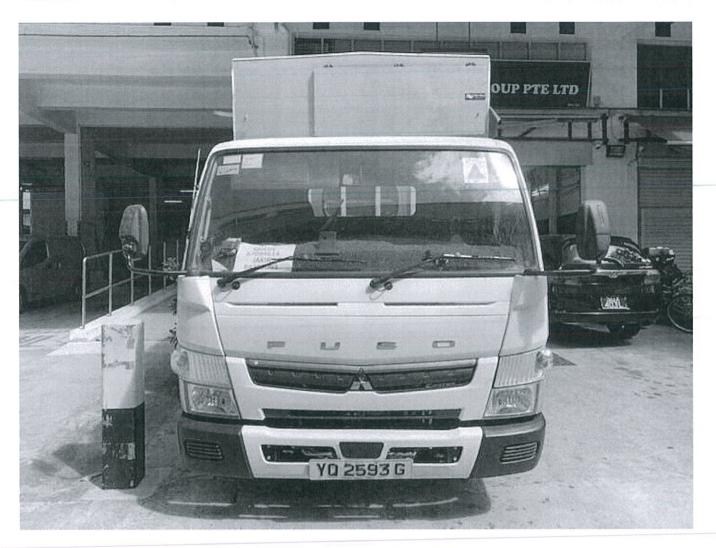
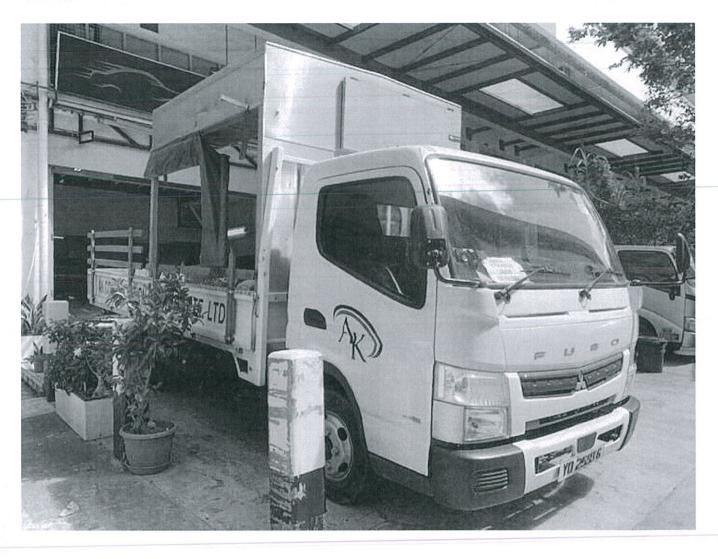
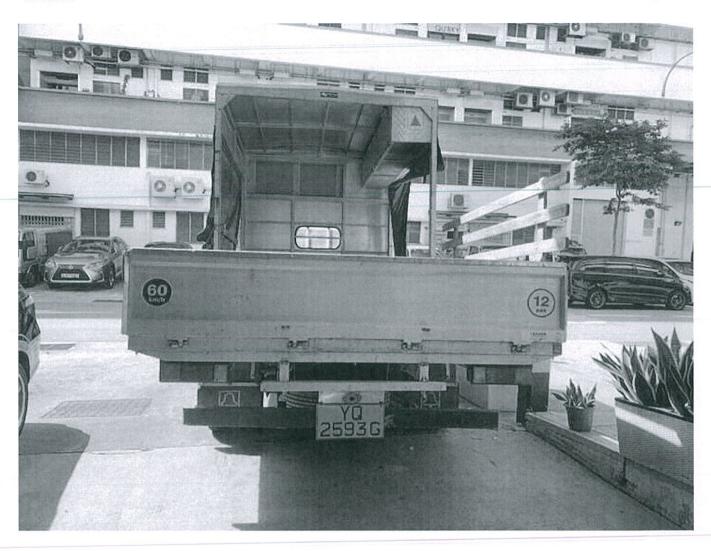
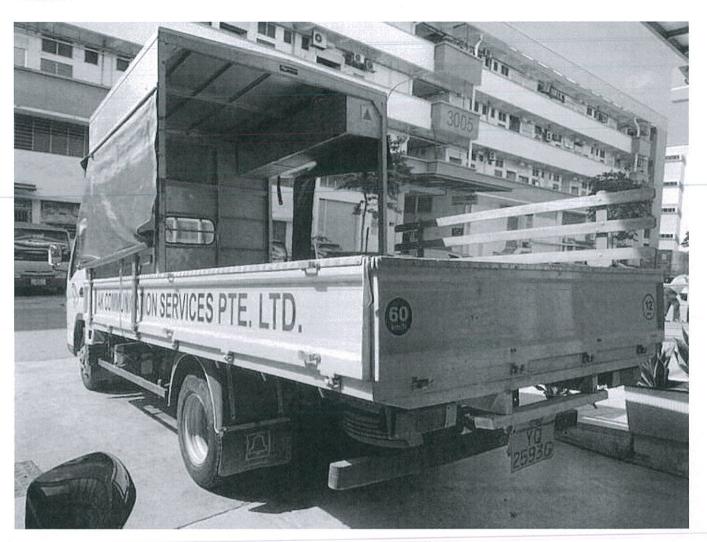
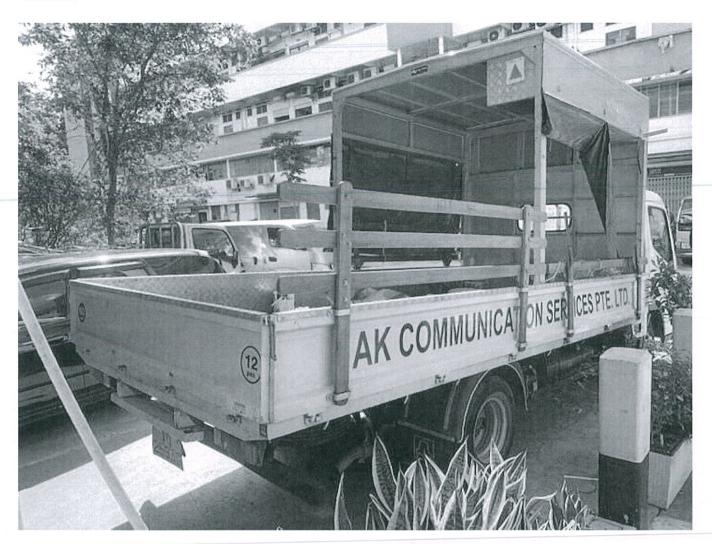
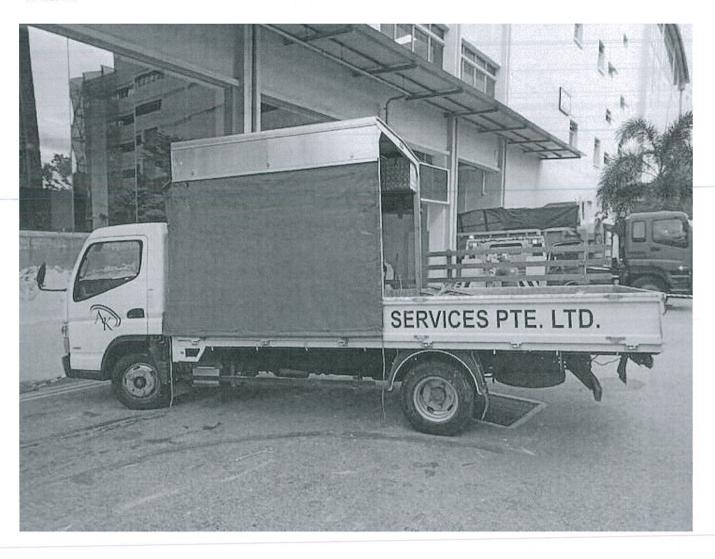
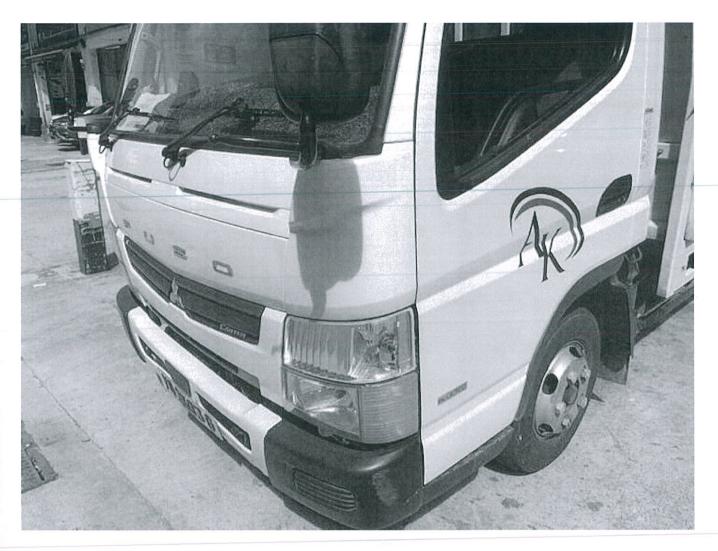
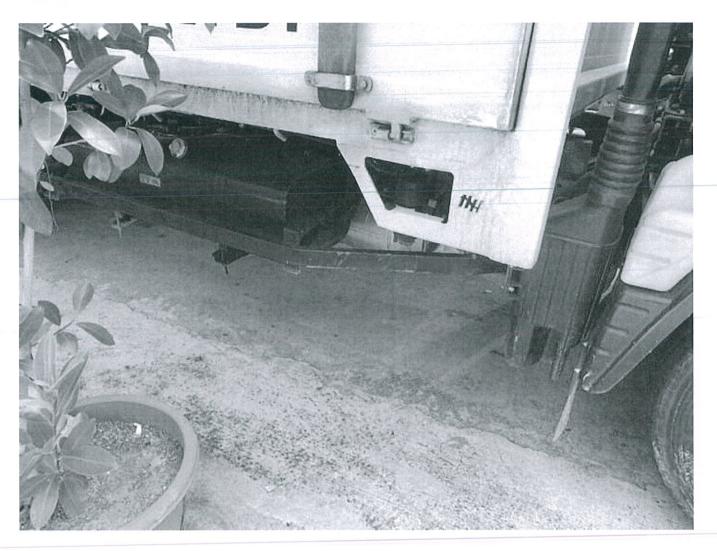
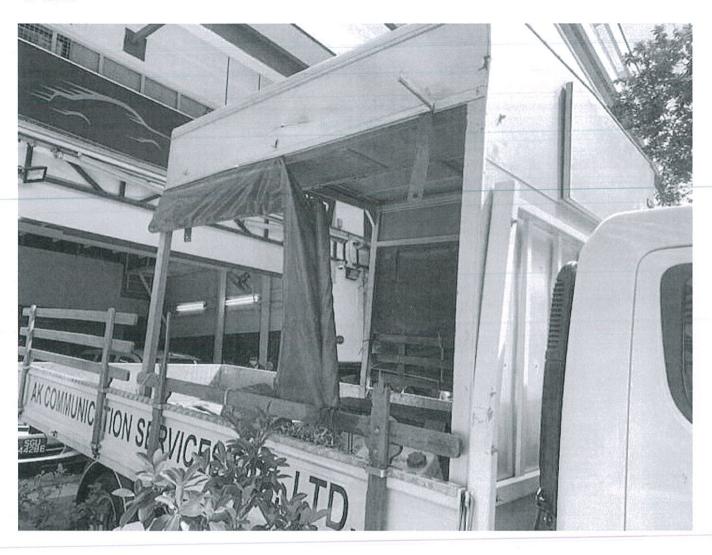
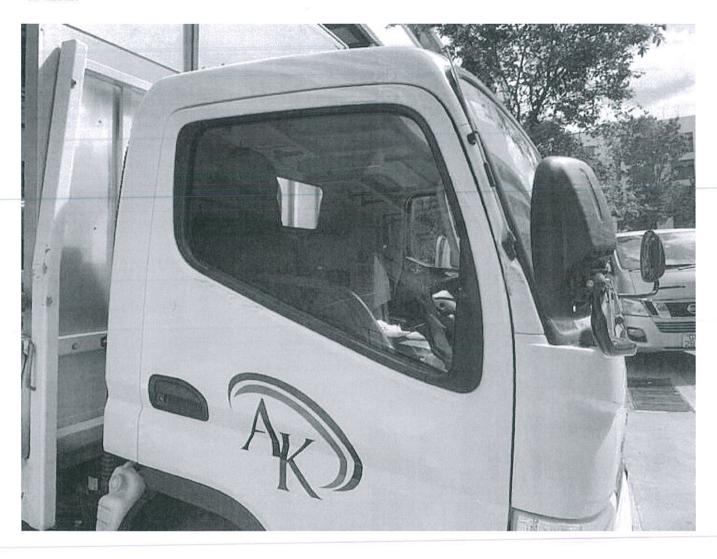
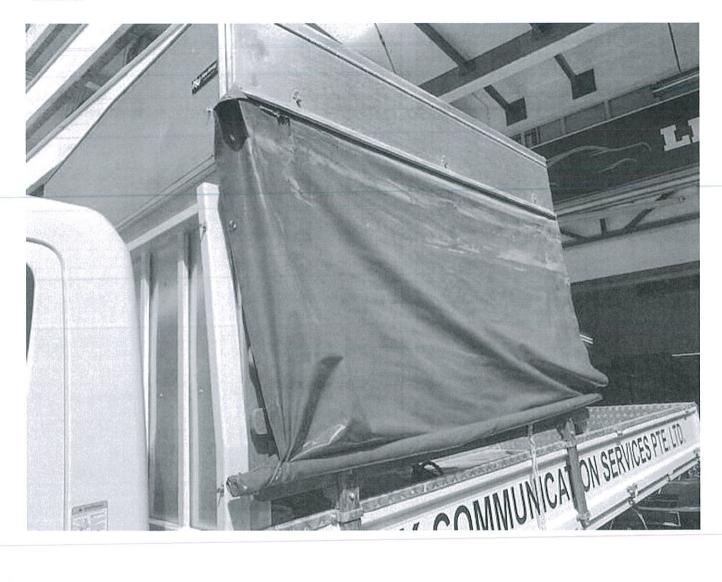
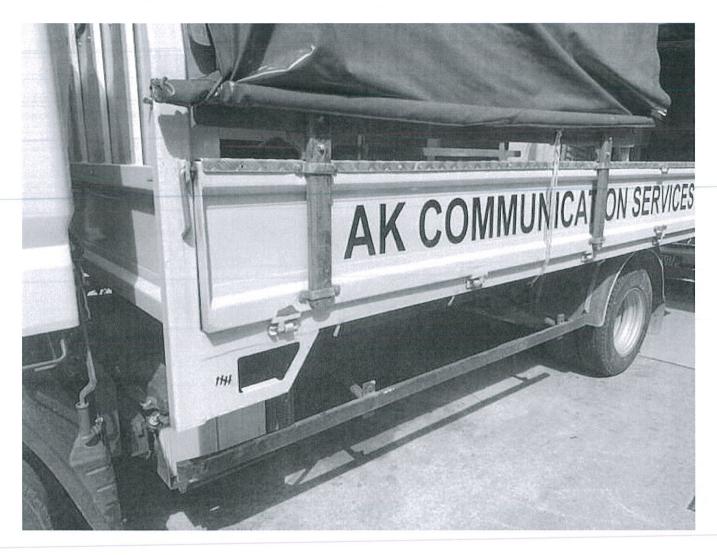
Postcode	· ·
Insurance Company Name	-
Nature Of Damage	-
Details of property damaged in accident	STATION VEHICLE YQ2593G HIT BY BOOM LIFT
No. Of Passenger (Including Driver)	-

Our adjusted cost of repair is SGD 29,864.05 to carry out the repairs. Please refer to Annex A (Appraisement Schedule) for a detailed account of the cost estimates.

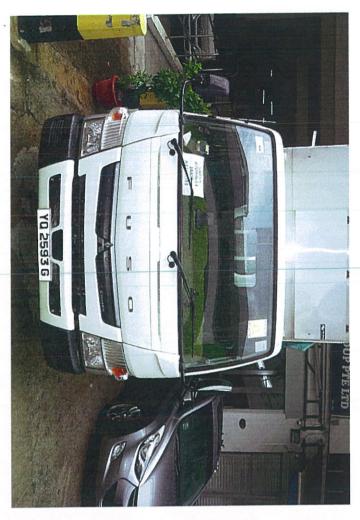
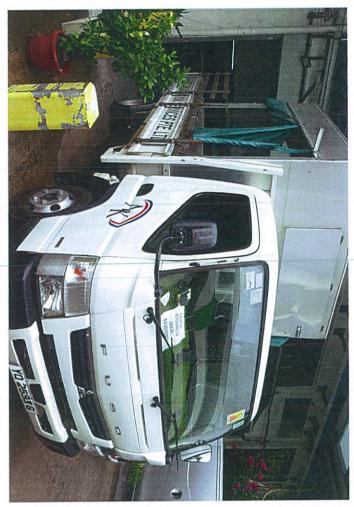
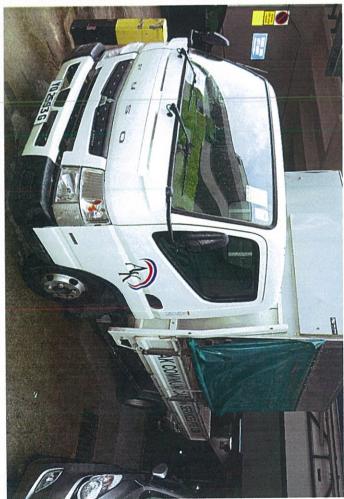
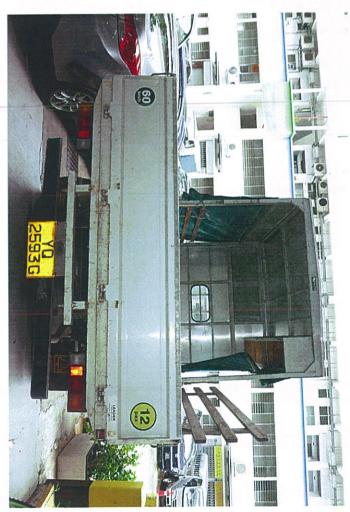
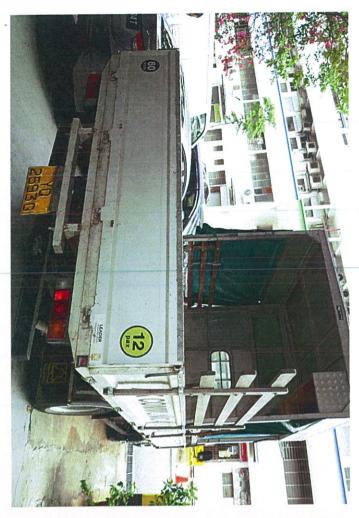
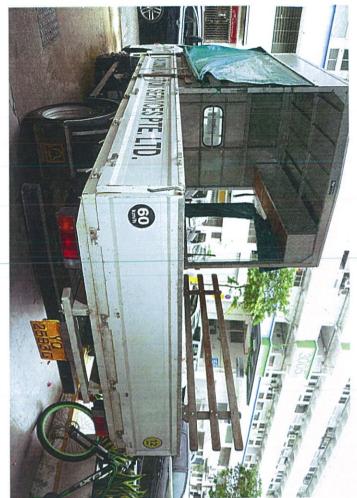
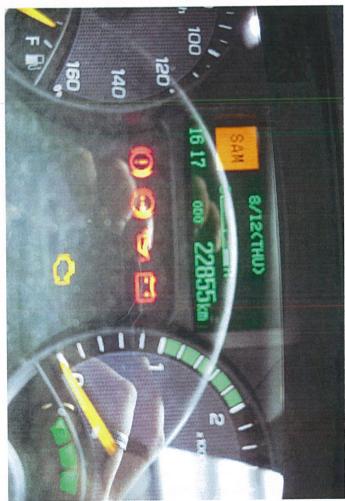
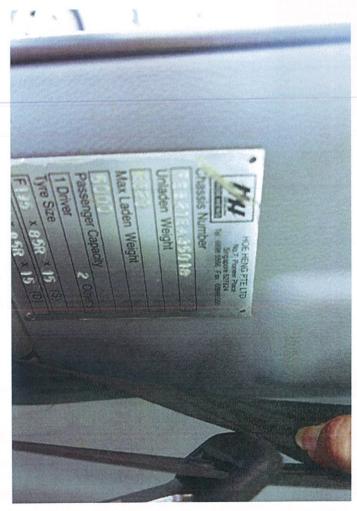
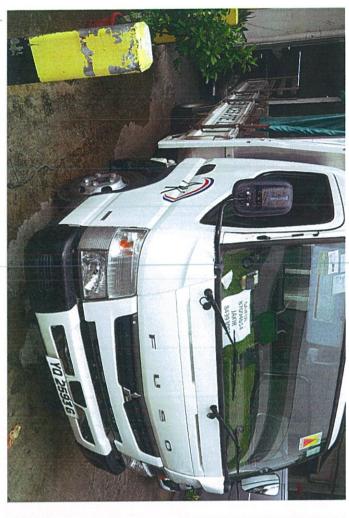
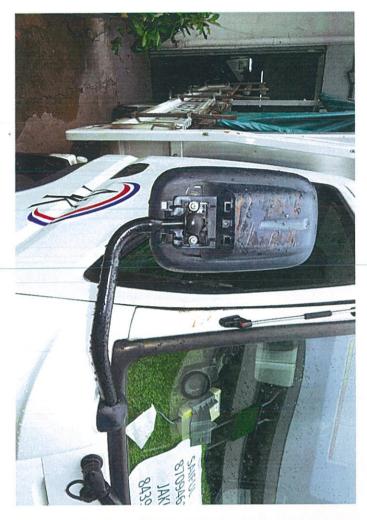
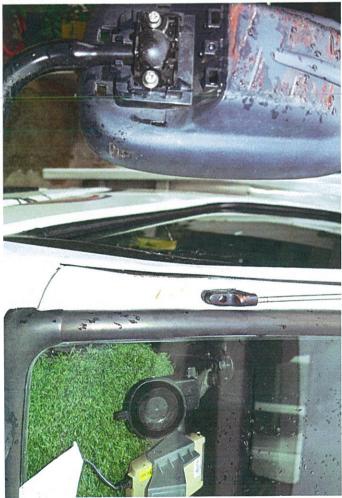
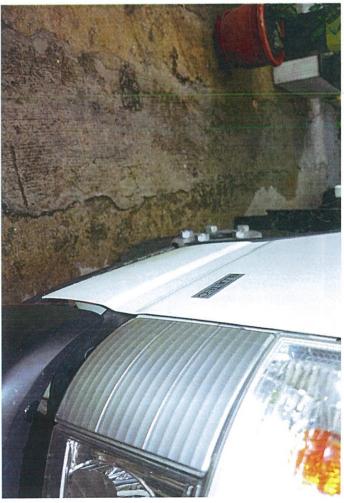
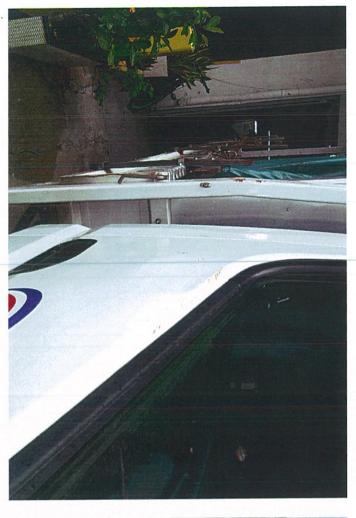
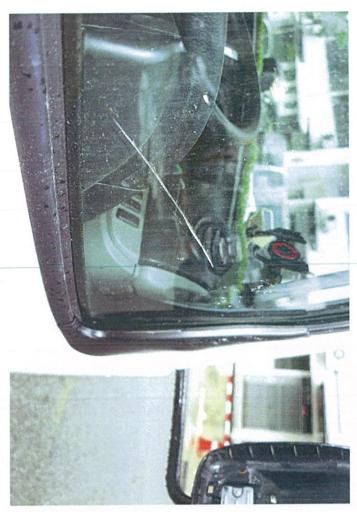
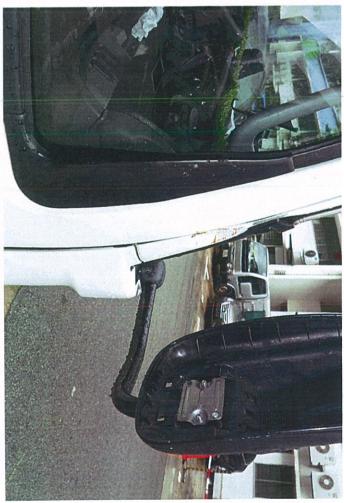
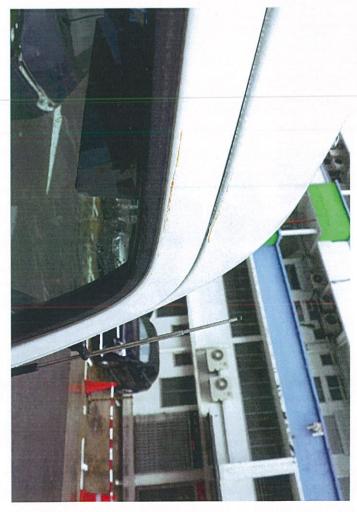
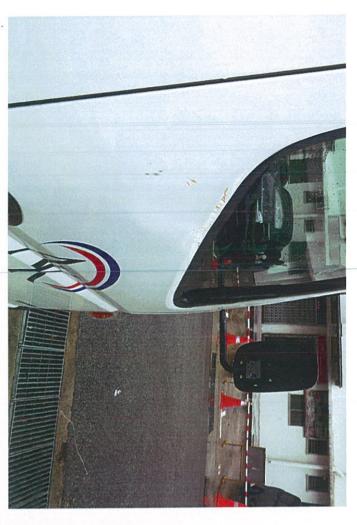
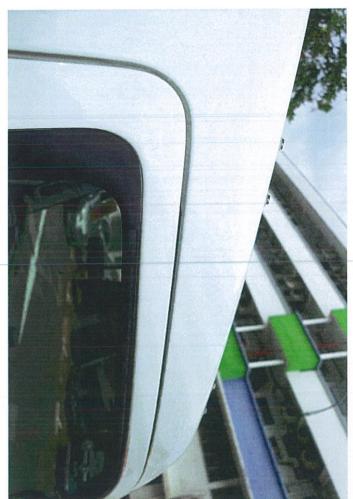
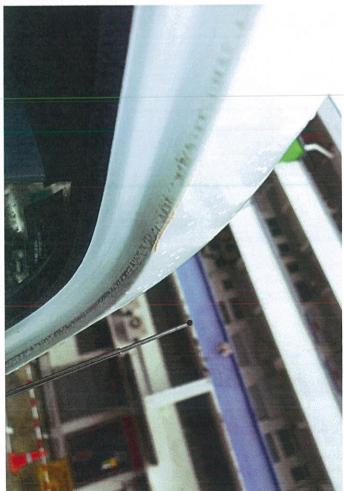
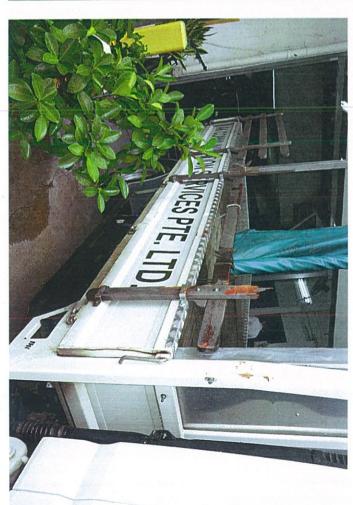
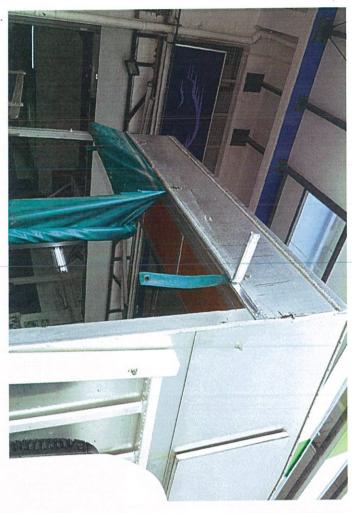
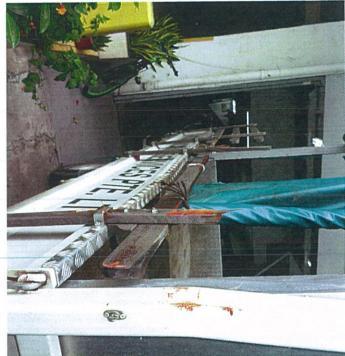
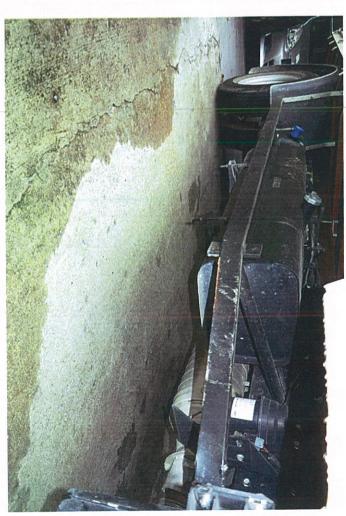
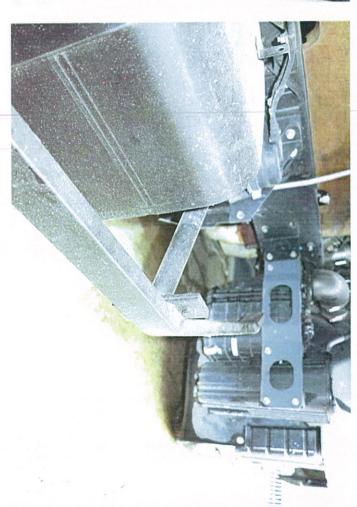
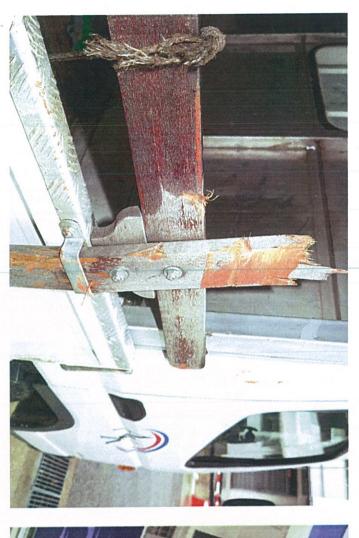
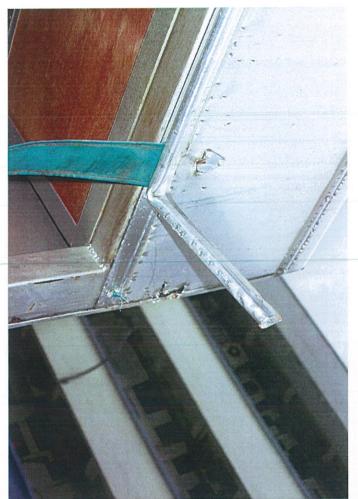
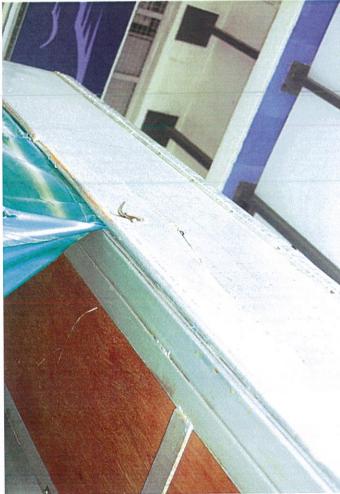
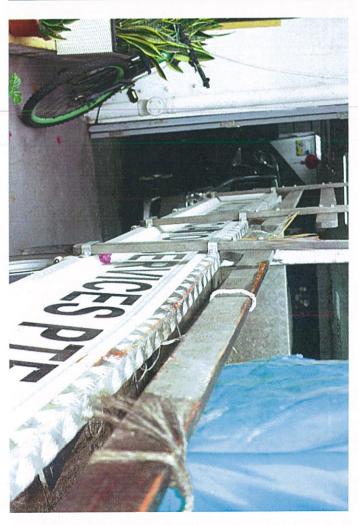
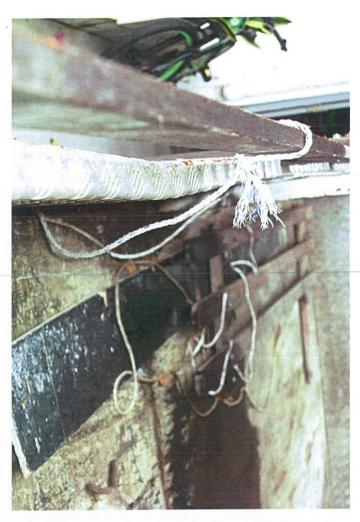
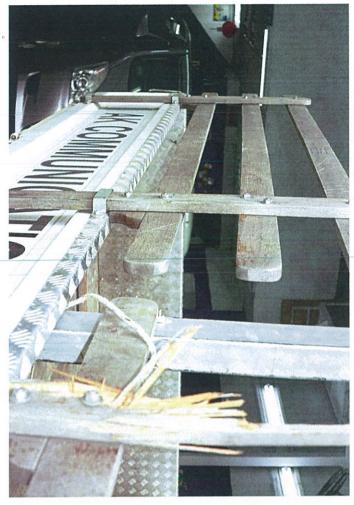
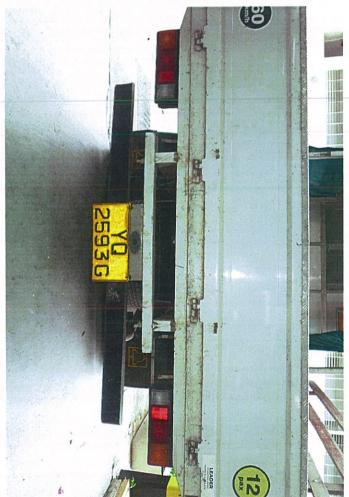
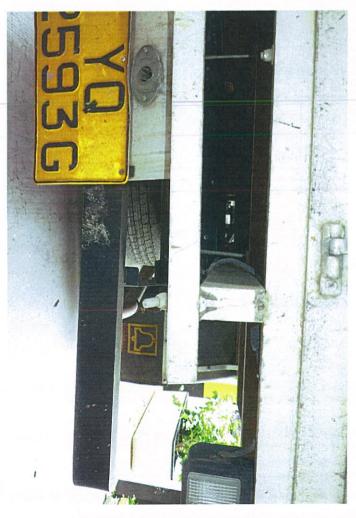
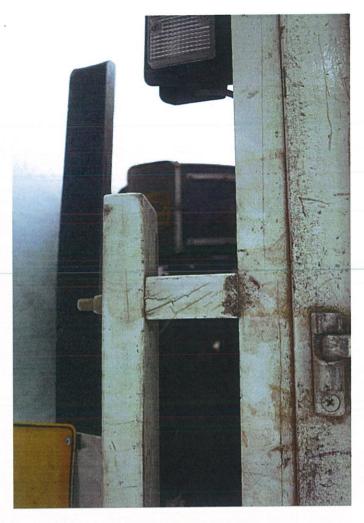
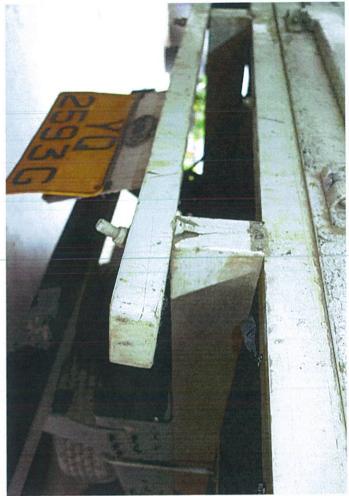
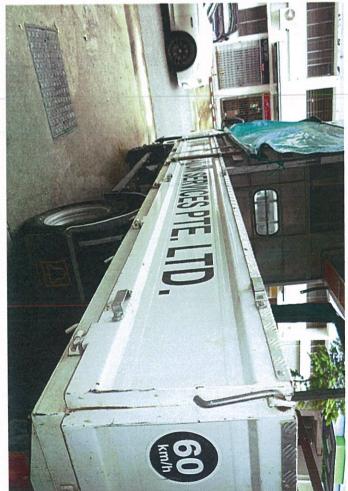
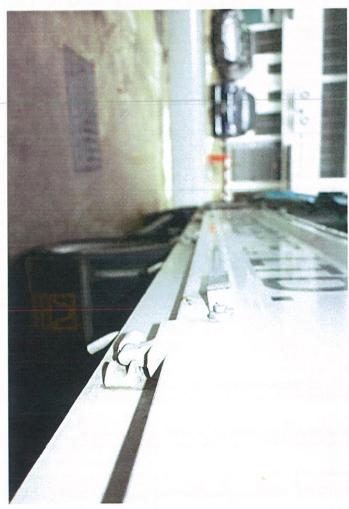
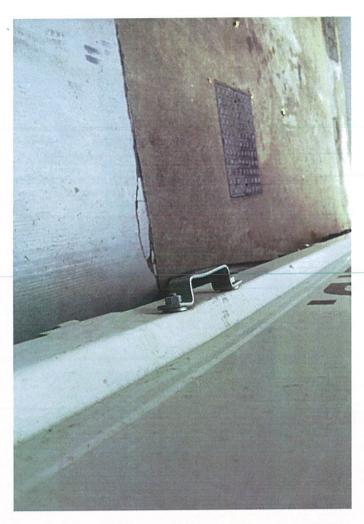
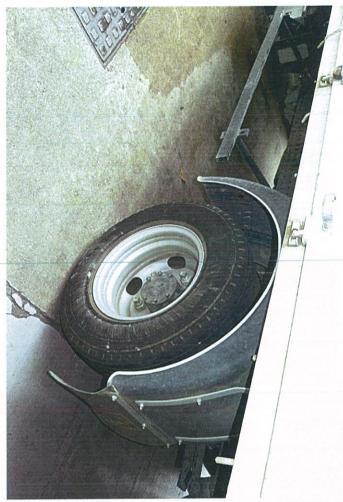
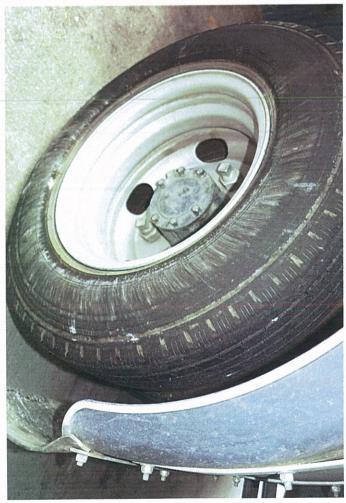
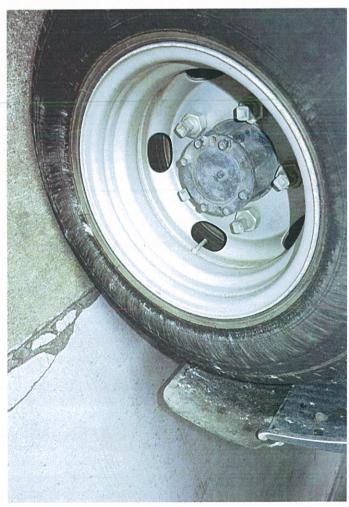
Please refer to Annex A (Appraisement Schedule) for a detailed account of the damages and photographs taken.

as per schedule attached has been revised and scrutinised, and in our opinion, we consider it to be fair and reasonable. The repairers have agreed to undertake the repairs to the owner's satisfaction at our revision. We have not authorised the repairs.
