# LKK Auto Consultants Pte Ltd

| Affiliated to Federation Internationale Des Experts En Automobile | | | | |
|---|---|---|---|--|
| <b>4. Description of Damages</b> | | | | |

## ADJUSTMENT ON REPAIR COST FOR VEHICLE NO. SHA 9092A

PHOTOGRAPHS FOR VEHICLE NO. SHA 9092A

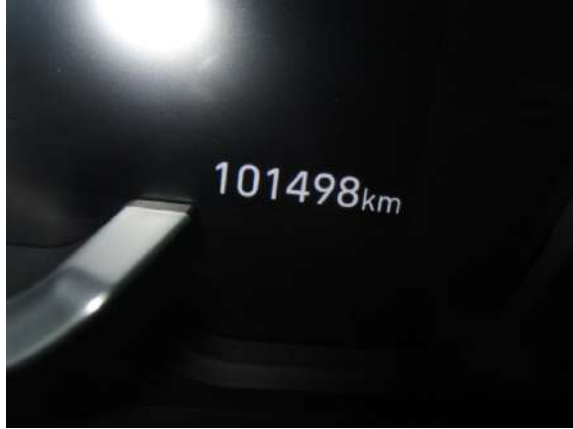
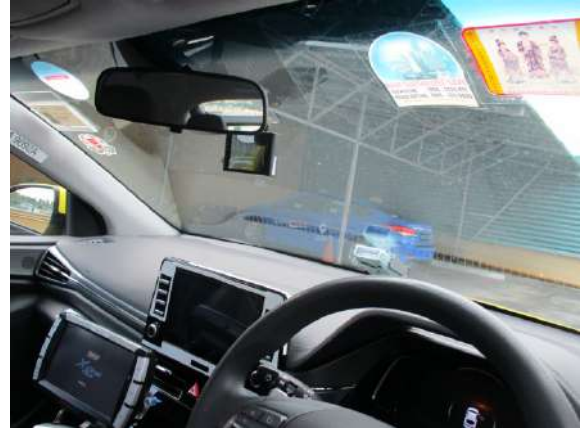
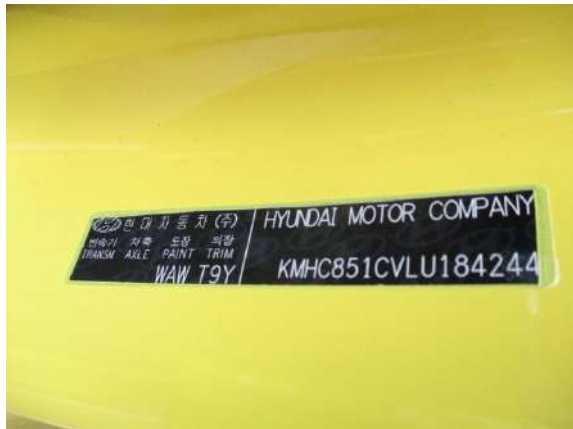
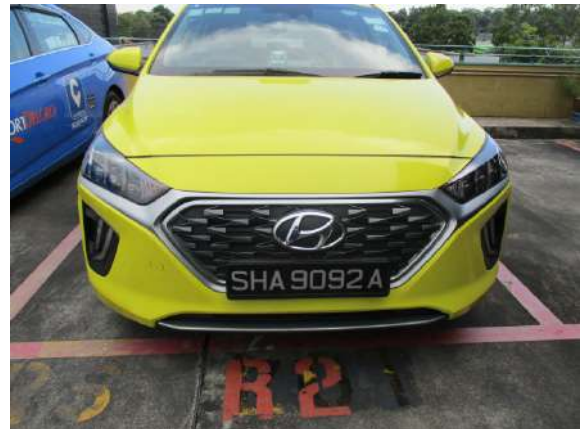
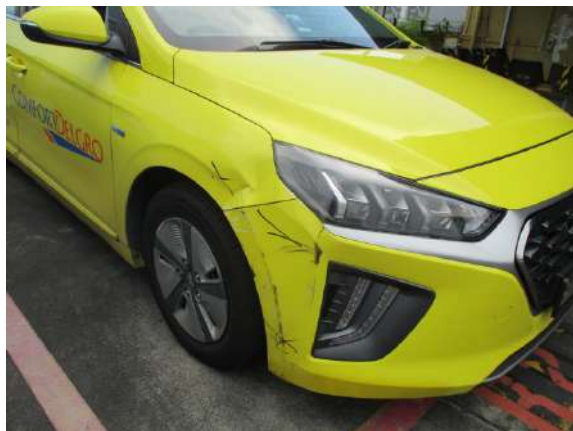
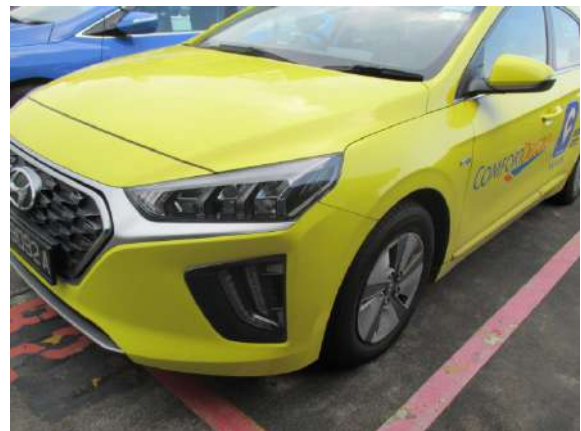
INSPECTION

| Affiliated to Federation Internationale Des Experts En Automobile | | | | |
|---|---|---|---|--|
| THE VEHICLE SUSTAINED DAMAGES AT THE O/S BODY.<br><br>DAMAGES SEE DETAILS. | | | | |
