# LKK Auto Consultants Pte Ltd

| Affiliated to Federation Internationale Des Experts En Automobile | | | | |
|---|---|---|---|---|
| | THE VEHICLE SUSTAINED DAMAGES AT THE REAR PORTION. | | | |

**Registration No. QX 1169M**

### PHOTOGRAPHS FOR VEHICLE NO. QX 1169M

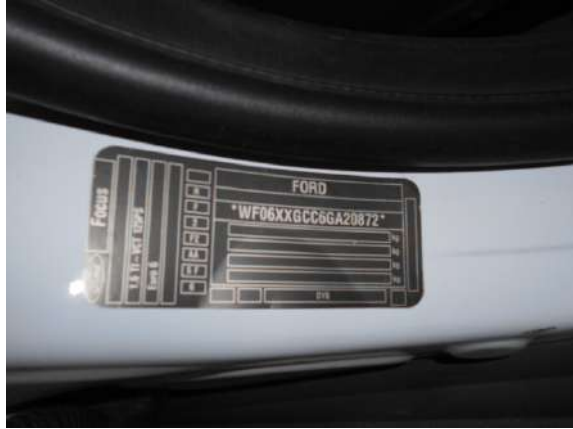
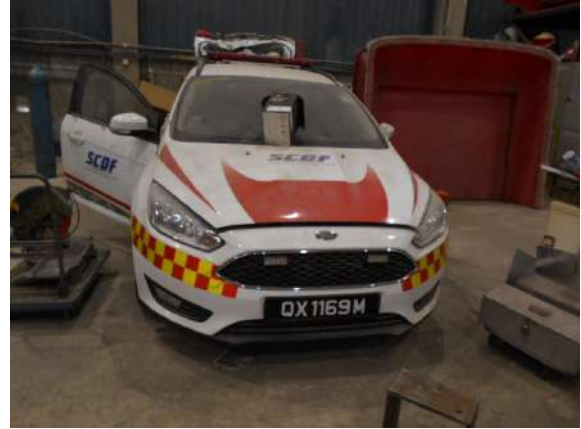
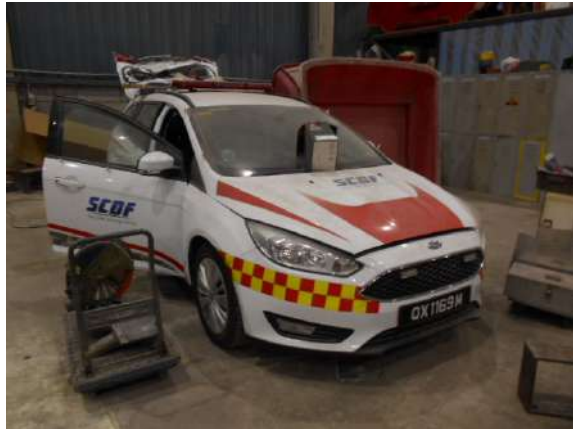
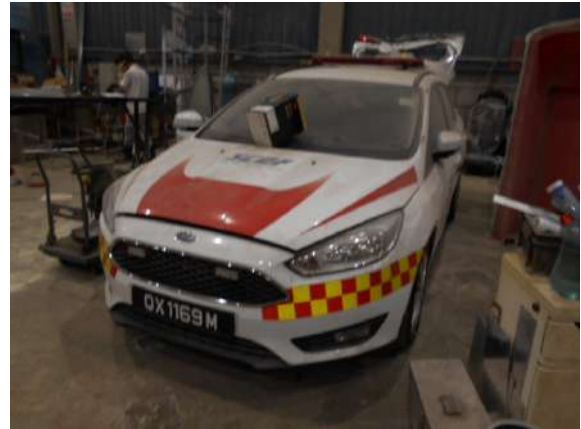
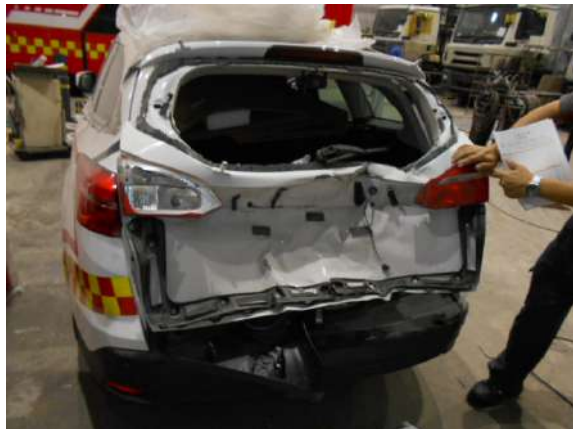
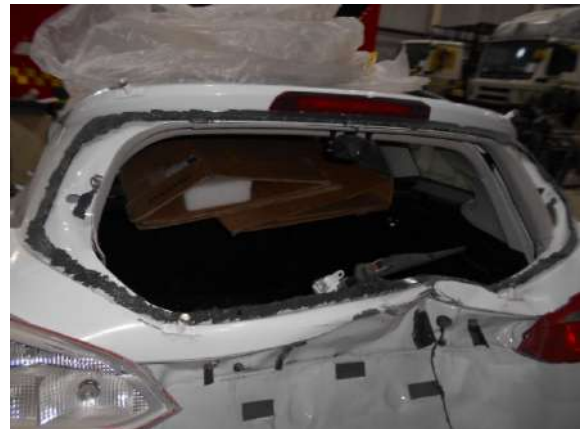
| Affiliated to Federation Internationale Des Experts En Automobile | | | | |
|---|---|---|---|---|
| | DAMAGES SEE DETAILS. | | | |
