4. Description of Damages				
	THE VEHICLE SUSTAINED DAMAGES AT THE FRONT O/S PORTION. DAMAGES SEE DETAILS.			
5. General Information				
Accident Date	20/09/2021		Inspection Date	20/10/2021
Survey held at	WAH HONG MOTORS & CREDIT PTE LTD 38 TOH GUAN ROAD EAST #01-57 ENTERPRISE HUB SINGAPORE 608581			
5a. Remarks				
	A)THE INSPECTION WAS CONDUCTED ON A"WITHOUT PREJUDICE" BASIS. B)IN ACCORDANCE TO YOUR INSTRUCTIONS, WE HAVE NOT AUTHORISED REPAIRS.			
5b. Estimate Days of Repair				
	ESTIMATED NORMAL PERIOD FOR REPAIR:		3 Working Days

ADJUSTMENT ON REPAIR COST FOR VEHICLE NO. SMQ 413Z

PHOTOGRAPHS FOR VEHICLE NO. SMQ 413Z

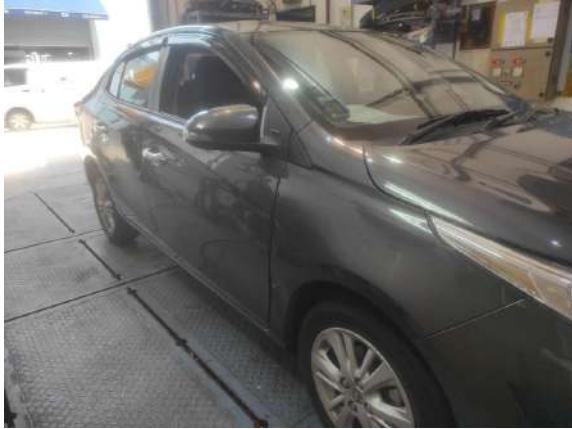
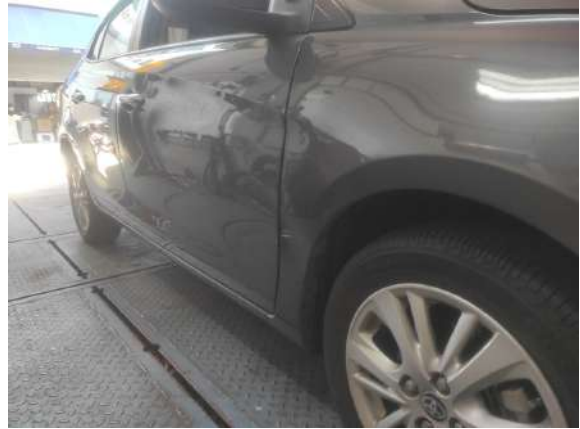
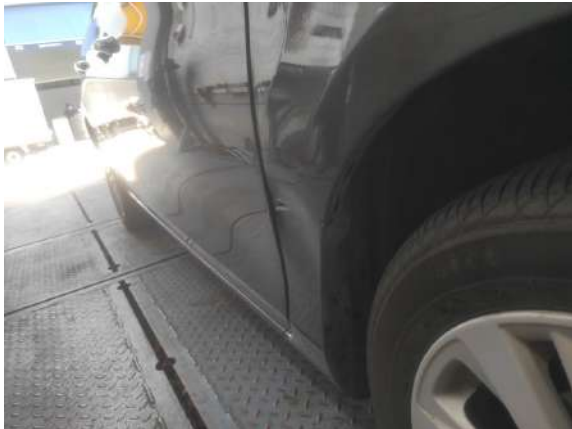
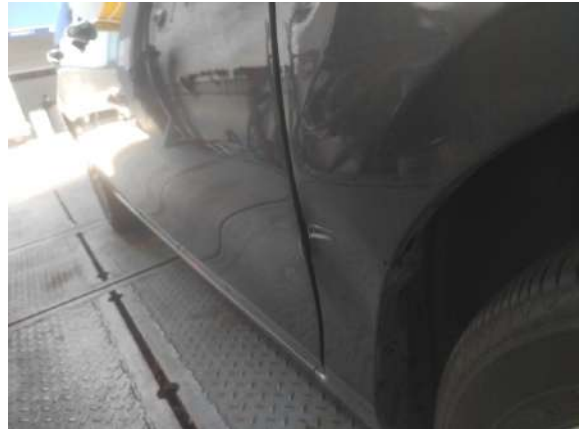
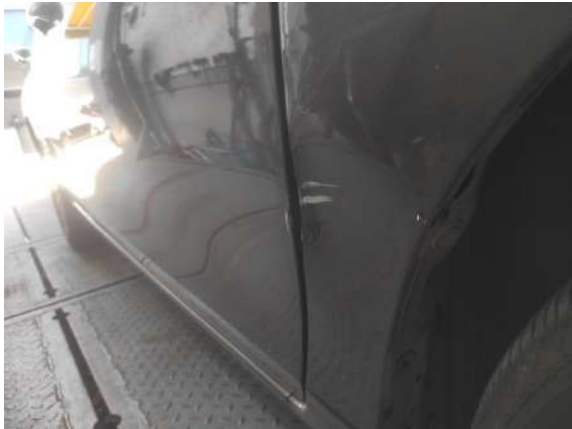
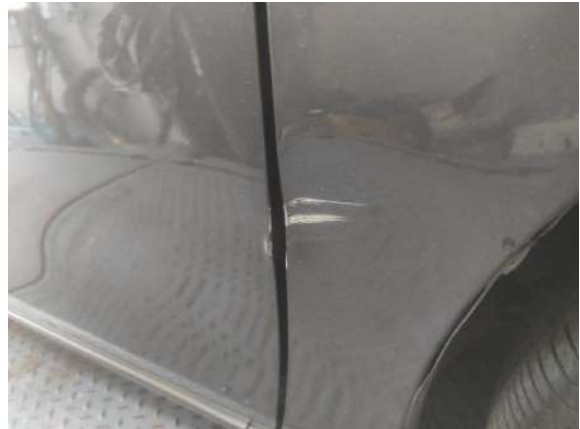
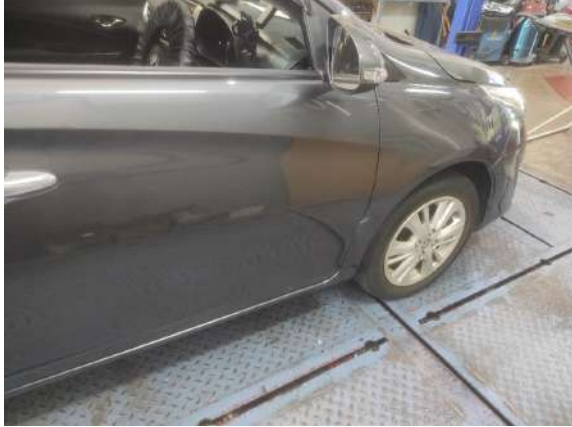
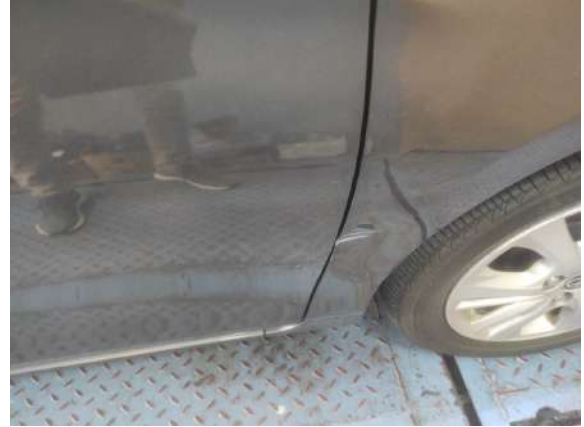
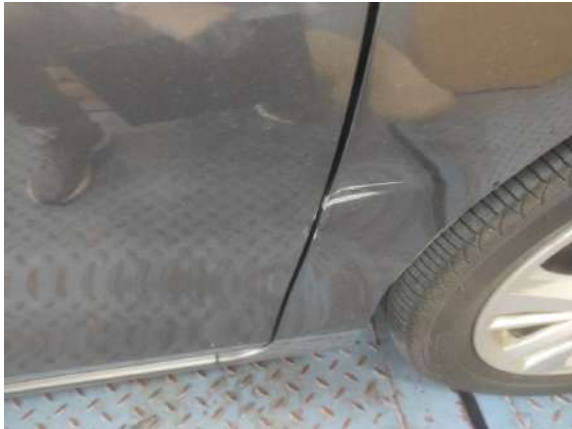
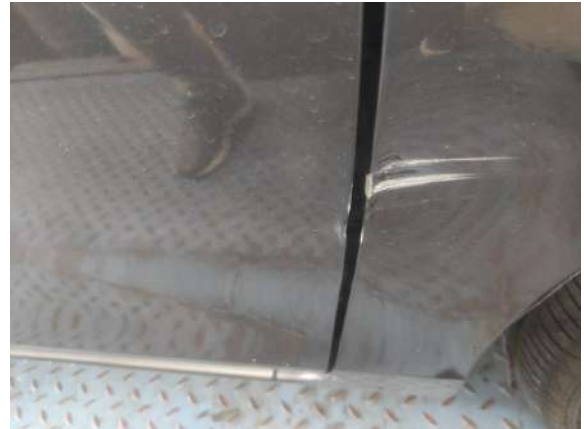
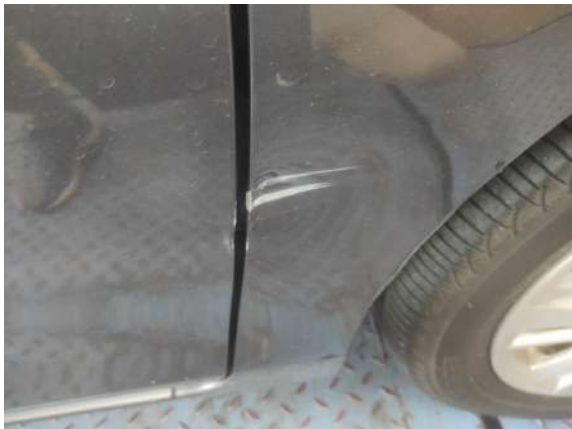
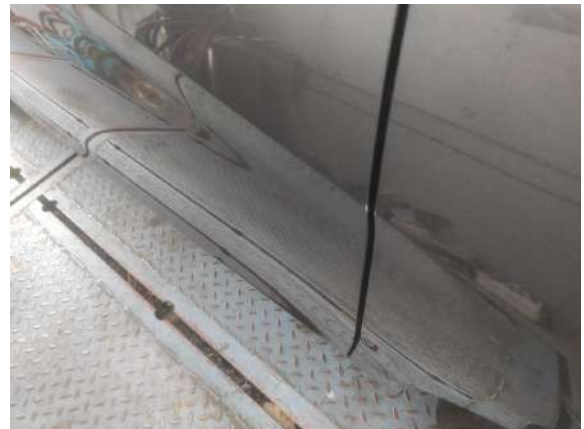
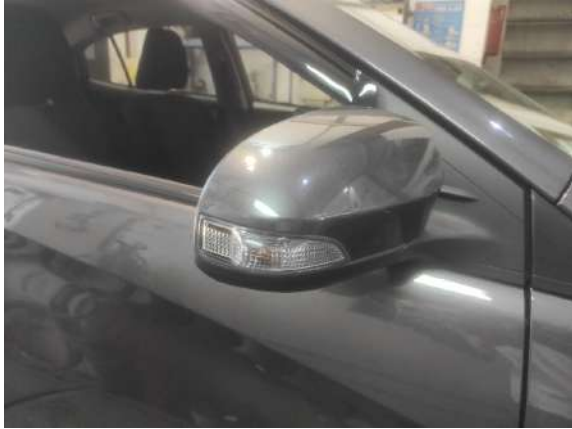
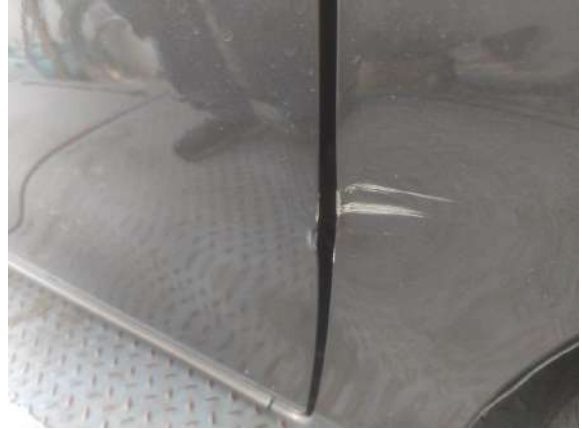
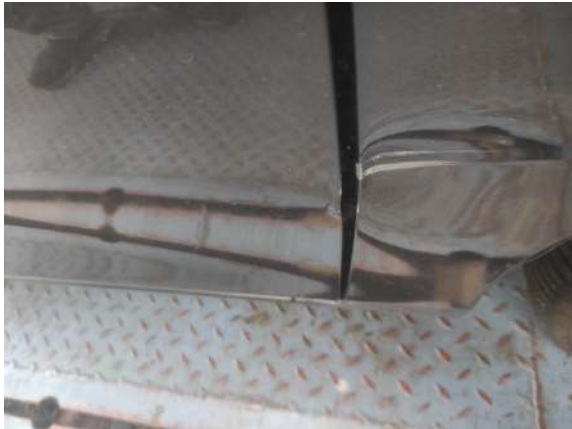
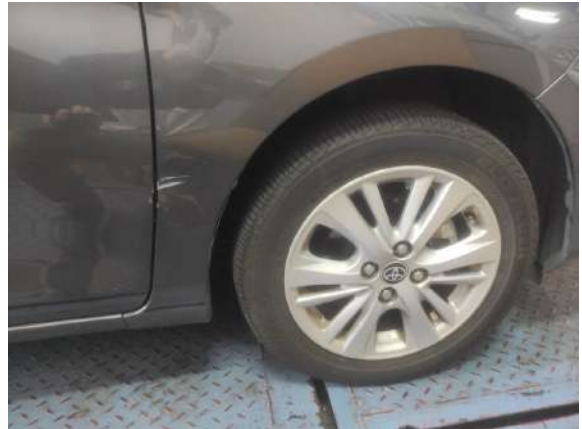
Qty	Description of Parts	Condition	Estimate By Workshop (\$)	Our Adjusted (\$)
	<u>REPLACEMENT OF PARTS</u>			
1	FRONT DOOR RH	TO REPAIR SEE LABOUR	200.00	-
1	FRONT FENDER RH	DENTED	578.90	578.90
	LESS 10% DISCOUNT		-77.89	-
	LESS 25% DISCOUNT		-	-144.73

701.01	434.17
	<u>SPECIAL NETT ITEMS</u>			
1	FRONT FENDER CLIPS (SN)	NOT NECESSARY	35.00	-
			35.00	-
	<u>LABOUR</u>			
	TO REMOVE THE AFFECTED PARTS & FITTINGS TO COMMENCE REPAIRS ,PANEL BEAT & RESHAPE THE AFFECTED AREAS AND REPLACE THE DAMAGED PARTS AND COMPONENTS.INCLUSIVE OF THE REPAIR OF FRONT DOOR RH .		400.00	250.00
	TO SUPPLY PAINT MATERIALS ,EXPANDABLE ITEMS & PUTTY,RESPRAY PAINT ON PARTS REPLACED & REPAIRED.		400.00	400.00
	TO PERFORM ANTI-RUST TREATMENT ON AFFECTED AREAS .		40.00	30.00
	TO REMOVE AND REFIX WIRING SYSTEM AT ACCIDENT DAMAGED AREA AND CHECK FOR ALL ELECTRICAL PROPER FUNCTION.		30.00	30.00
	TO REMOVE AND REFIT /REPLACE FRONT DOOR RH FITTING ,TRIMMINGS ,GARNISH,WINDOW GLASS AND LOCK MECHANISM .	NOT NECESSARY	100.00	-

RECOMMENDED COST OF LUMP SUM REPAIRS (TO ITS PRE-ACCIDENT CONDITION)			900.00
---	--	--	---------------
