2. Vehicle Particulars & Condition

4. Description of Damages

ADJUSTMENT ON REPAIR COST FOR VEHICLE NO. GBK 6290H

PHOTOGRAPHS FOR VEHICLE NO. GBK 6290H

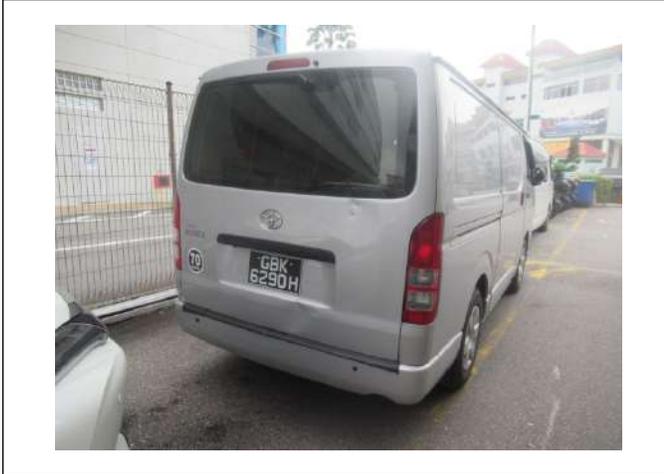
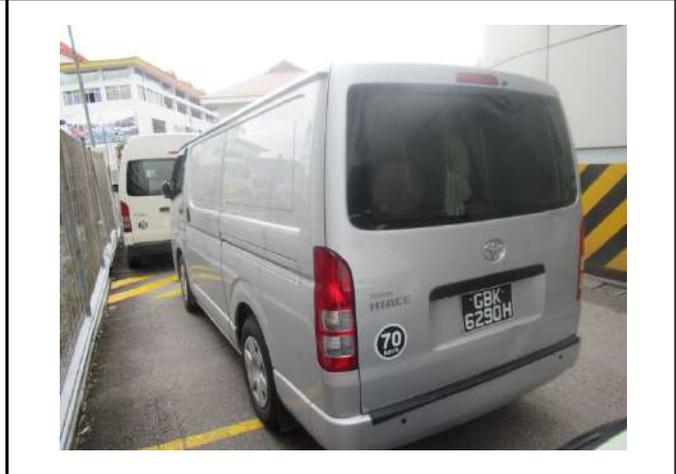
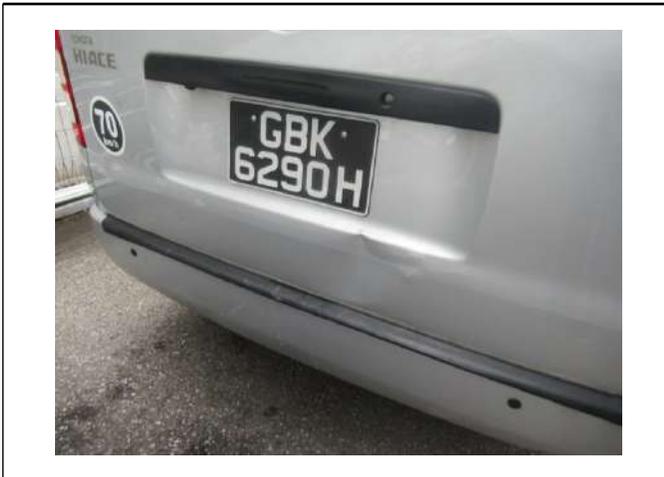
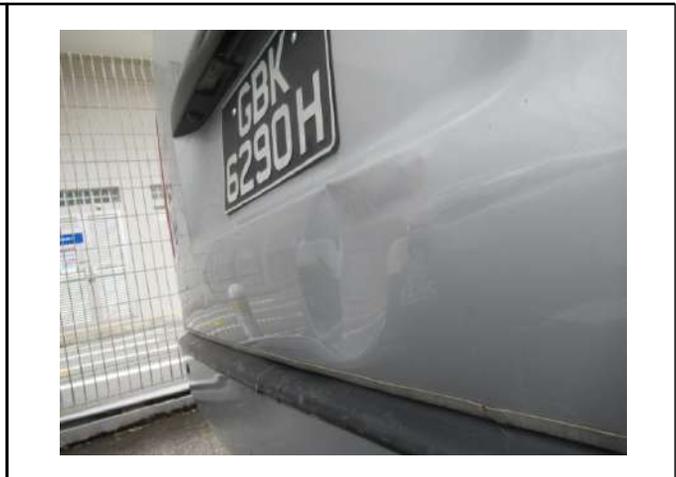
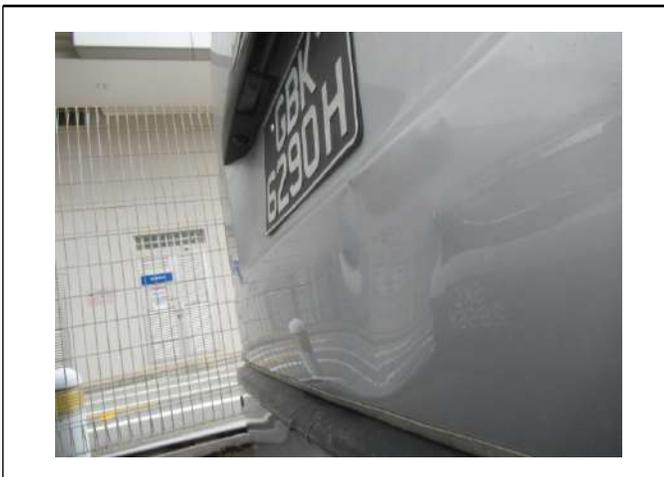
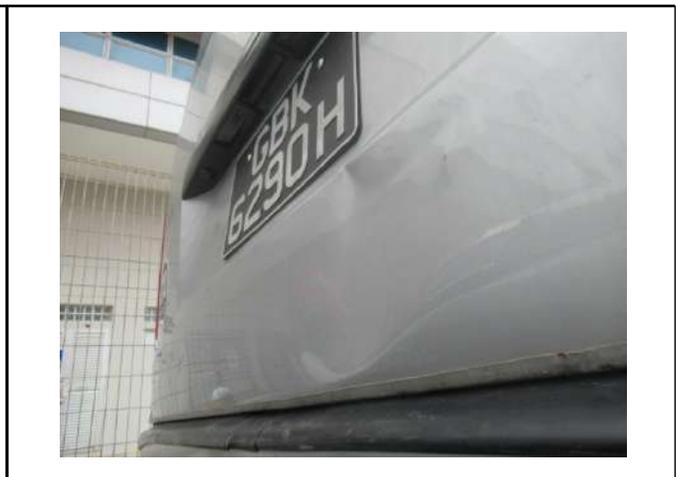
INSPECTION

THE VEHICLE SUSTAINED DAMAGES AT THE REAR PORTION.
DAMAGES SEE DETAILS.

Qty	Description of Parts	Condition	Estimate By Workshop (\$)	Our Adjusted (\$)
REPLACEMENT OF PARTS				
1	SUNDRIES (SN)	NECESSARY	30.00	30.00
1	REAR BUMPER COVER (SN)	DENTED / BENT	458.80	458.80
1	L/R BPR SIDE SUPPORT (SN)	NOT NECESSARY	23.60	-
1	R/R SIDE BPR RETAINER (SN)	NOT NECESSARY	23.60	-
4	REAR BUMPER BRACKET (SN)	BENT / NECESSARY	105.60	105.60
4	GROMMET SCREW (SN)	NECESSARY	8.80	8.80
1	REAR OUTER FLR MEMBER (SN)	TO REPAIR SEE LABOUR	346.40	-
1	PANEL SUB-ASSY ,BACK (SN)	DENTED	2,184.00	2,184.00
1	RR BACK DOOR W/STRIP (SN)	NECESSARY	412.60	-
1	GLAS SUB-ASSY ,BACK (SN)	NECESSARY	1,352.20	1,352.20
1	EMBLEM (SN)	NECESSARY	72.20	72.20
1	PLATE LUGGAGE (SN)	NECESSARY	49.10	49.10
2	SIKA182010 SIKA TACK GO (BLA) (SN)	NECESSARY	216.00	216.00
1	SIKA 207 G+P ADHESIVE PRIMER (SN)	NECESSARY	200.00	200.00
1	TAILGATE STICKER -70KM/H (SN)	NECESSARY	18.00	18.00
2	PT SENSOR FOR HIACE (SN)	NECESSARY	56.40	56.40
			5,557.30	4,751.10

LABOUR				
DRILL HOLE & INSTALL REAR REVERSE SENSOR .			180.00	180.00
CHECK LIGHTING & CONDUCT WATER LEAK TEST.			180.00	180.00
SUPPLY SEALANT -TAILGATE.			60.00	60.00
TRANSFER & INSTALL COMPONENTS TO NEW TAILGATE.			360.00	360.00
REPLACE & INSTALL REAR WINDSCREEN GLASS .			495.00	462.00
TO RESET ECU AND REPROGRAMME.			180.00	180.00
REPLACE REAR ACCIDENT DAMAGED PARTS STRAIGHTEN & ALIGN REAR ACCIDENT AFFECTED AREAS .INCLUSIVE OF THE REPAIR OF REAR OUTER FLR MEMBER.			2,880.00	1,800.00
