Vehicle No. SKZ 2636K  
Insured Veh. SLP 2994S  
Claim No. SNM21D206586/C02  
Policy No. DMPCSNW00097242100  
Accident Date 13/11/2021  
Inspection Date 17/11/2021

## ADJUSTMENT ON REPAIR COST FOR VEHICLE NO. SKZ 2636K

### PHOTOGRAPHS FOR VEHICLE NO. SKZ 2636K

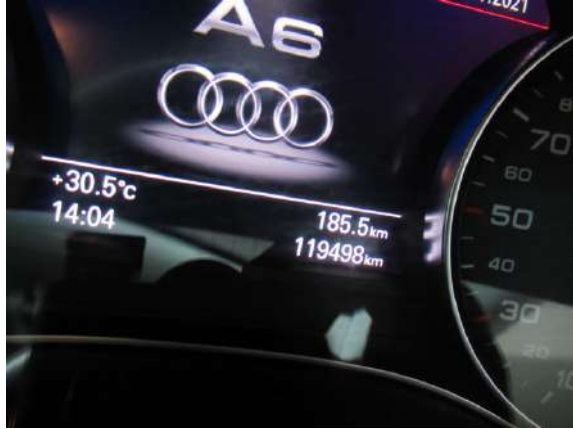
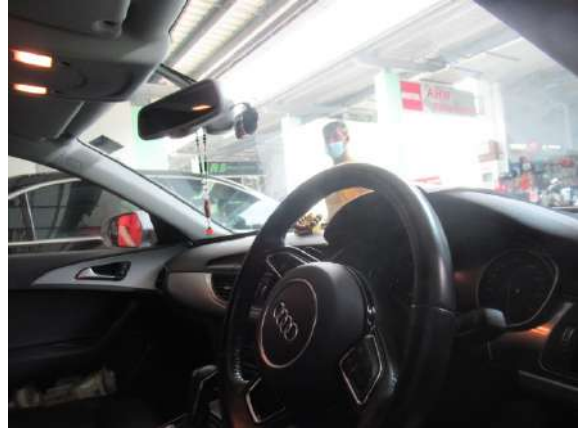
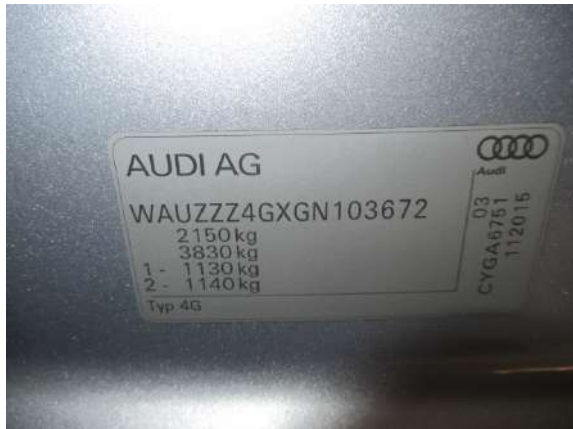
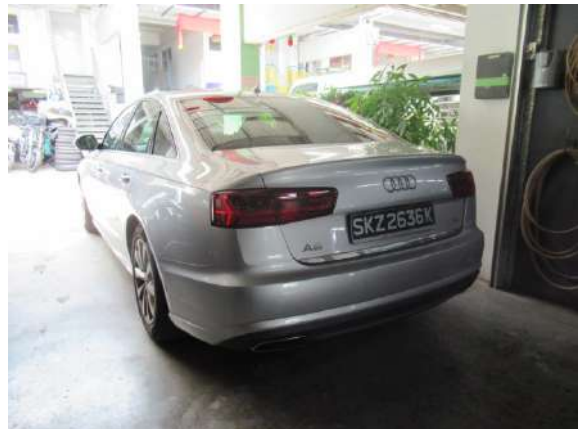
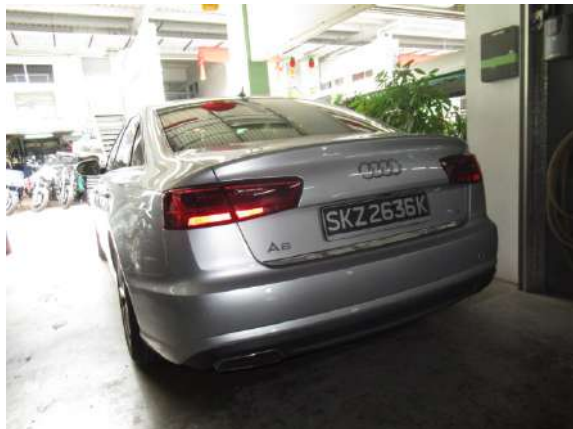
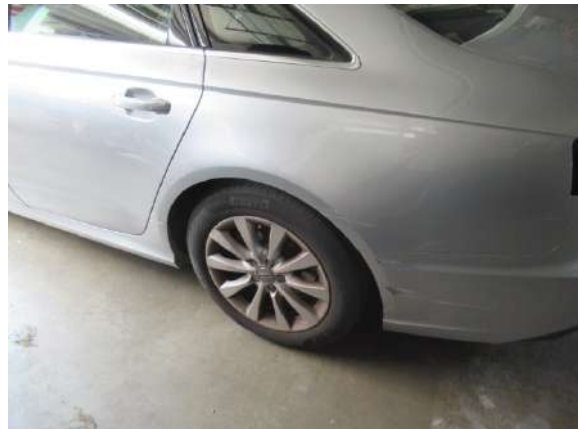
### INSPECTION

| Affiliated to Federation Internationale Des Experts En Automobile | | | | |
|---|---|---|---|---|
| | THE VEHICLE SUSTAINED DAMAGES AT THE N/S REAR PORTION.THE UNDERCARRIAGE AFFECTED DUE TO COLLISION.<br><br>DAMAGES SEE DETAILS. | | | |

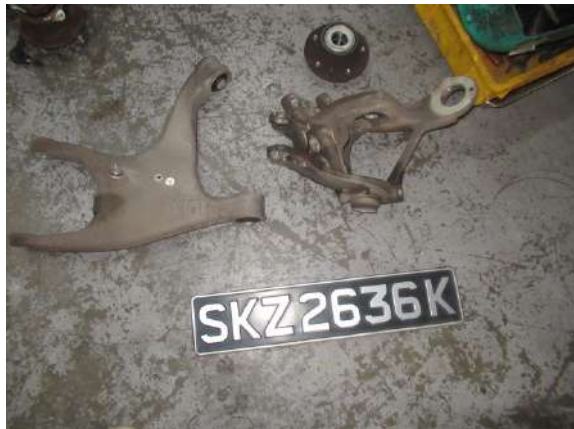
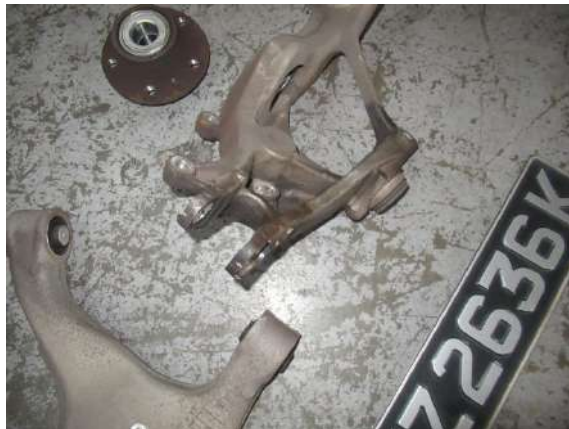
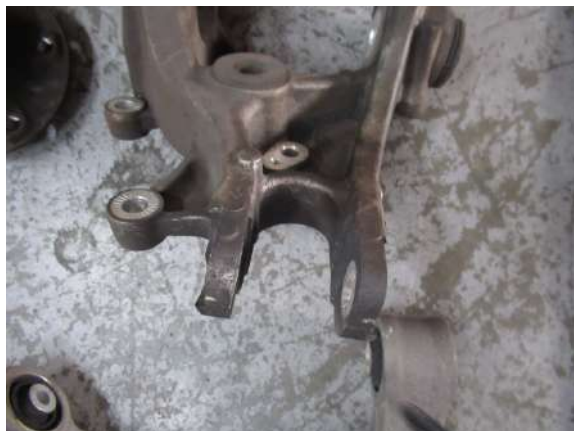
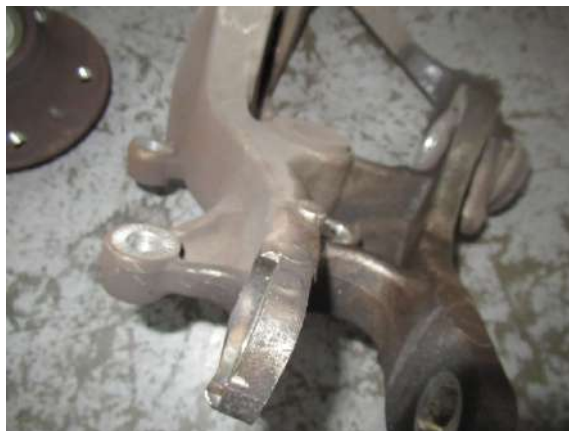
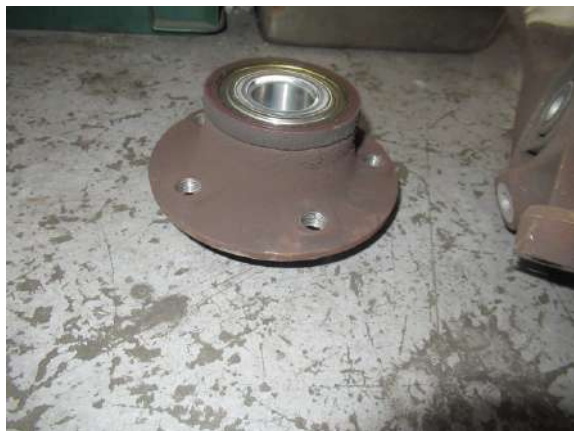
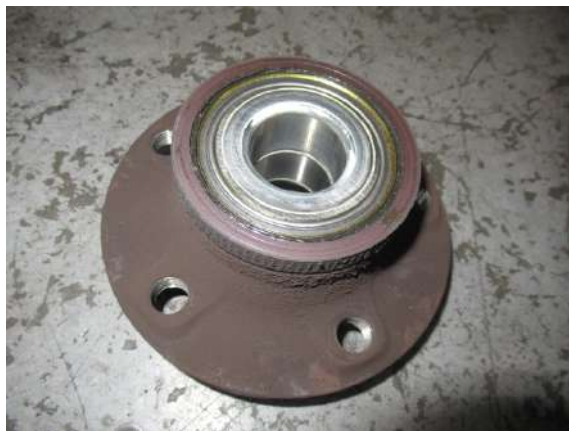
PHOTOGRAPHS FOR VEHICLE NO. SKZ 2636K

RE-INSPECTION
