# LKK Auto Consultants Pte Ltd

## ADJUSTMENT ON REPAIR COST FOR VEHICLE NO. SKK 7823H

### PHOTOGRAPHS FOR VEHICLE NO. SKK 7823H

### INSPECTION

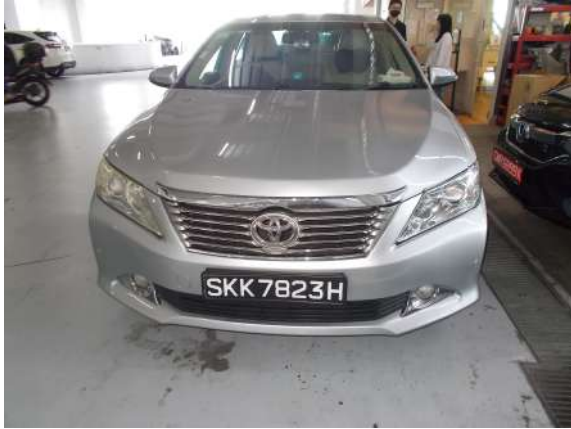
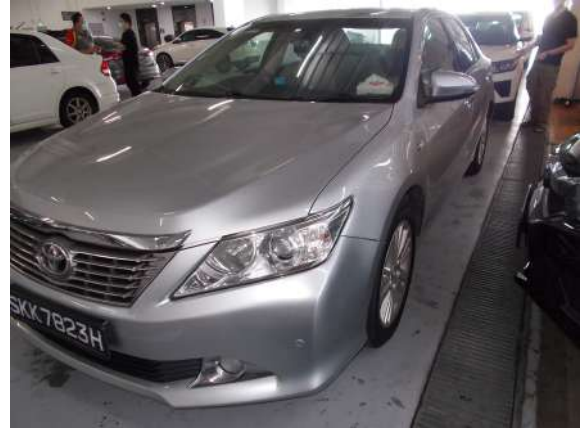
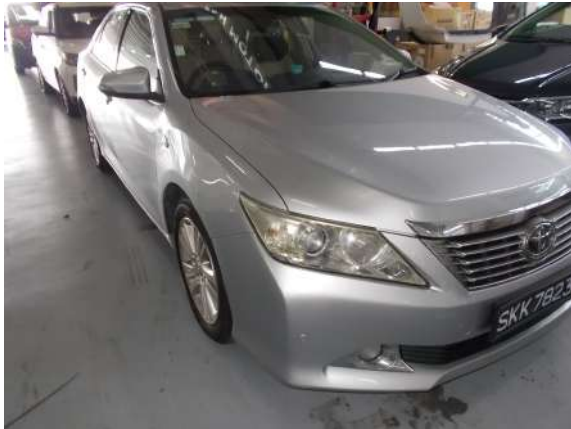
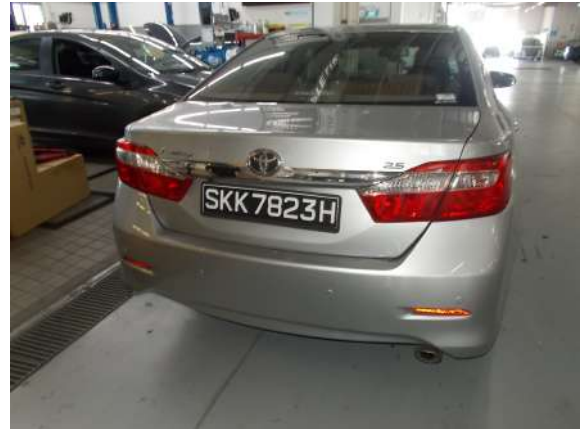
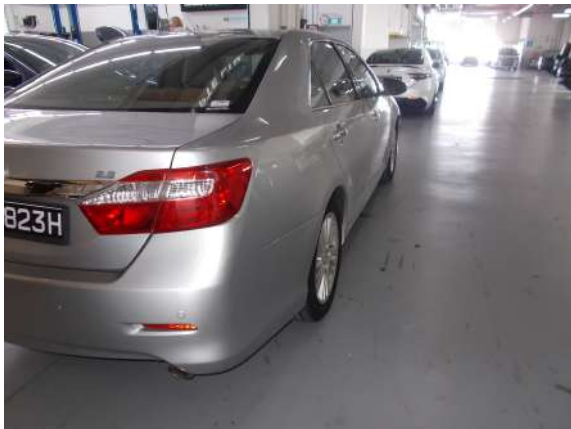
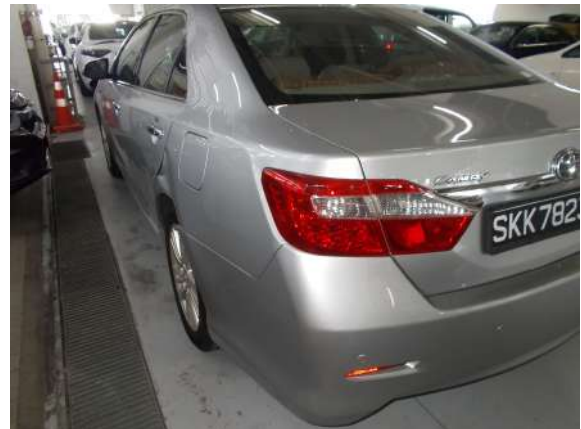
<b>4. Description of Damages</b>				
THE VEHICLE SUSTAINED DAMAGES AT THE N/S BODY.				
DAMAGES SEE DETAILS.				
<b>5. General Information</b>				
Accident Date	24/11/2021	Inspection Date	13/12/2021	
Survey held at	S & H MOTOR PTE LTD 160 SIN MING DRIVE #07-02 SIN MING AUTOCITY SINGAPORE 575722			
<b>5a. Remarks</b>				
A)THE INSPECTION WAS CONDUCTED ON A"WITHOUT PREJUDICE" BASIS. B)IN ACCORDANCE TO YOUR INSTRUCTIONS, WE HAVE NOT AUTHORISED REPAIRS.				
<b>5b. Estimate Days of Repair</b>				
ESTIMATED NORMAL PERIOD FOR REPAIR:			6 Working Days

Qty	Description of Parts	Condition	Estimate By Workshop (\$)	Our Adjusted (\$)
	<b><u>REPLACEMENT OF PARTS</u></b>			
1	LH REAR FENDER	DENTED	963.90	845.10
1	LH REAR FENDER WHEEL COWLING	NOT DAMAGED	349.20	-
1	SET LH REAR FENDER WHEEL COWLING CLIPS	NOT NECESSARY	35.00	-
1	REAR WINDSCREEN MOULDING	NECESSARY	120.70	120.70
1	LH REAR BUMPER RETAINER	NECESSARY	162.80	109.30
1	LH REAR DOOR	DENTED	1,503.00	1,248.50
1	LH REAR DOOR WINDOW REGULATOR	NOT DAMAGED	255.00	-
1	LH REAR DOOR WINDOW REGULATOR MOTOR	NOT DAMAGED	1,160.90	-
1	LH RUNNING BOARD GARNISH	DENTED	595.40	498.66
1	LH RUNNING BOARD GARNISH CHROME MOULDING	CUT	144.60	144.60
	LESS 20% DISCOUNT		-1,058.10	-
	LESS 25% DISCOUNT		-	-741.72
			4,232.40	2,225.14
	<b><u>SPECIAL NETT ITEMS</u></b>			
1	REAR WINDSCREEN SEALANT (SN)	NECESSARY	60.00	30.00
1	REAR WINDSCREEN INNER RUBBER SEAL (SN)	NECESSARY	28.00	28.00

88.00	58.00
	<b><u>LABOUR</u></b>			
	TO REMOVE AND REINSTALL REAR WINDSCREEN AND CONDUCT WATER LEAK TEST.		120.00	120.00
	TO REMOVE DAMAGED PARTS, TO JACK OUT LH REAR FENDER INNER PANEL, LH CENTRE DOOR PILLAR, LH RUNNING BOARD PANEL, AND CUT OUT DAMAGED PANELS, TO REWELD, RESHAPE AND REPAIR LH REAR FENDER AND INNER PANEL, LH CENTRE DOOR PILLAR, TO REMOVE AND REFIT DOOR TRIM, LOCK, WINDOW, TO REPLACE DAMAGED PARTS AND ADJUST BODY PANEL ALIGNMENT.		800.00	600.00
	TO SPRAY PAINT AFFECTED LH SIDE AND INNER DAMAGED PORTION INCLUSIVE OF PREPARATORY WORKS AND MATERIAL.		1,050.00	1,000.00
