ASSIGNMENT

Remark: The veh had commenced its
repair at the time of inspection.

Manufacturer: VOLVO
Model: V40 (M)
Sub Model: BASE MODEL
Model Sheet Number: 41 29 01
Registration: SLV 2734U

SINGAPORE ACCIDENT STATEMENT

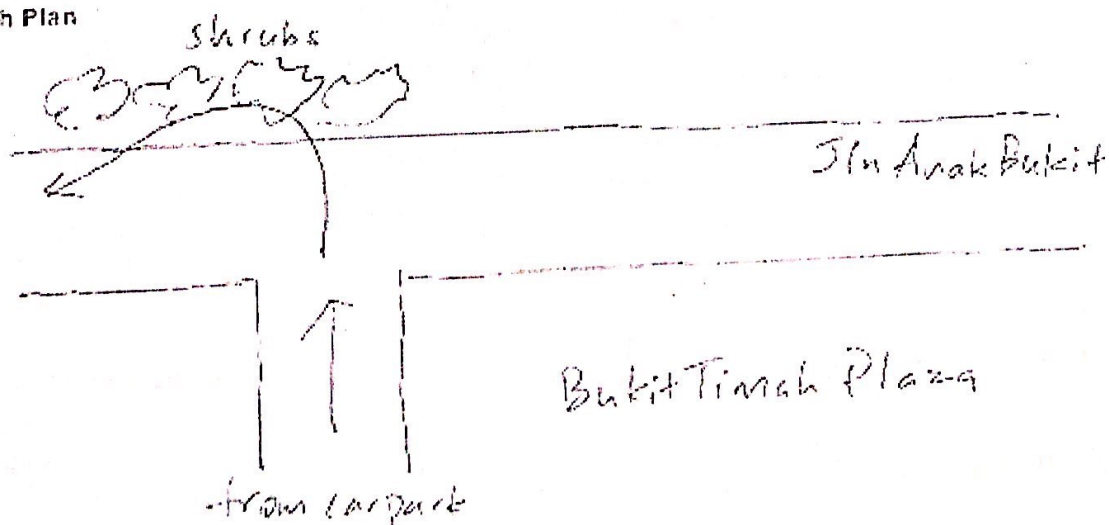
Sketch Plan

Date of Submission	07/12/2021 17:17 (SGT)
Date of Accident	06/12/2021 20:00 (SGT)
Exact Location of Accident	Jln Anak Bukit, Singapore
Additional Location Information	turning out from car park of Bukit Timah Plaza
Country/State of Loss	Singapore
