SF0H214J0002 / FALCON-AIR AUTO SERVICES PTE LTD [128228]  
ENTRY DATE & TIME: 19/04/2021 12:45 (SGT)  
SUBMITTED BY: Andy Esporanza  
VERSION: 1 (19/04/2021 12:45 (SGT))

## SINGAPORE ACCIDENT STATEMENT

## VEHICLE INSPECTION REPORT

Report No. TP/0007/21	Date of Report	: 19 May 21
To : Chan Eng Huat	Date of Request	: 22 April 21
Block 533 #22-807	Report requested by	: Chan Eng Huat
Bukit Panjang Ring Road	Date of Accident	: 16 April 21
Singapore 670533	Date of Inspection	: 22 April 21
	Claim No.	: Third Party Claim

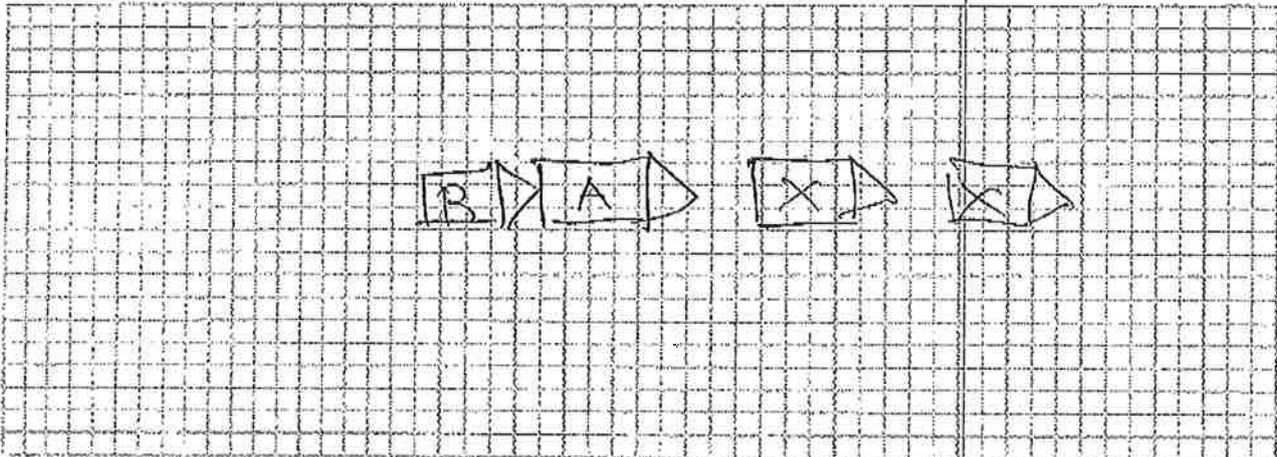
**Sketch Plan**

IT WAS A HEAVY TRAFFIC. VEHICLE IN FRONT OF ME STOPPED. I ALSO STOPPED. SUDDENLY VEHICLE B (SLL 8980M) HIT THE REAR PORTION OF MY VEHICLE

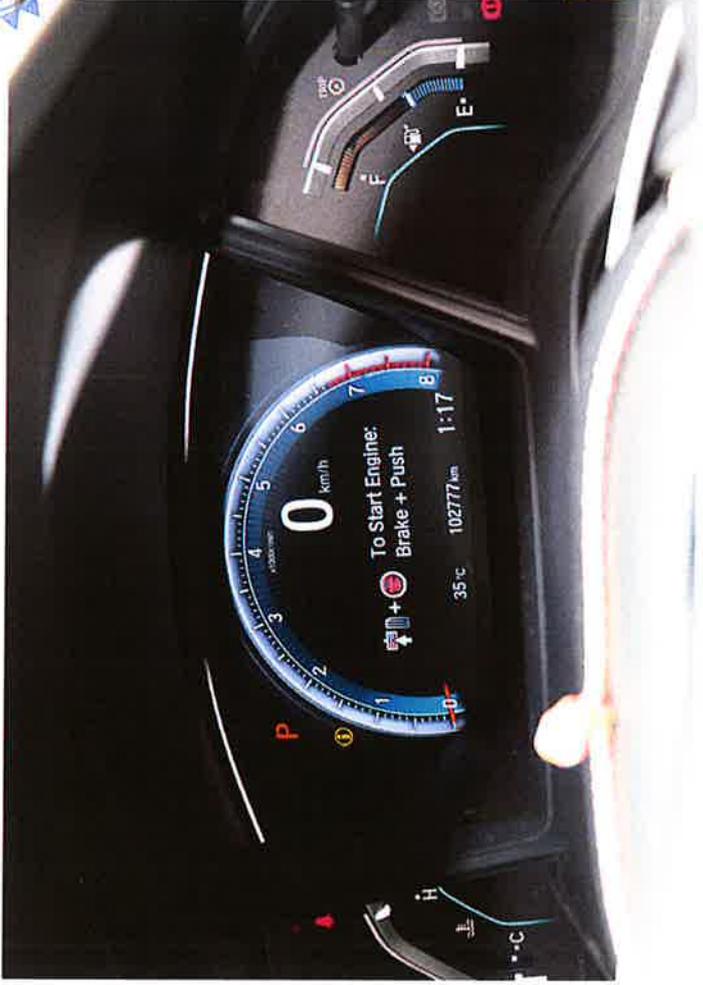
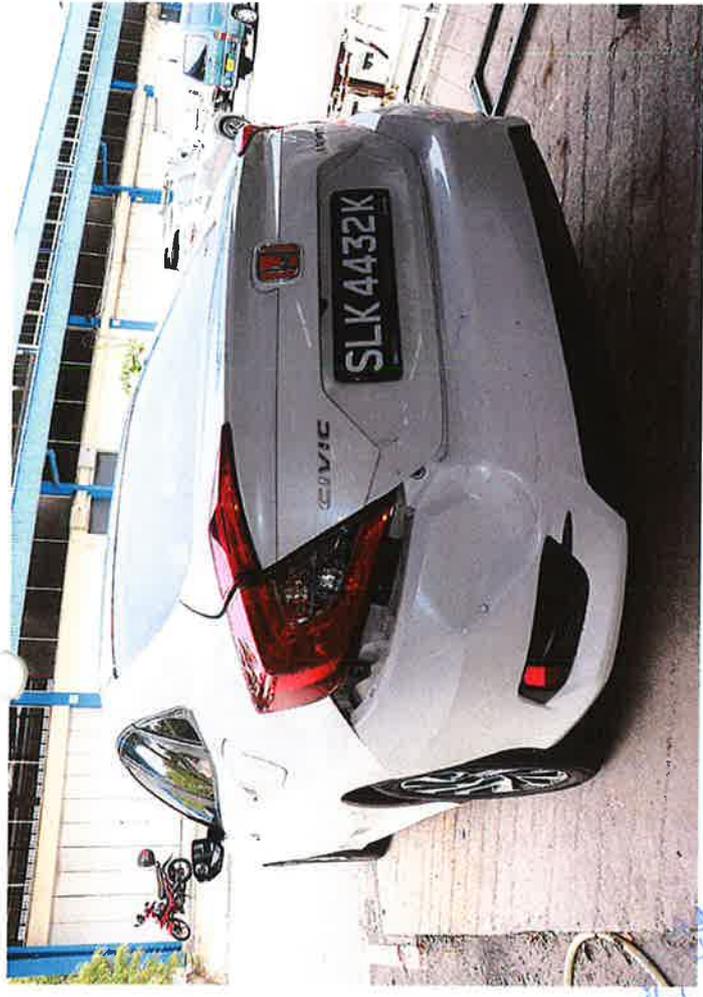
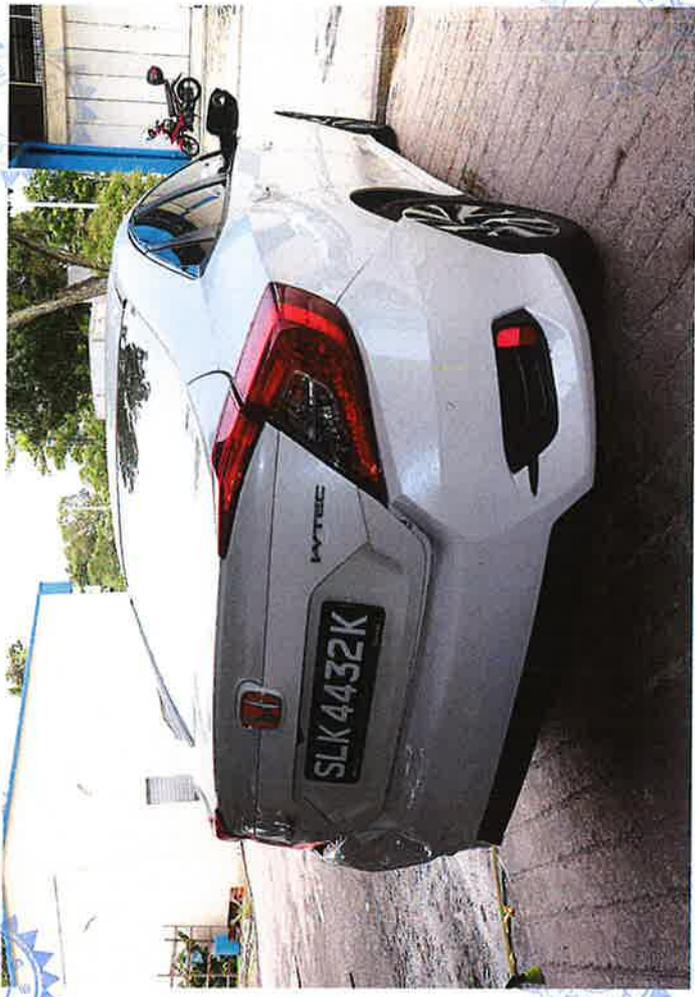
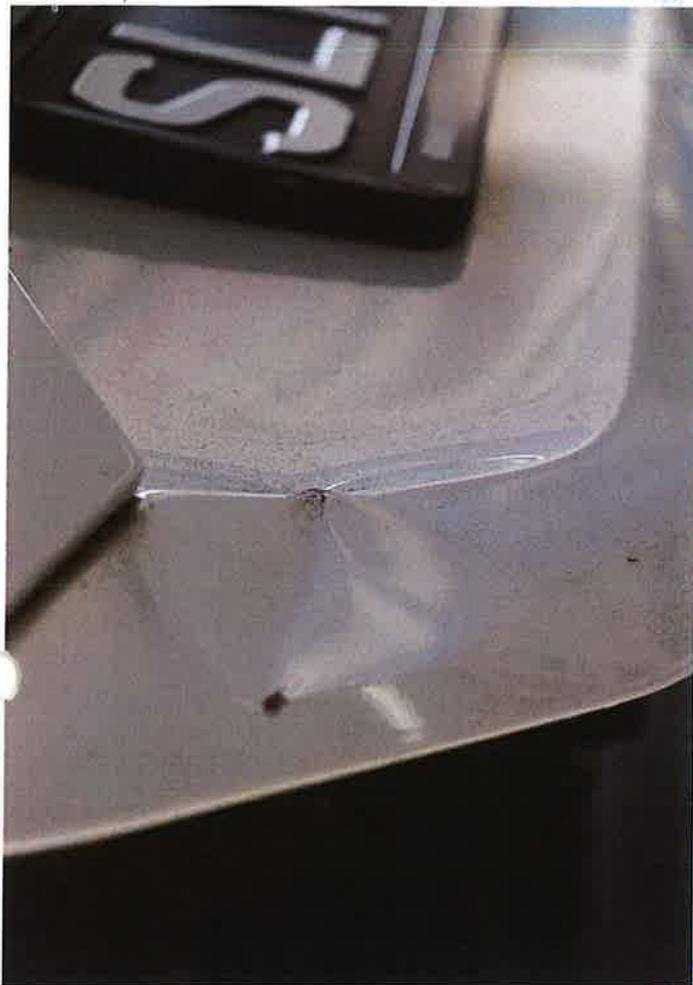
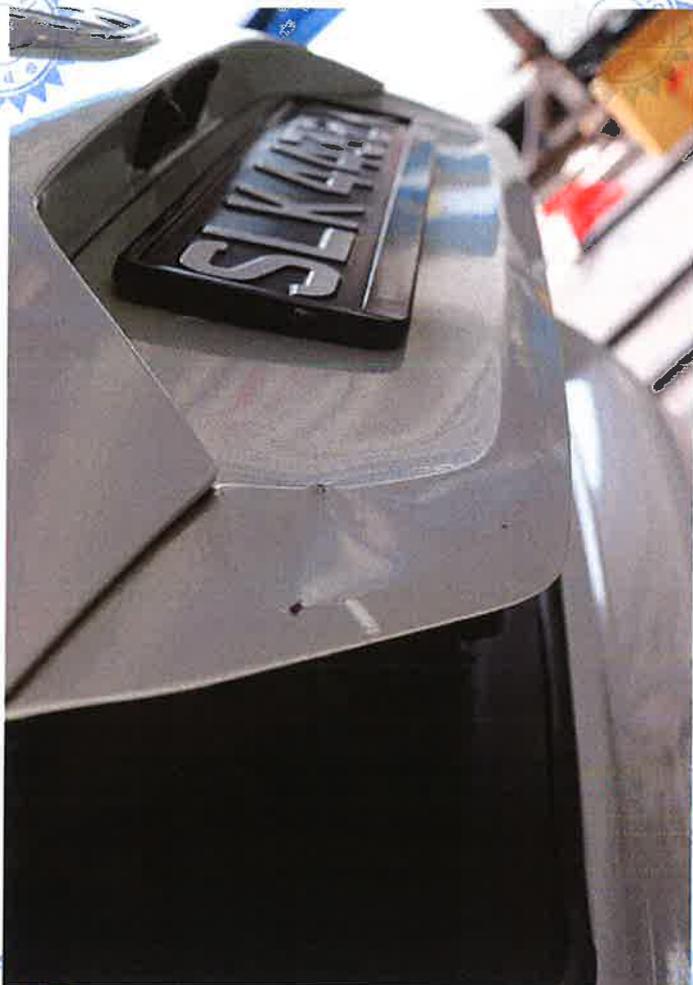
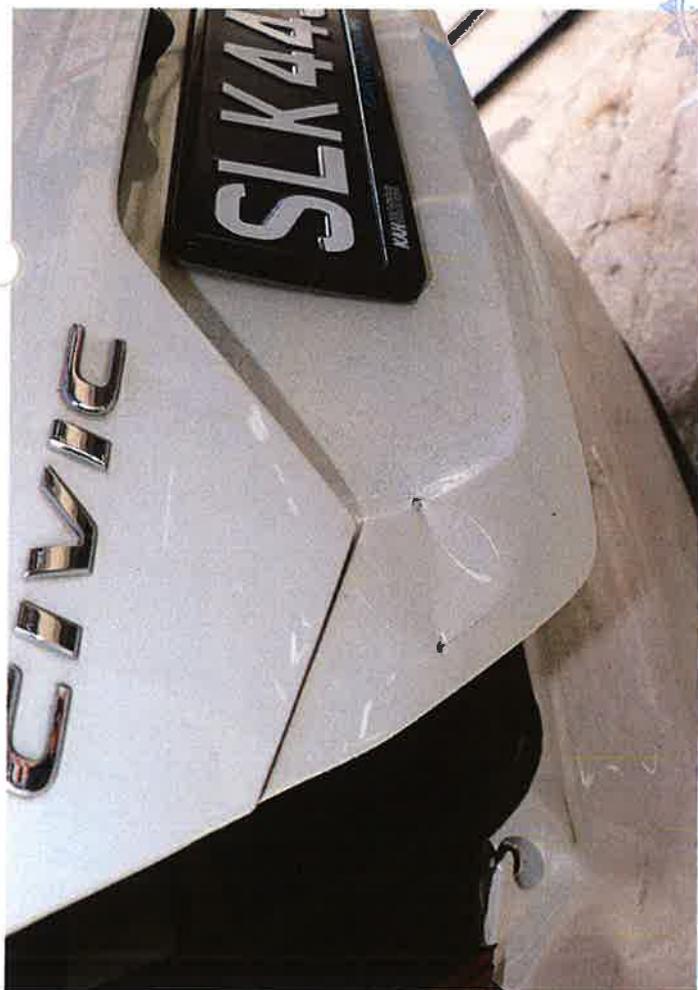
Encl. Photographs of the damaged vehicle taken by us during inspection.

Point of Impact

At the rear portion.

Damages

The boot lid, boot lid outer garnish, rear bumper, rear bumper lower garnish, end panel and etc.

Other parts were also found damaged. (see schedule for details)

We have inspected thoroughly each and every item on the repairer's estimate against the actual damages found on the vehicle and we list the breakdown of our findings and our recommendation as per schedule attached.

Our adjusted amount for the cost of repairs is \$3,001.36

The repairer has agreed to undertake repairs at a lump sum of \$2,400.00
