SF0H214J0002 / FALCON-AIR AUTO SERVICES PTE LTD [128228]  
ENTRY DATE & TIME: 19/04/2021 12:45 (SGT)  
SUBMITTED BY: Andy Esporanza  
VERSION: 1 (19/04/2021 12:45 (SGT))

## SINGAPORE ACCIDENT STATEMENT

## VEHICLE INSPECTION REPORT

Report No. TP/0007/21	Date of Report	: 19 May 21
To : Chan Eng Huat	Date of Request	: 22 April 21
Block 533 #22-807	Report requested by	: Chan Eng Huat
Bukit Panjang Ring Road	Date of Accident	: 16 April 21
Singapore 670533	Date of Inspection	: 22 April 21
	Claim No.	: Third Party Claim

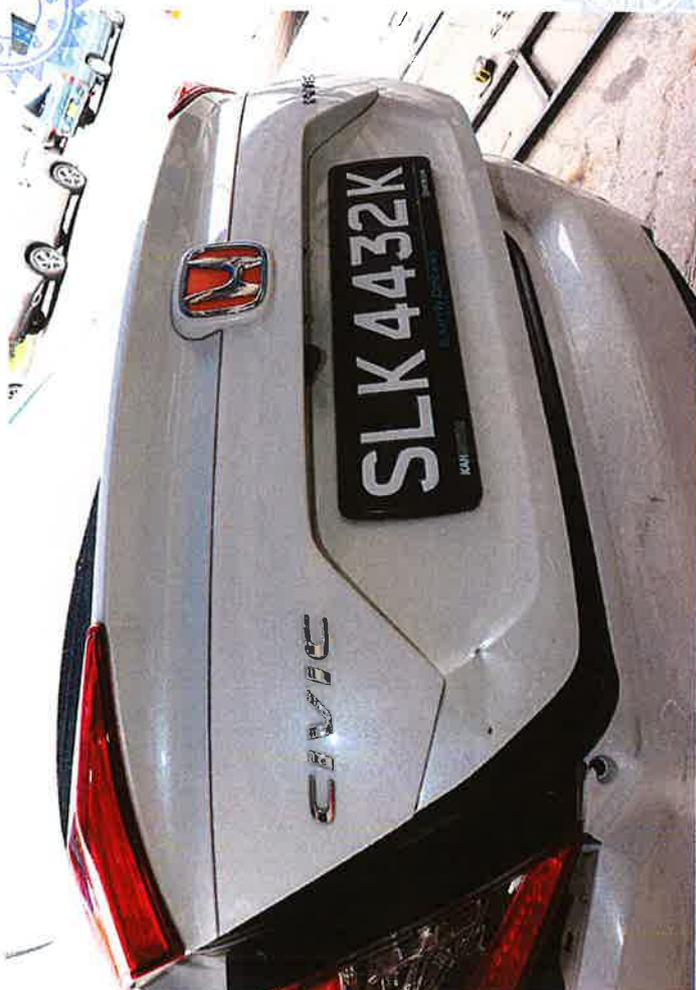
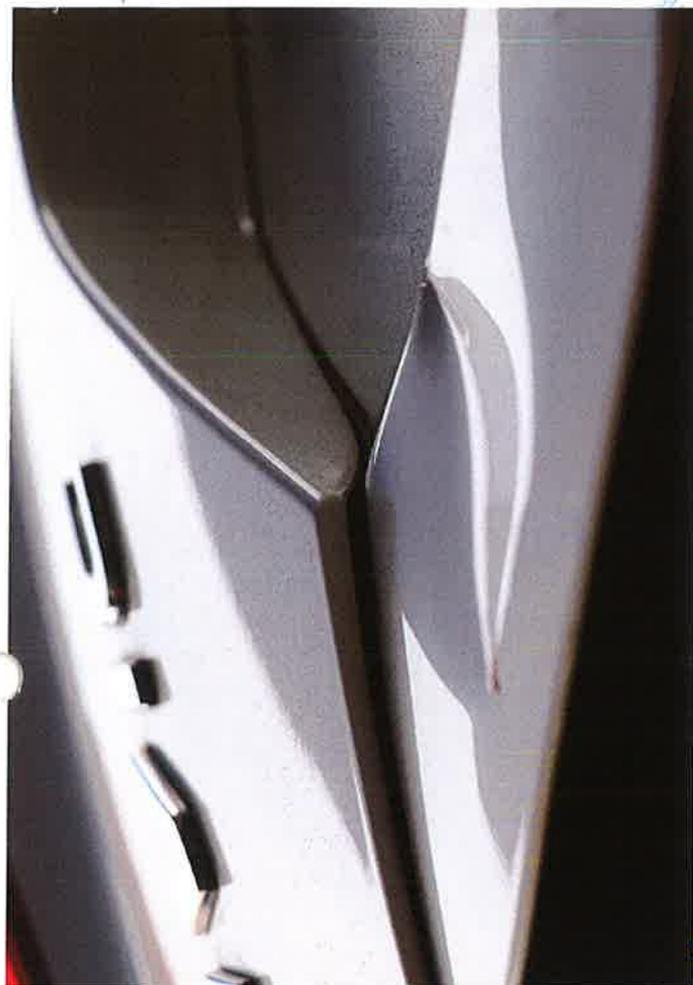
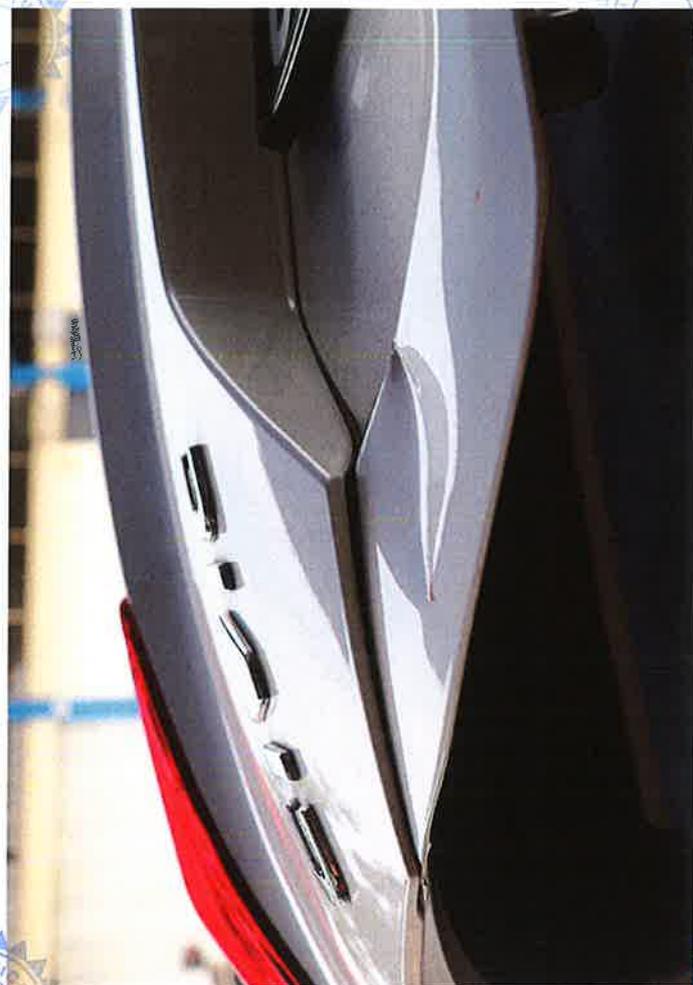
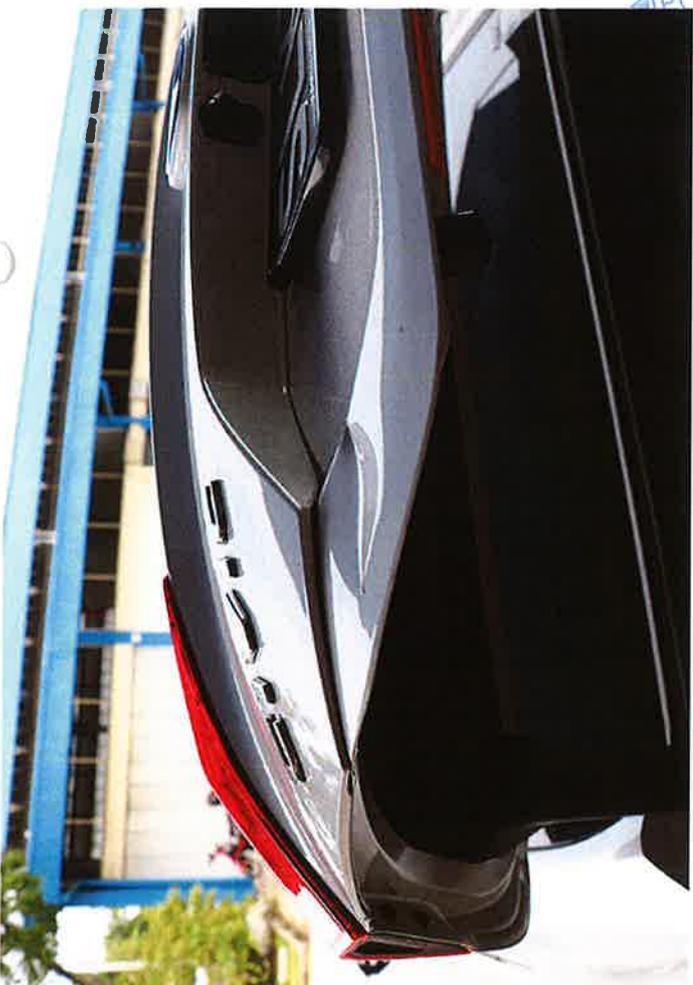
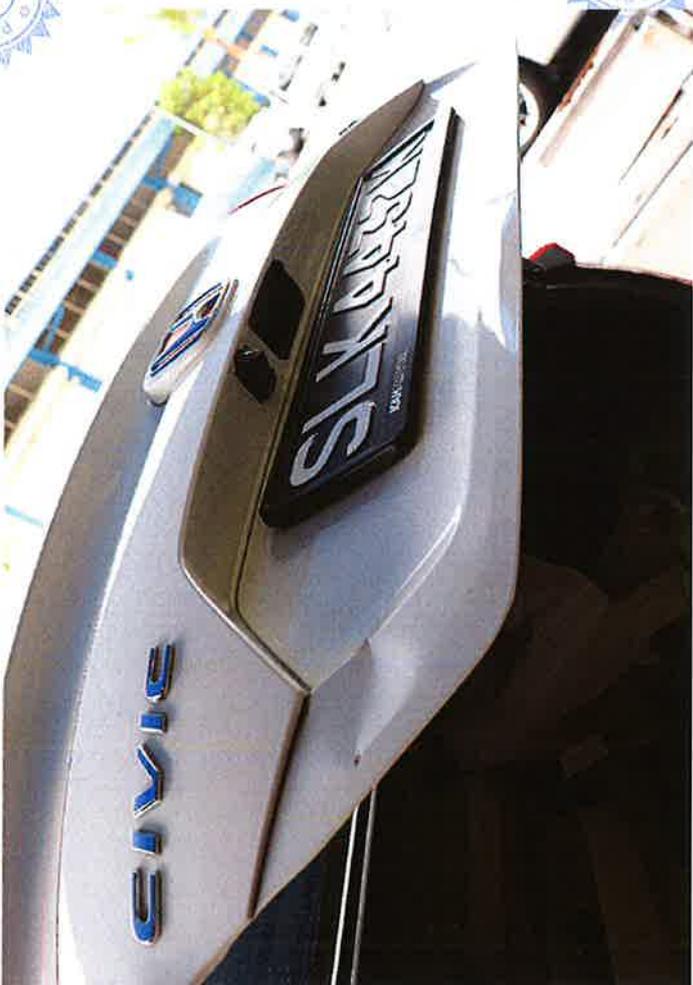
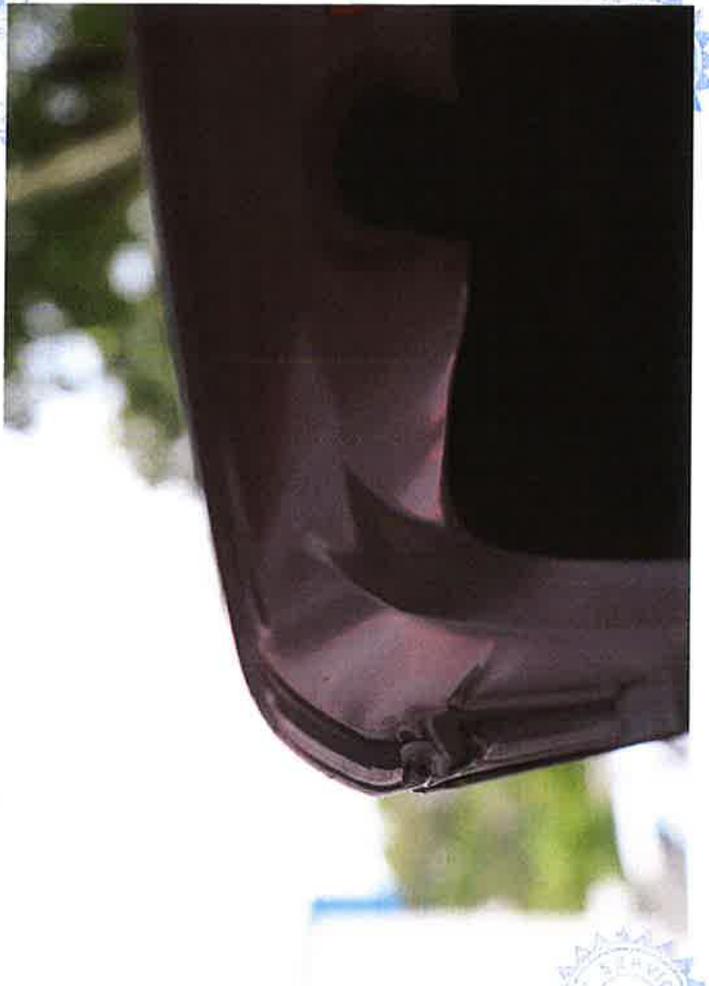
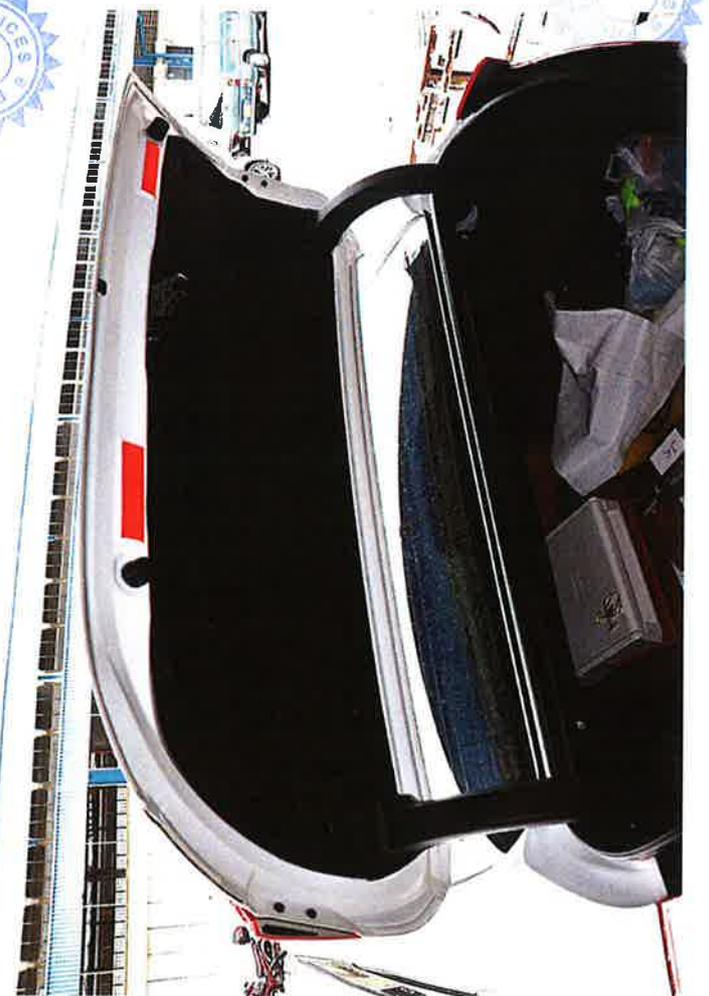
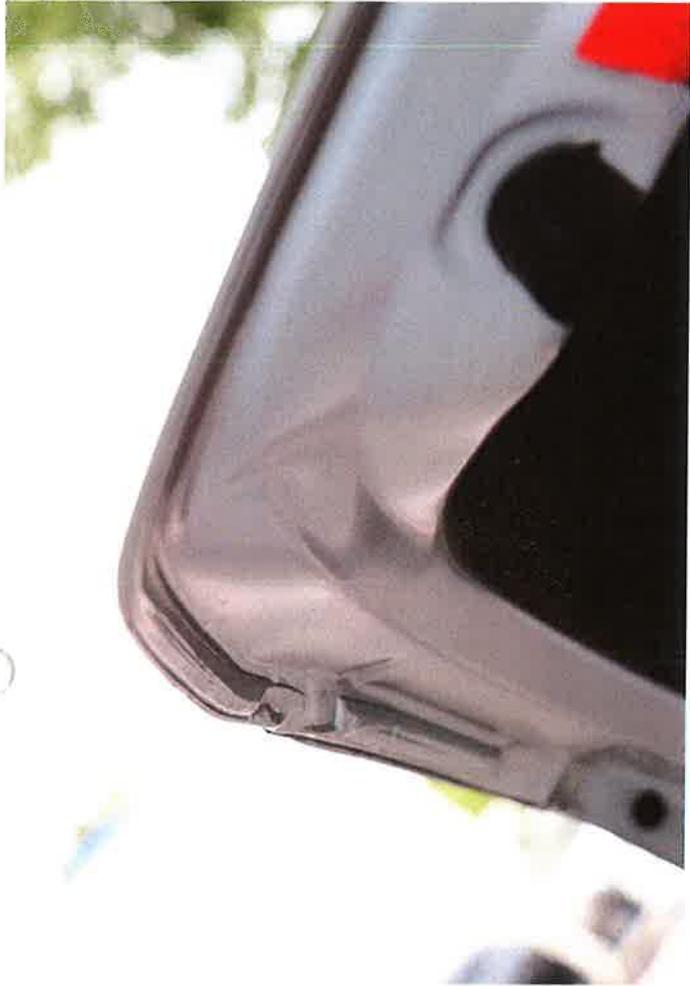
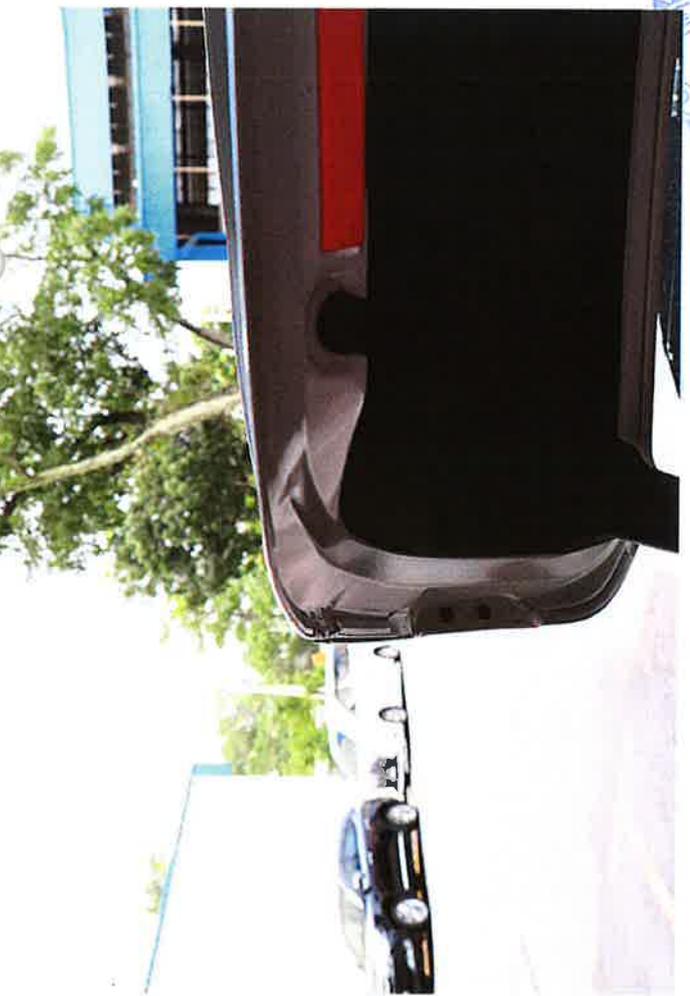
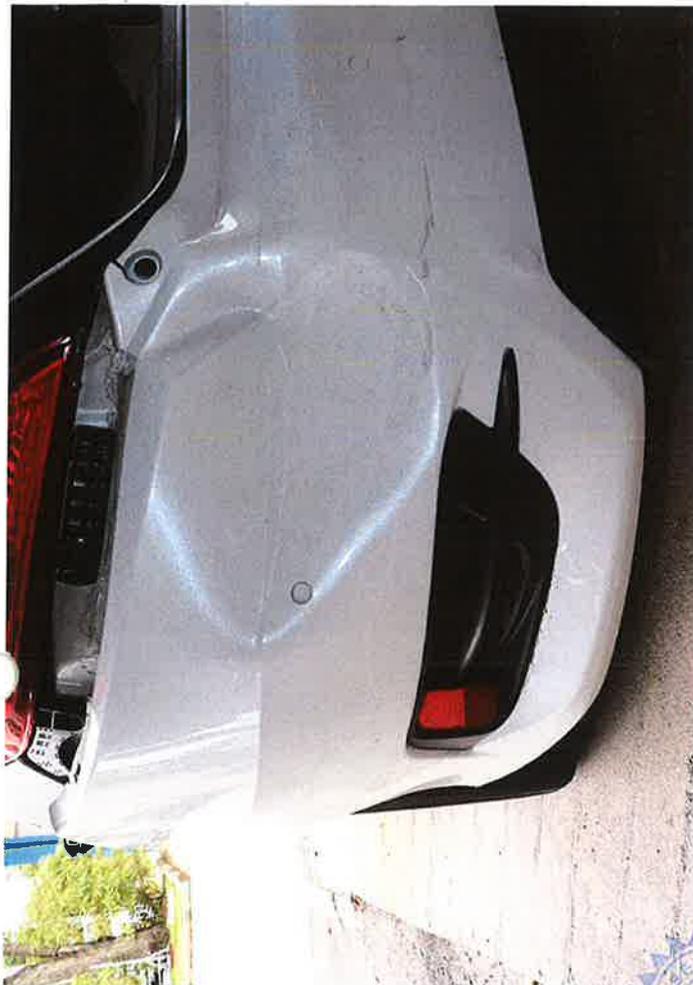
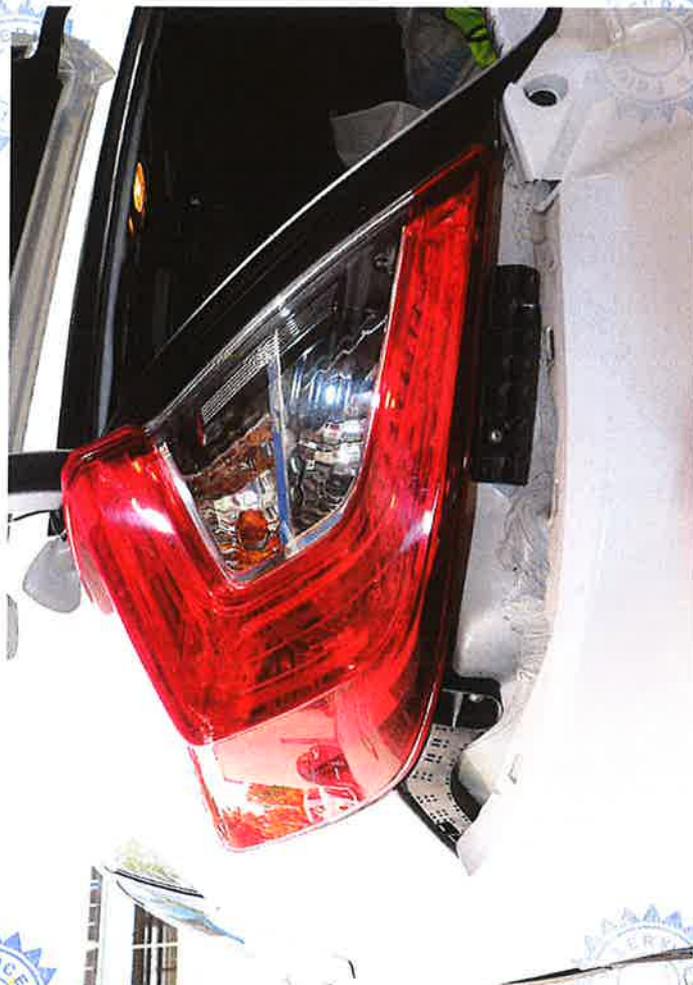
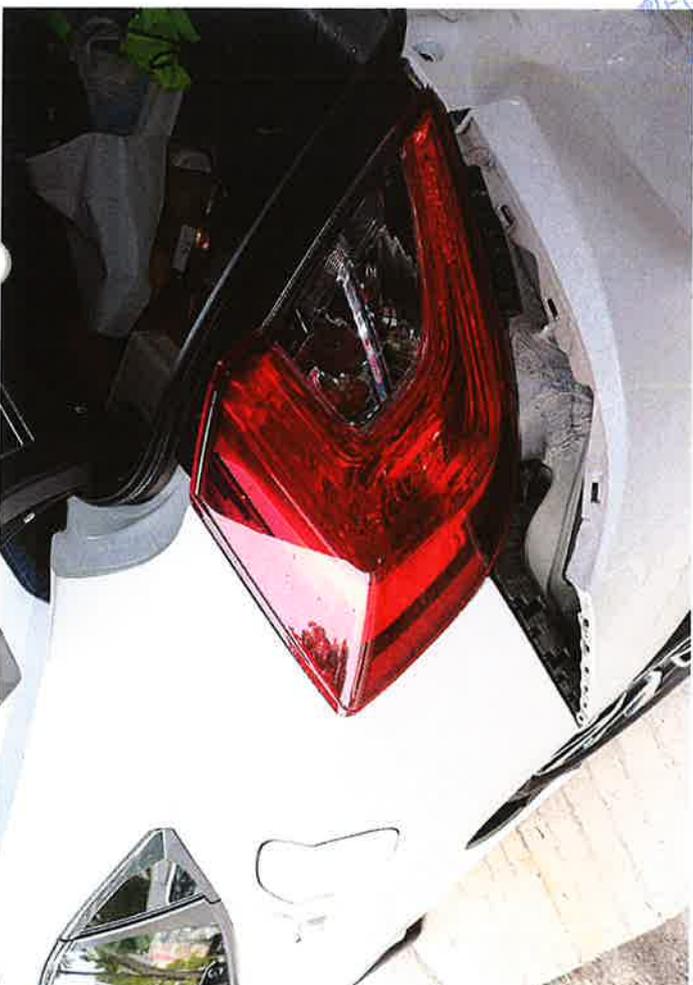
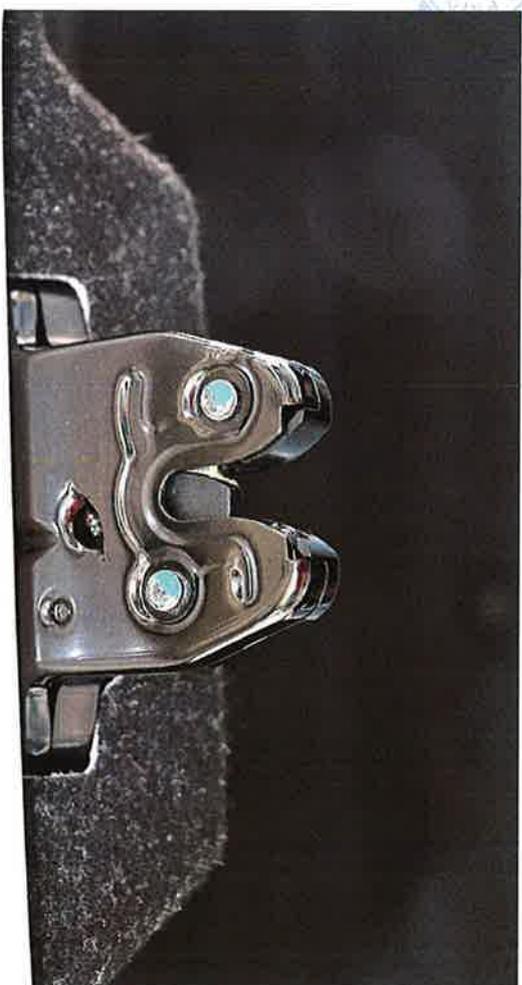
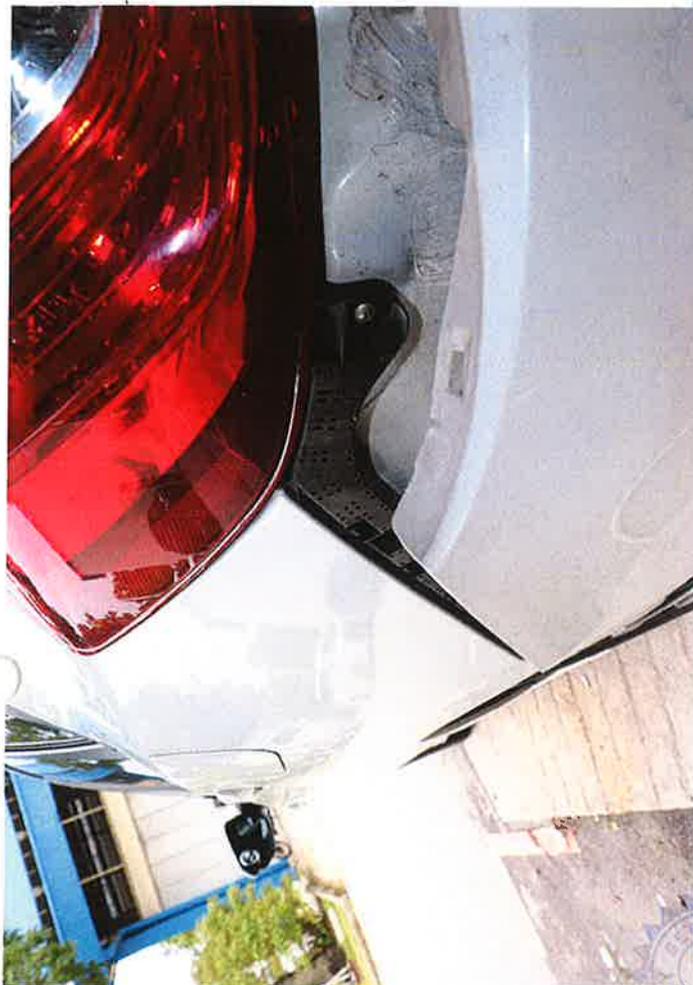
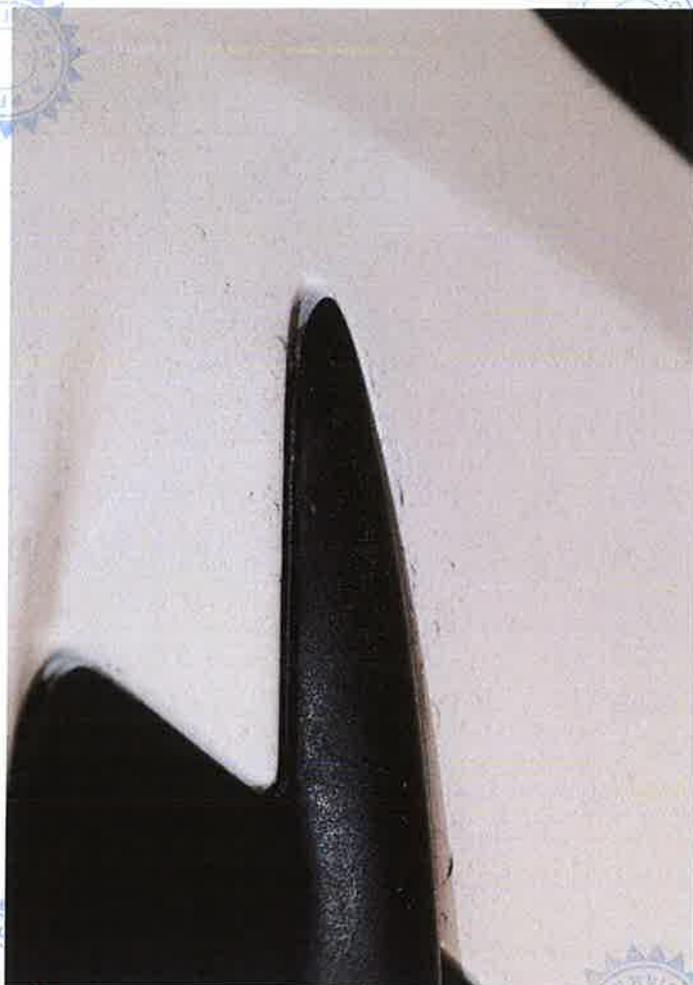
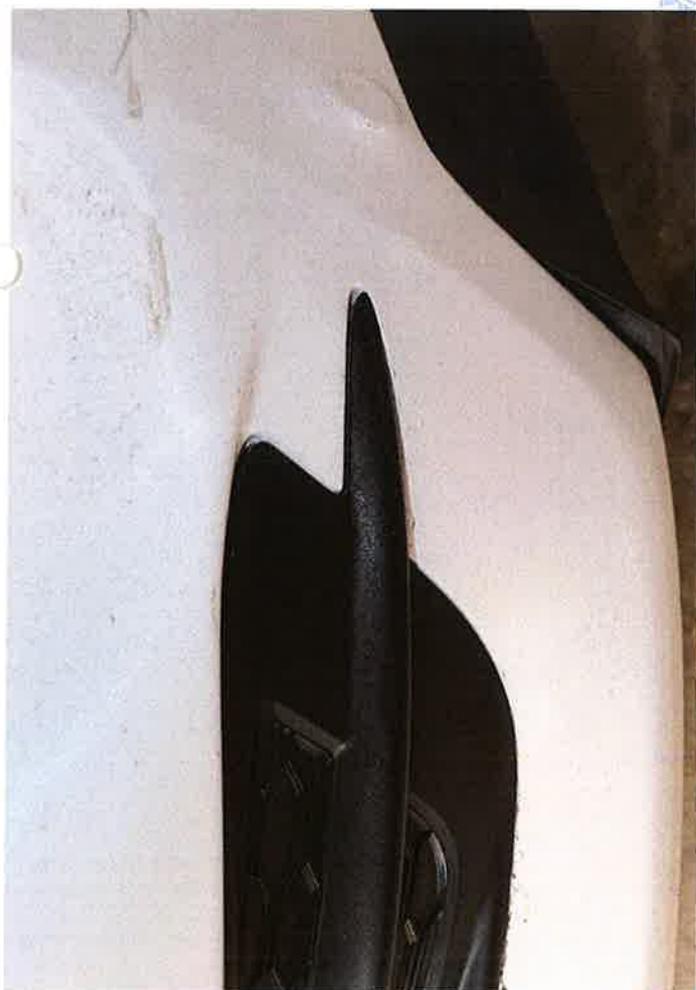
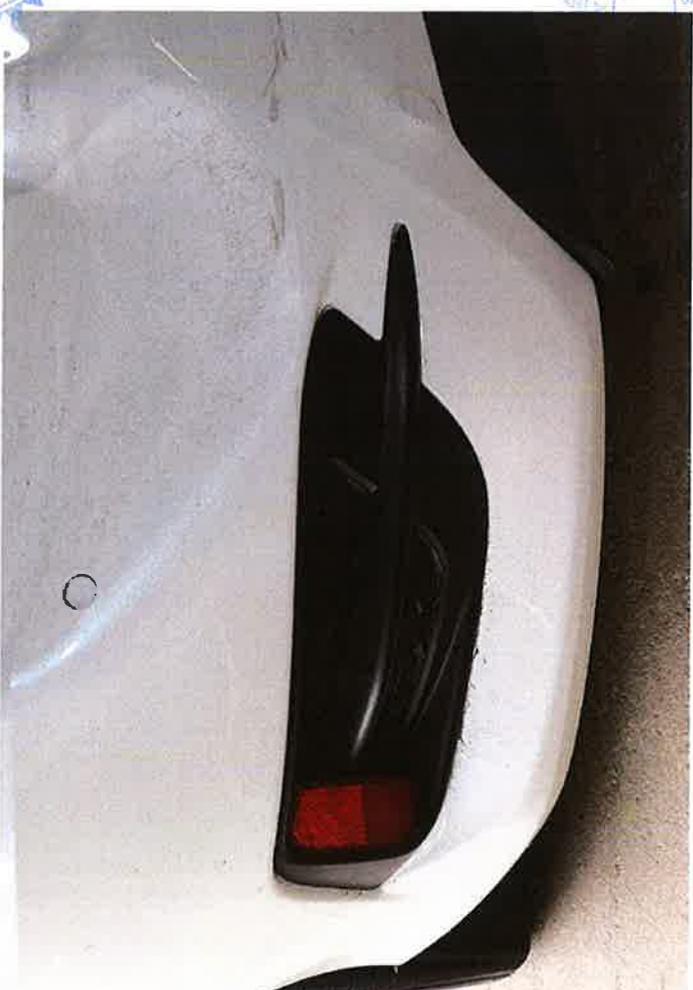
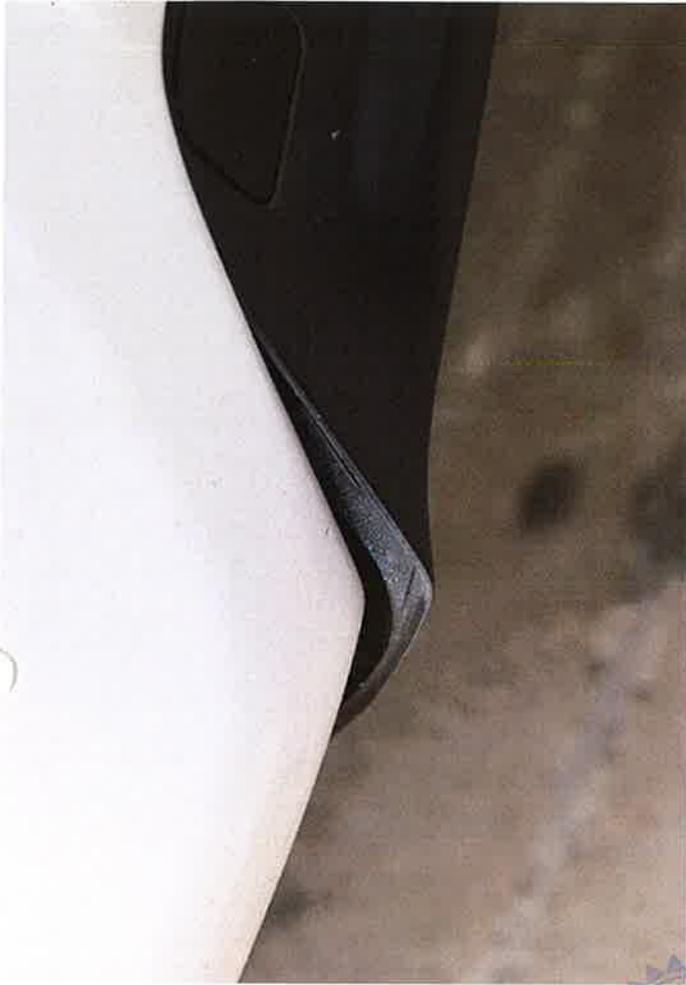
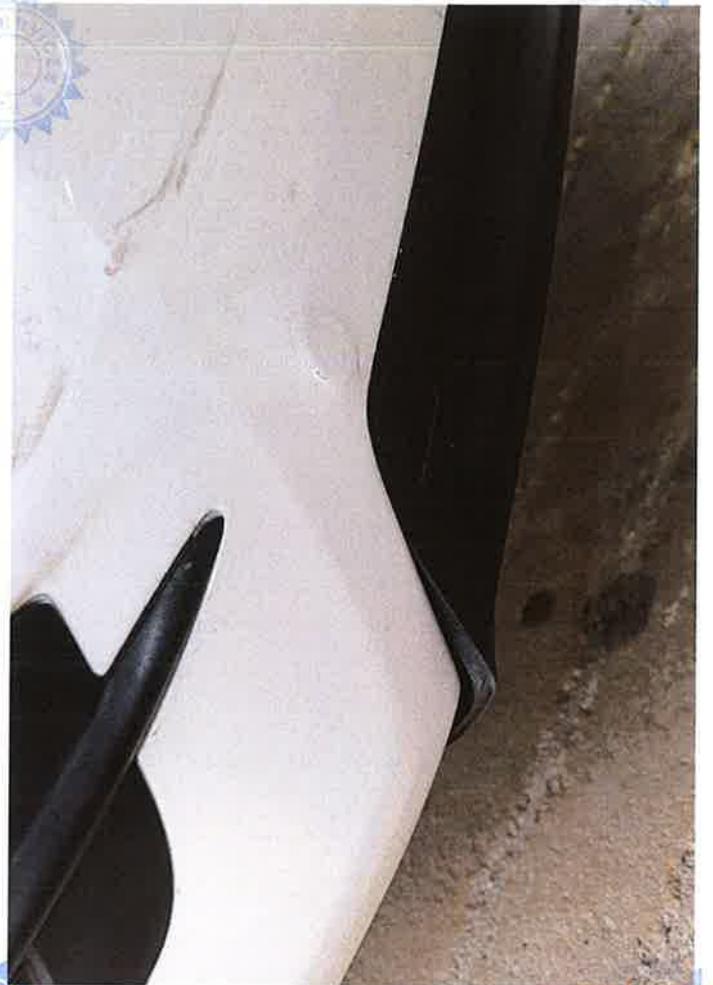
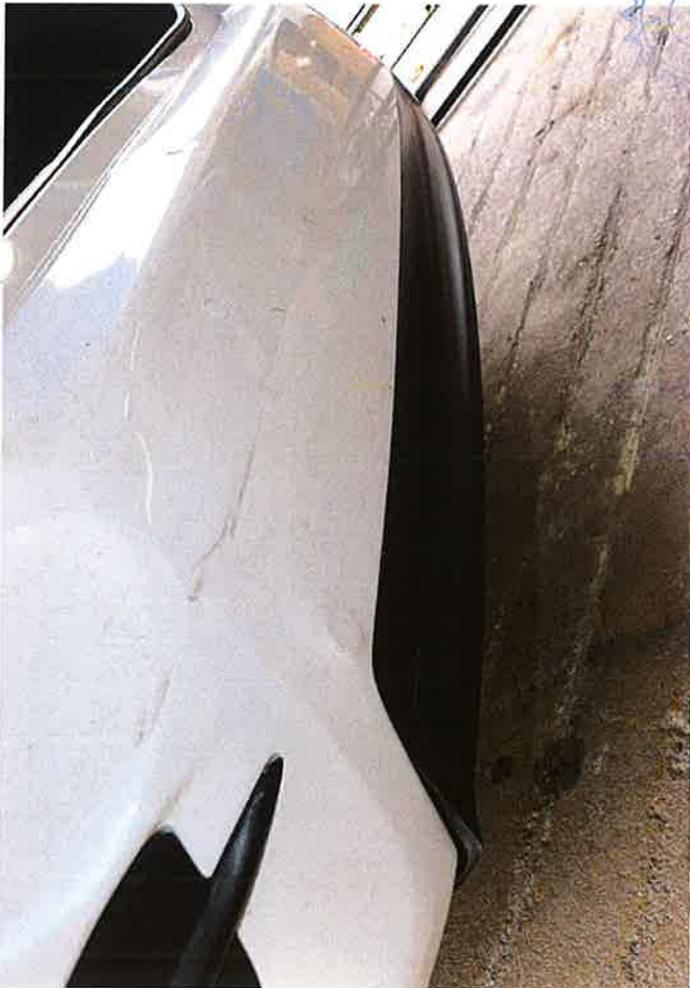
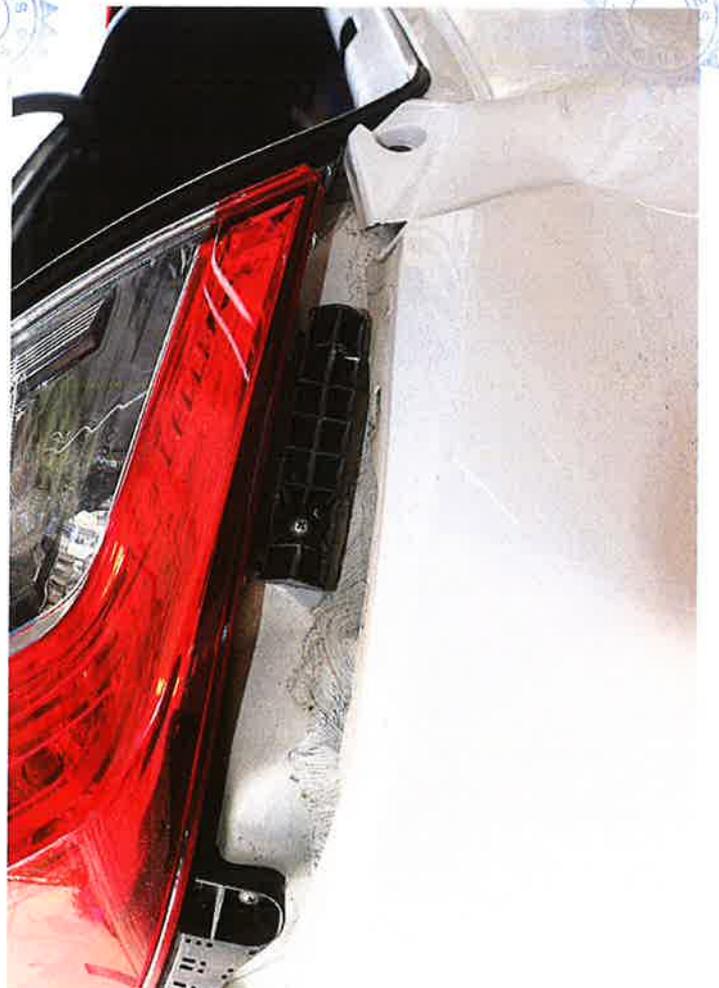
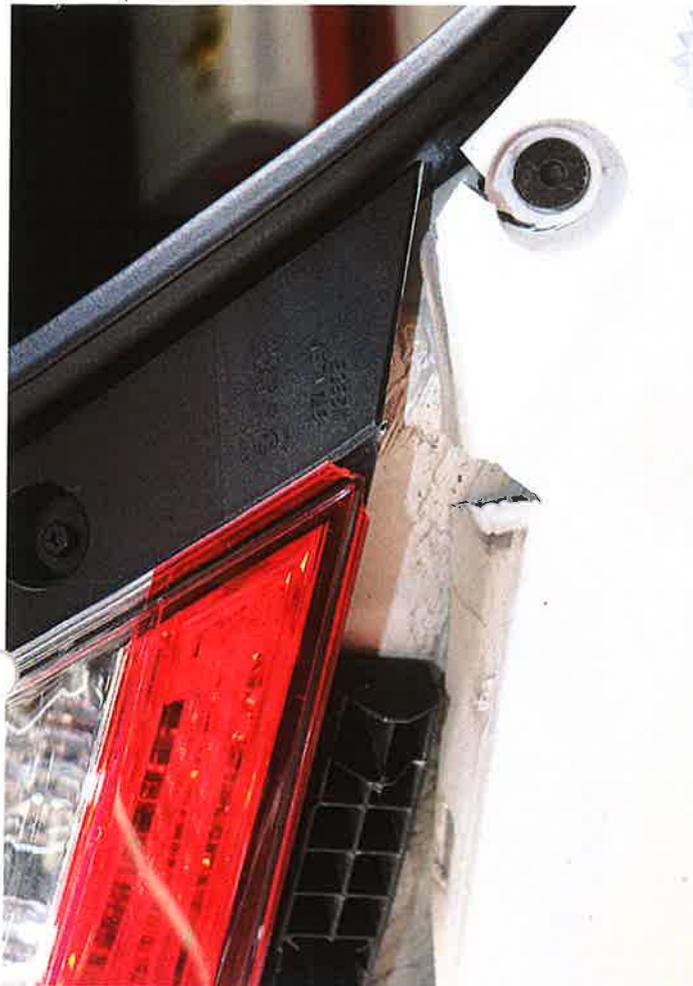
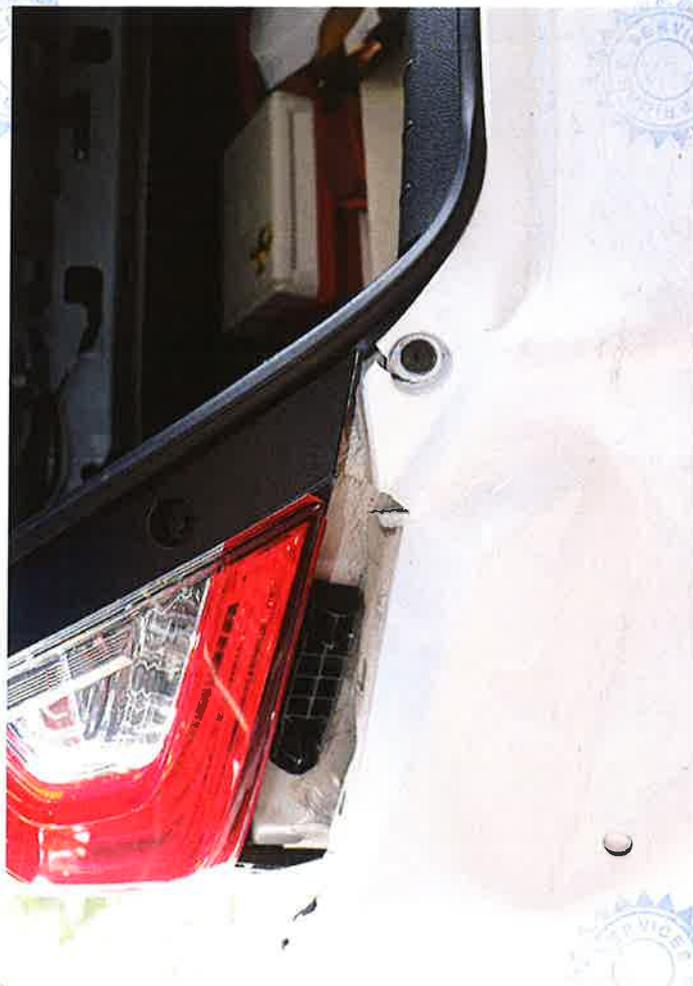
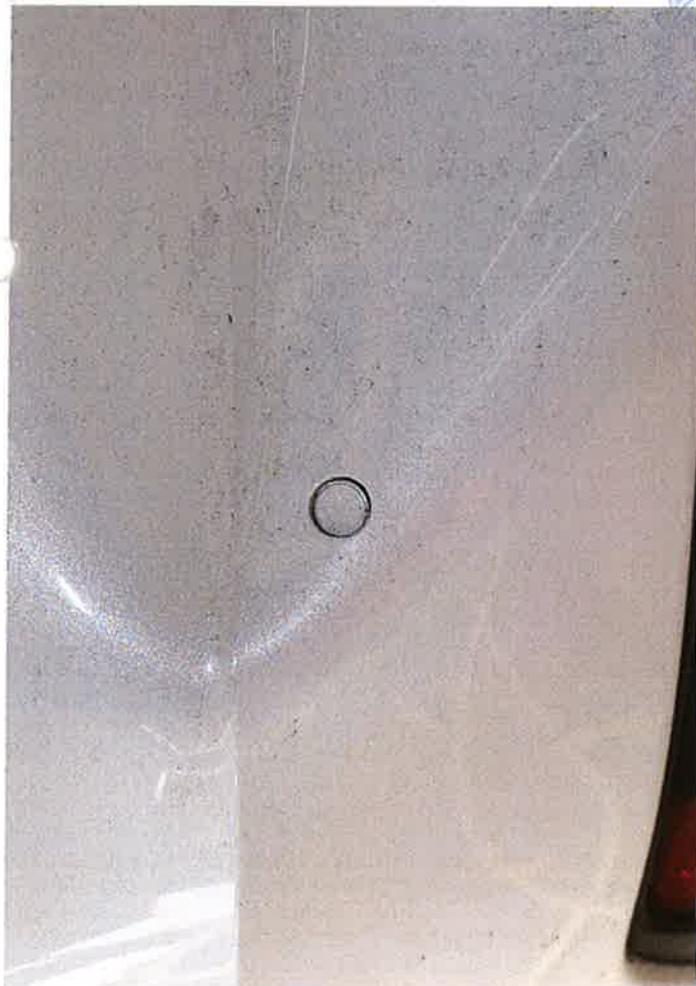
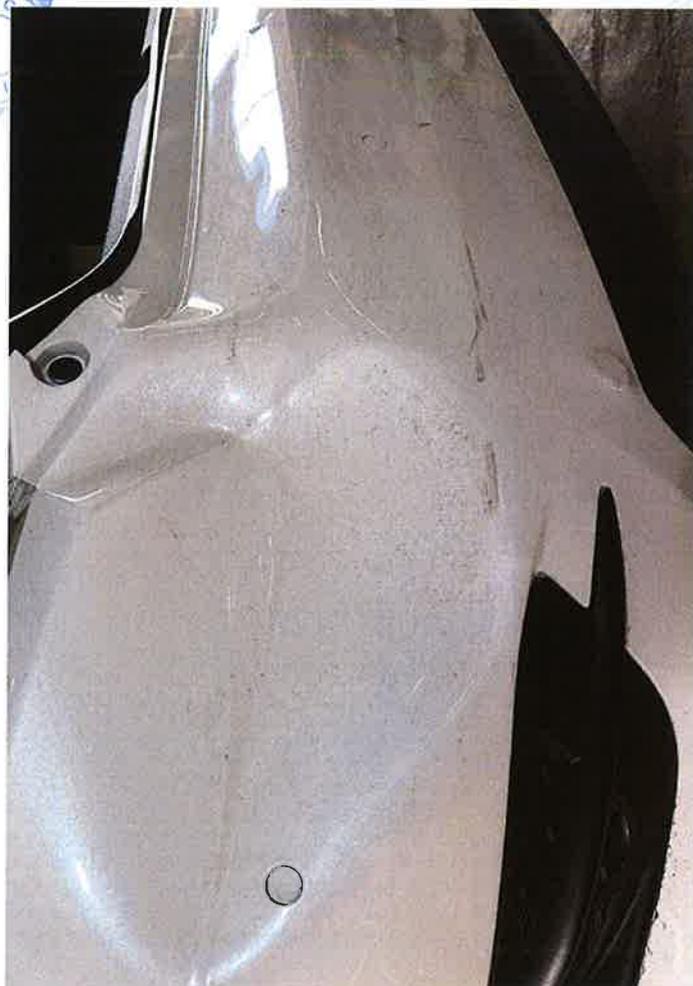
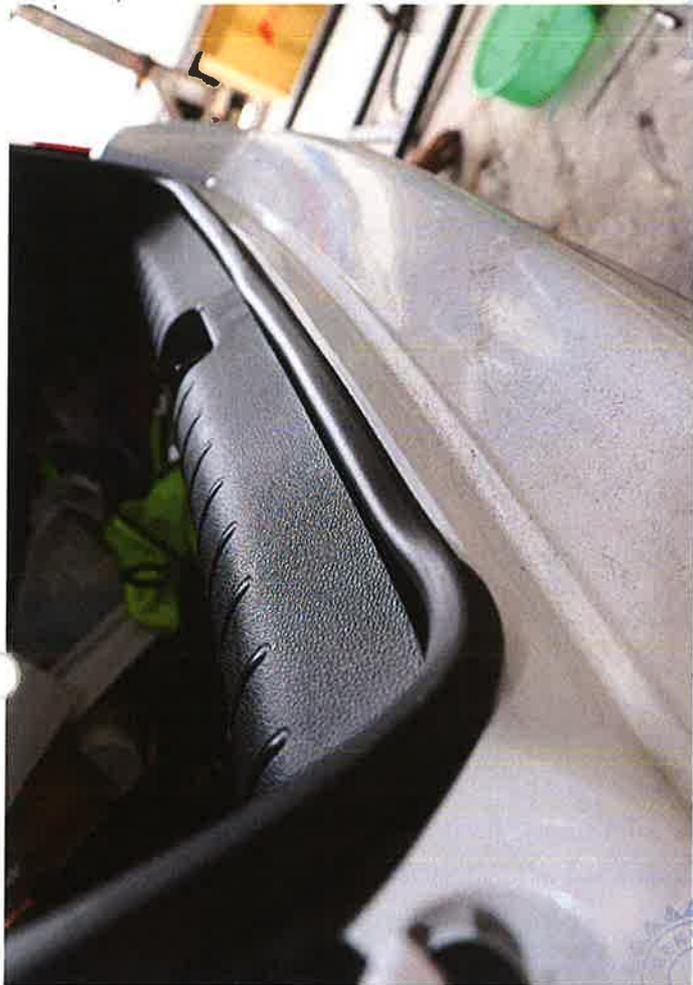
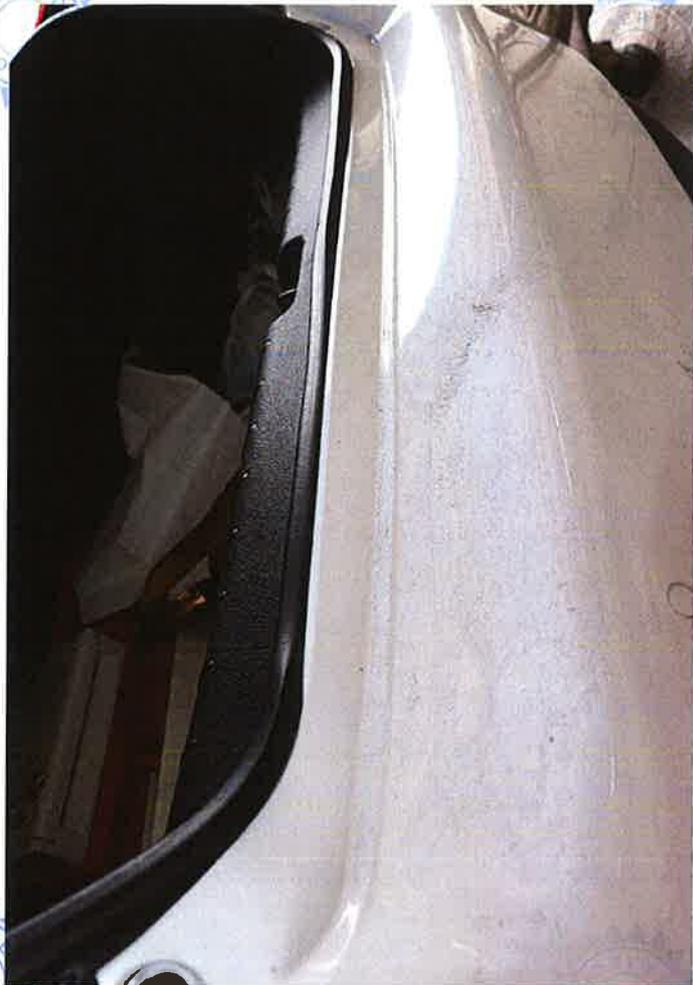
Encl. Photographs of the damaged vehicle taken by us during inspection.

Other parts were also found damaged. (see schedule for details)

Replacement of Parts	Condition	Repairer's Estimate (S \$)	Dist. %	Our Recommendation (S \$)	Dist. %
<b>To Supply :</b>					
1pc. Boot lid	Dented/bent	704.30		531.20	20
1pc. Boot lid outer garnish	Dented/holder Cracked	109.90		109.90	20
1pc. Boot lid outer garnish CIVIC garnish	Necessary	12.00		12.00	20
1pc. Boot lid centre emblem	Necessary	13.30		13.30	20
1pc. Boot lid I-VTEC emblem	Necessary	12.00		12.00	20
1pc. Boot lid lock	Serviceable	81.20		--	20
1pc. Rear bumper	Dented	883.10		617.20	20
1set rear bumper clips	Necessary	75.00		30.00	20
1pc. Rear bumper lower garnish	Dented/cracked	39.80		39.80	20
1pc. Rear bumper LH side reverse sensor	Dented/malfunctioned	145.80		145.80	20
1pc. Rear bumper LH centre reverse sensor	Dented/malfunctioned	145.80		145.80	20
1pc. Rear bumper RH centre reverse sensor	Refit	145.80		--	20
1pc. Rear bumper RH side reverse sensor	Refit	145.80		--	20
1pc. Rear bumper LH reflector cover	Dented/cracked	33.00		8.50	20

1pc. Rear bumper LH reflector	Cracked	23.00		7.90	20
1pc. Rear bumper reinforcement	Dented	180.00		180.00	20
1pc. End panel	Dented/repair	265.70		--	20
1pc. End panel inner garnish	Refit	50.30		--	20
1pc. Rear antenna sensor	Cracked	60.80		60.80	20
1pc. LH tail lamp assy	Refit	307.40		--	20
<b>Sub-Total :-</b>		<b>3,434.00</b>		<b>1,914.20</b>	
<b>Total Discount :-</b>		<b>--</b>		<b>382.84</b>	
		<b>3,434.00</b>		<b>1,531.36</b>	
<b>Special Nett Items :-</b>					
1pc. Rear number plate	Refit	70.00		--	
<b>Total For Parts :-</b>		<b>3,504.00</b>		<b>1,531.36</b>	
<b>Labour Charges :</b>					
Labour charges to panel beating, straighten and realign all affected areas. To remove, check, reinstall and replace parts.		900.00		500.00	
Check wiring and lighting system for proper function.		70.00		30.00

We have inspected thoroughly each and every item on the repairer's estimate against the actual damages found on the vehicle and we list the breakdown of our findings and our recommendation as per schedule attached.

Our adjusted amount for the cost of repairs is \$3,001.36

The repairer has agreed to undertake repairs at a lump sum of \$2,400.00
