SF0H214J0002 / FALCON-AIR AUTO SERVICES PTE LTD [128228]  
ENTRY DATE & TIME: 19/04/2021 12:45 (SGT)  
SUBMITTED BY: Andy Esporanza  
VERSION: 1 (19/04/2021 12:45 (SGT))

## SINGAPORE ACCIDENT STATEMENT

## VEHICLE INSPECTION REPORT

Report No. TP/0007/21	Date of Report	: 19 May 21
To : Chan Eng Huat	Date of Request	: 22 April 21
Block 533 #22-807	Report requested by	: Chan Eng Huat
Bukit Panjang Ring Road	Date of Accident	: 16 April 21
Singapore 670533	Date of Inspection	: 22 April 21
	Claim No.	: Third Party Claim

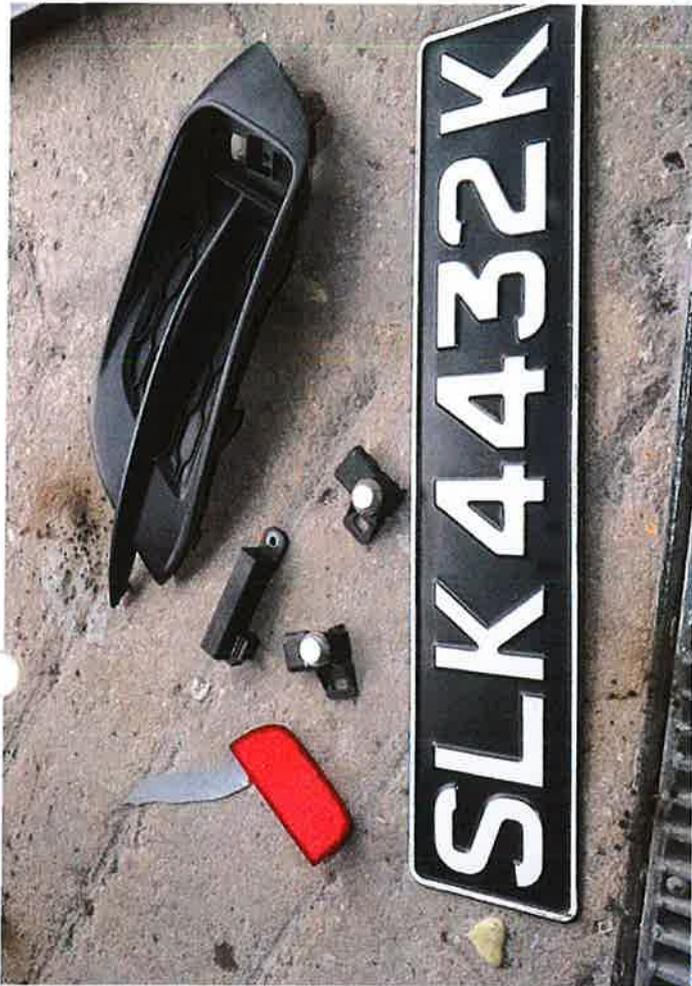
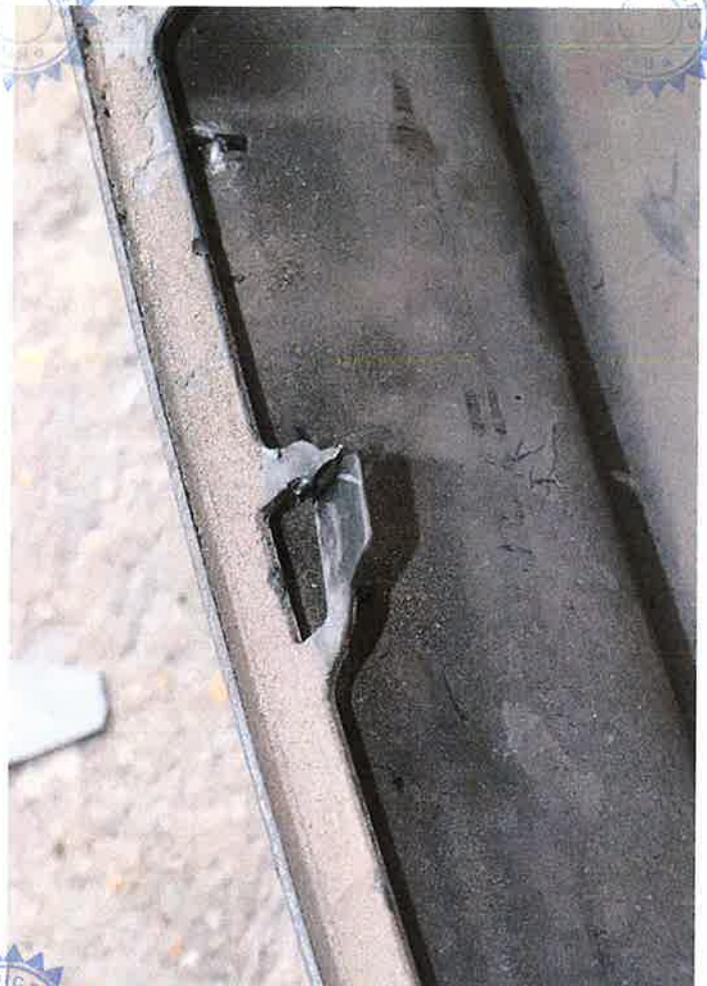
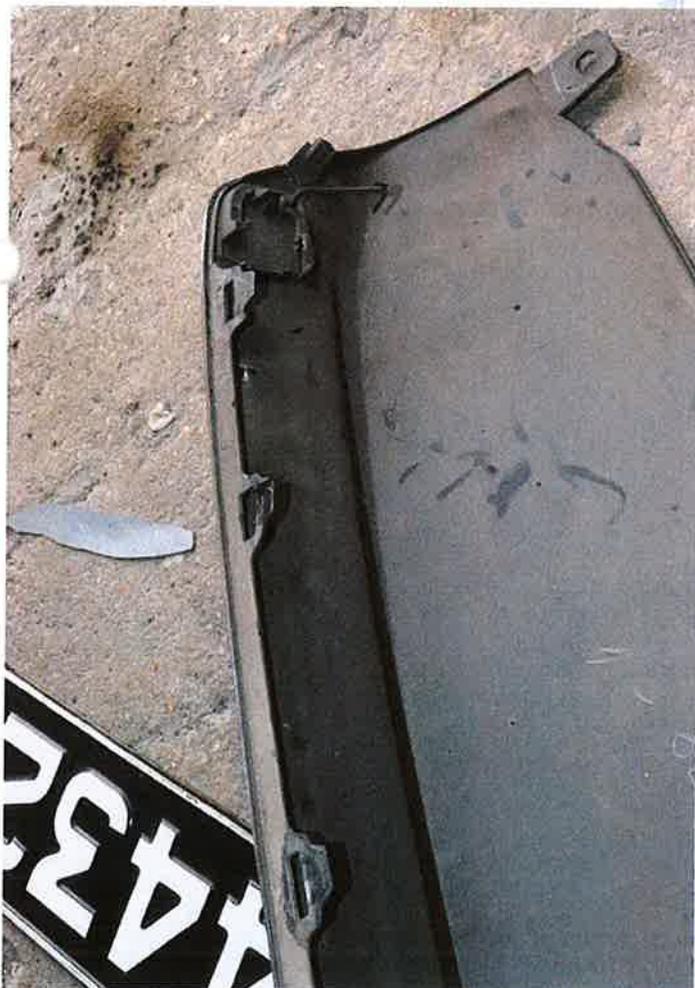
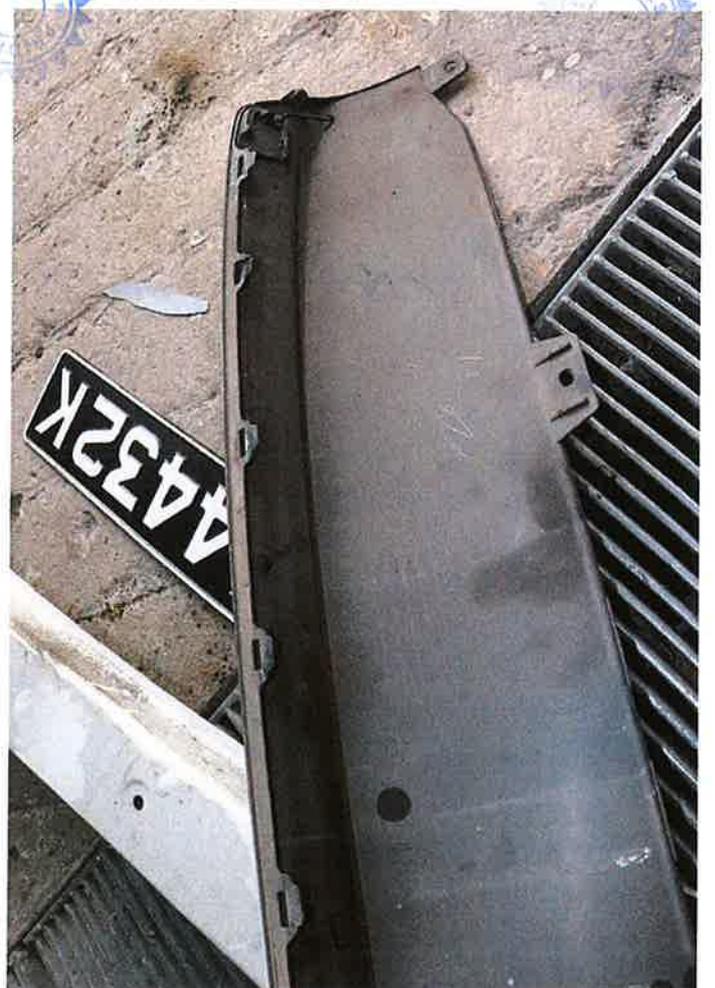
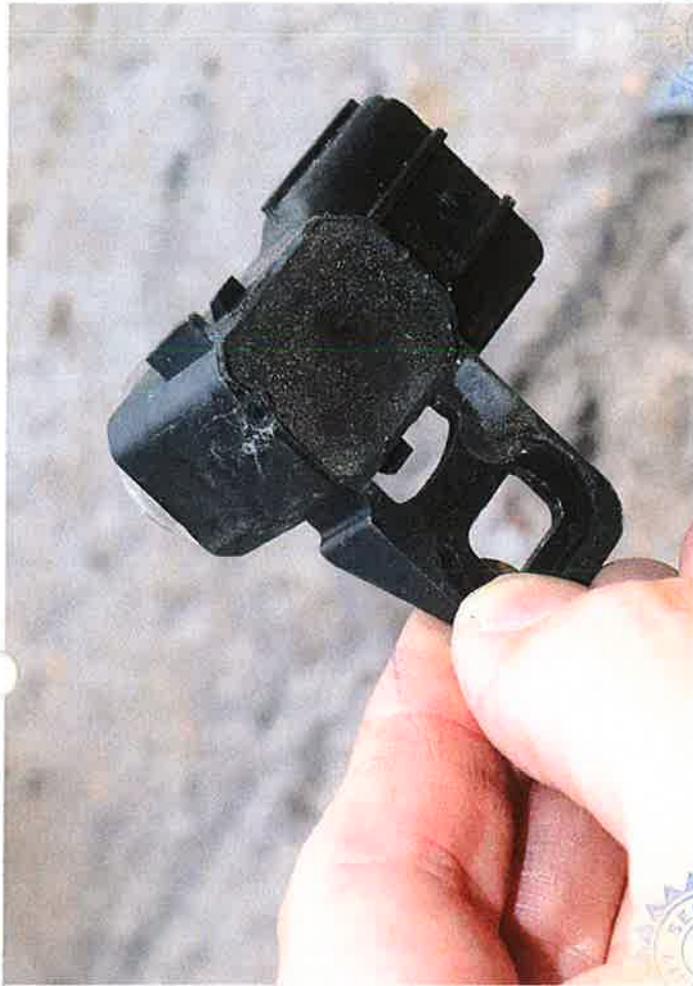
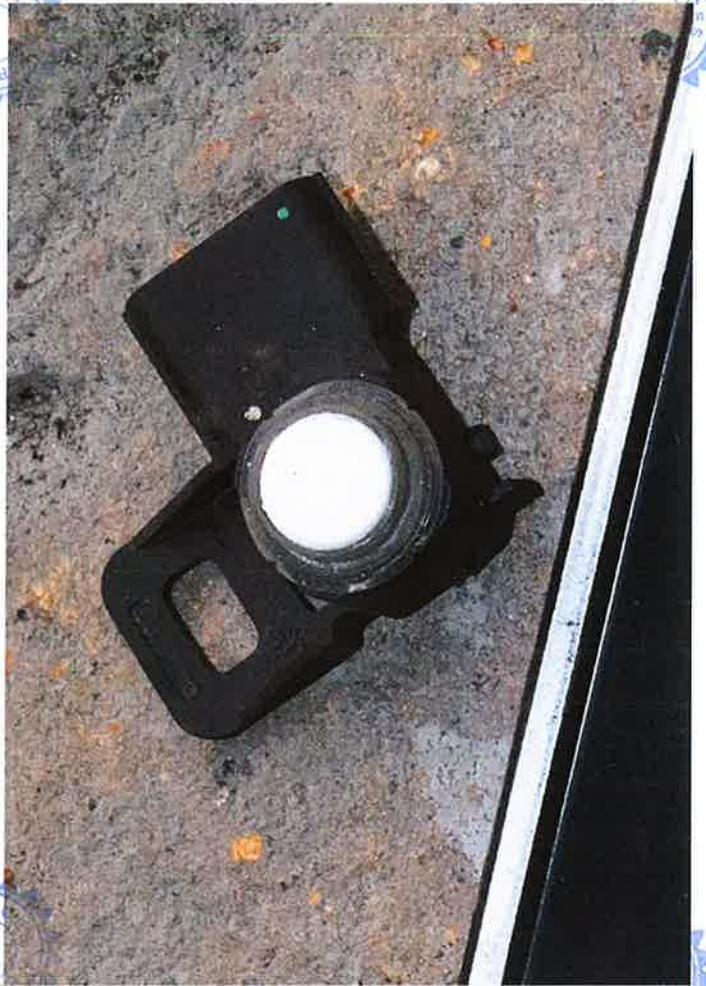
SLK 4432 K

Other parts were also found damaged. (see schedule for details)

Replacement of Parts	Condition	Repairer's Estimate (S \$)	Dist. %	Our Recommendation (S \$)	Dist. %
<b>To Supply :</b>					
1pc. Boot lid	Dented/bent	704.30		531.20	20
1pc. Boot lid outer garnish	Dented/holder Cracked	109.90		109.90	20
1pc. Boot lid outer garnish CIVIC garnish	Necessary	12.00		12.00	20
1pc. Boot lid centre emblem	Necessary	13.30		13.30	20
1pc. Boot lid I-VTEC emblem	Necessary	12.00		12.00	20
1pc. Boot lid lock	Serviceable	81.20		--	20
1pc. Rear bumper	Dented	883.10		617.20	20
1set rear bumper clips	Necessary	75.00		30.00	20
1pc. Rear bumper lower garnish	Dented/cracked	39.80		39.80	20
1pc. Rear bumper LH side reverse sensor	Dented/malfunctioned	145.80		145.80	20
1pc. Rear bumper LH centre reverse sensor	Dented/malfunctioned	145.80		145.80	20
1pc. Rear bumper RH centre reverse sensor	Refit	145.80		--	20
1pc. Rear bumper RH side reverse sensor	Refit	145.80		--	20
1pc. Rear bumper LH reflector cover	Dented/cracked	33.00		8.50	20

1pc. Rear bumper LH reflector	Cracked	23.00		7.90	20
1pc. Rear bumper reinforcement	Dented	180.00		180.00	20
1pc. End panel	Dented/repair	265.70		--	20
1pc. End panel inner garnish	Refit	50.30		--	20
1pc. Rear antenna sensor	Cracked	60.80		60.80	20
1pc. LH tail lamp assy	Refit	307.40		--	20
<b>Sub-Total :-</b>		<b>3,434.00</b>		<b>1,914.20</b>	
<b>Total Discount :-</b>		<b>--</b>		<b>382.84</b>	
		<b>3,434.00</b>		<b>1,531.36</b>	
<b>Special Nett Items :-</b>					
1pc. Rear number plate	Refit	70.00		--	
<b>Total For Parts :-</b>		<b>3,504.00</b>		<b>1,531.36</b>	
<b>Labour Charges :</b>					
Labour charges to panel beating, straighten and realign all affected areas. To remove, check, reinstall and replace parts.		900.00		500.00	
Check wiring and lighting system for proper function.		70.00		30.00

We have inspected thoroughly each and every item on the repairer's estimate against the actual damages found on the vehicle and we list the breakdown of our findings and our recommendation as per schedule attached.

Our adjusted amount for the cost of repairs is \$3,001.36

The repairer has agreed to undertake repairs at a lump sum of \$2,400.00
