Vehicle No. GBJ 5941A  
Insured Veh. YN 2555H  
Claim No. SNM22D200405/C02  
Policy No. DMCVSNA00049832100  
Accident Date 08/01/2022  
Inspection Date 17/01/2022

| Affiliated to Federation Internationale Des Experts En Automobile | | | | |
|---|---|---|---|---|
| | THE VEHICLE SUSTAINED DAMAGES AT THE REAR O/S PORTION.<br>DAMAGES SEE DETAILS. | | | |

### ADJUSTMENT ON REPAIR COST FOR VEHICLE NO. GBJ 5941A

### PHOTOGRAPHS FOR VEHICLE NO. GBJ 5941A

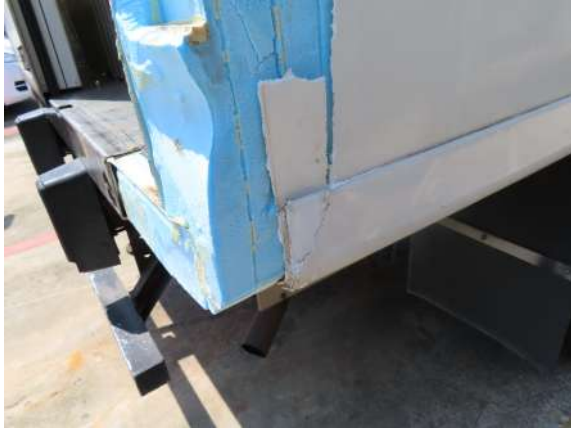
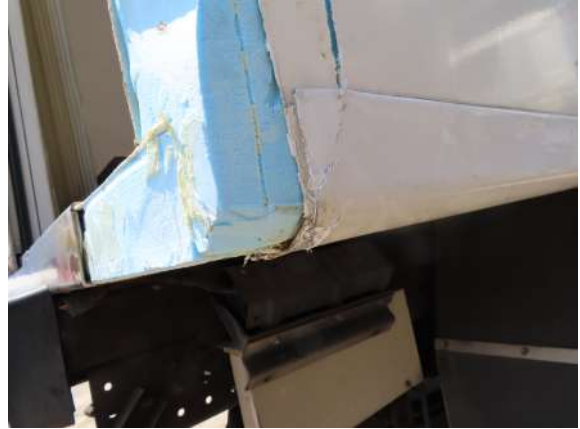
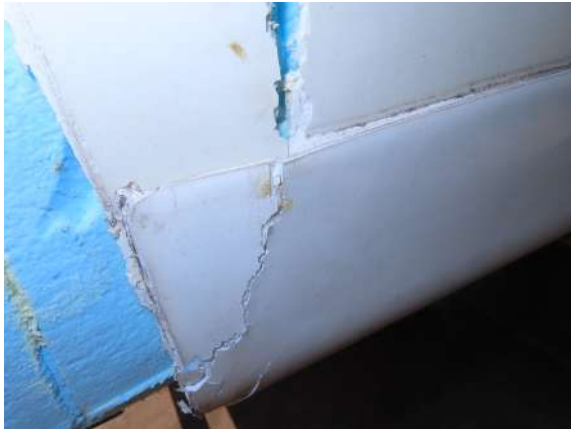
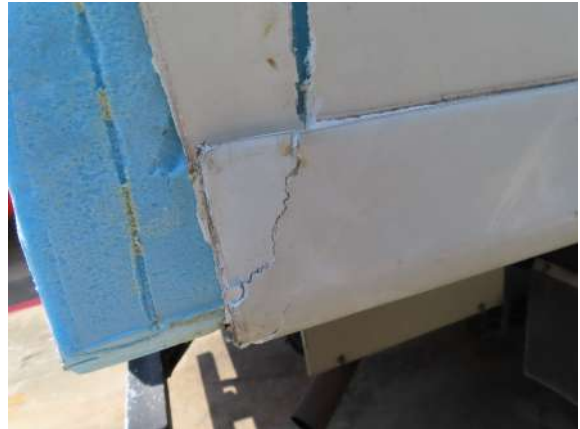
| Qty | Description of Parts | Condition | Estimate By Workshop (\$) | Our Adjusted (\$) |
|---|---|---|---|---|
| 1 | REAR RH FREEZER CARGO BOX STAINLESS PANEL (SN) | DISTORTED | 1,400.00 | 1,100.00 |
| 1 | REAR RH FREEZER CARGO BOX PANEL (SN) (LOCAL REPAIR) | CRACKED | 2,800.00 | 2,000.00 |
| 1 | REAR RH FREEZER CARGO BOX L PANEL (SN) | TO REPAIR SEE LABOUR | 850.00 | - |

| Qty | Description of Parts | Condition | Estimate By Workshop (\$) | Our Adjusted (\$) |
|---|---|---|---|---|
| | LABOR FOR PANEL BEATING ,CUT ,WELD ,STRAIGHTEN & REPLACING PARTS ETCS.INCLUSIVE OF THE REPAIR OF REAR RH FREEZER CARGO BOX L PANEL . | | 1,500.00 | 1,000.00 |
| <b>RECOMMENDED COST OF REPAIRS</b> | | | | <b>4,800.00</b> |

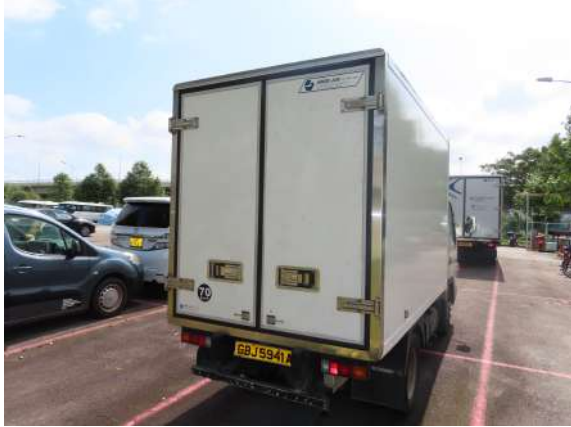
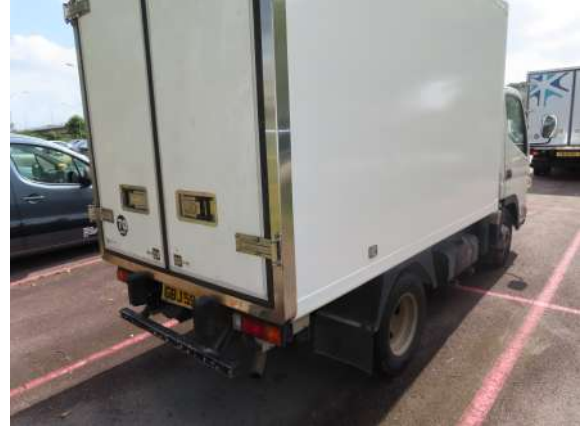
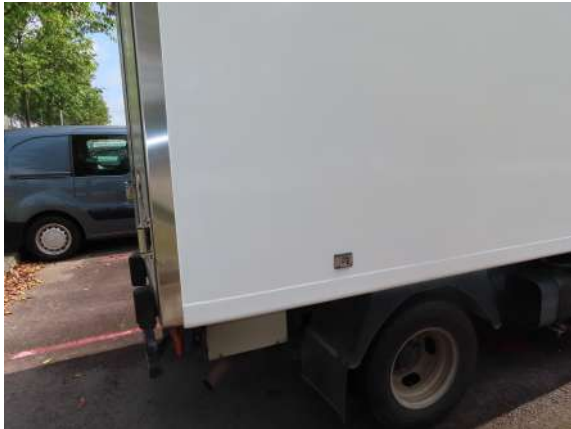
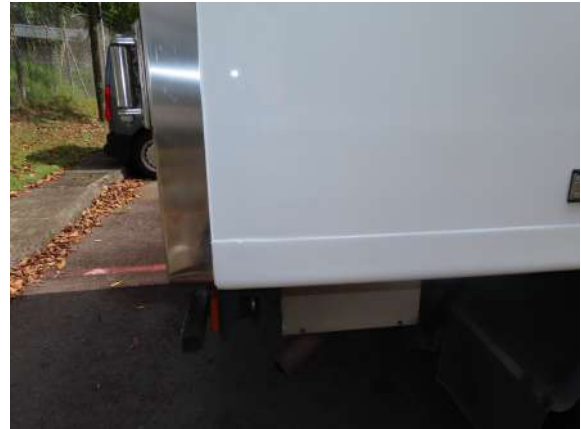
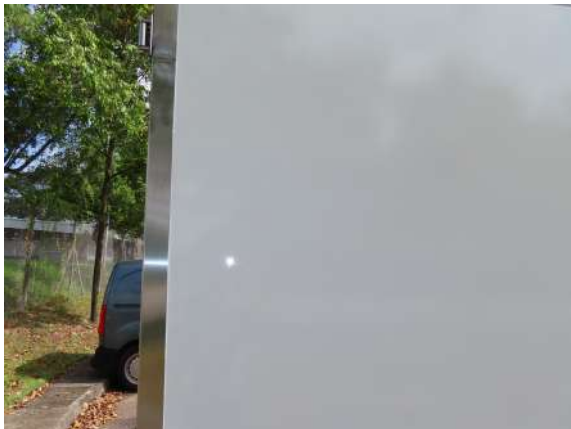
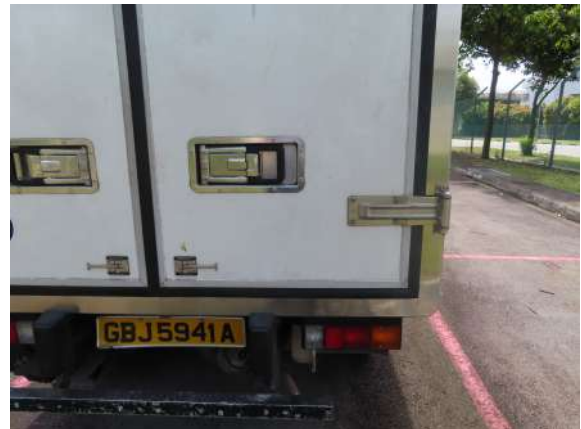
**PHOTOGRAPHS FOR VEHICLE NO. GBJ 5941A**

**RE-INSPECTION**
