Affiliated to Federation Internationale Des Experts En Automobile				
LONPAC INSURANCE BHD 300 BEACH ROAD #17-04/07 THE CONCOURSESINGAPORE 199555			Ref: CC4/LPC22001177/Epa3q2 Date: 19/10/2022 Code: LPC2

ADJUSTMENT ON REPAIR COST FOR VEHICLE NO. SLF 9964K

PHOTOGRAPHS FOR VEHICLE NO. SLF 9964K

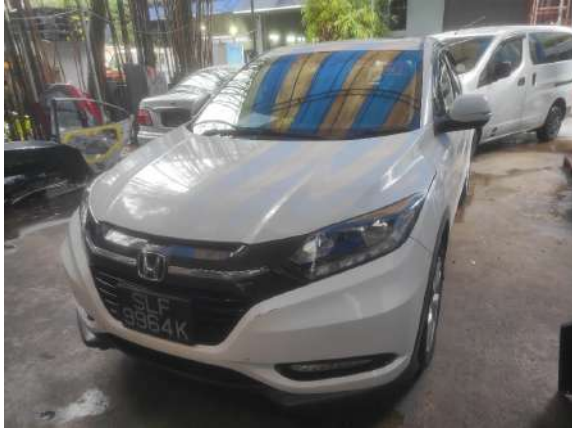
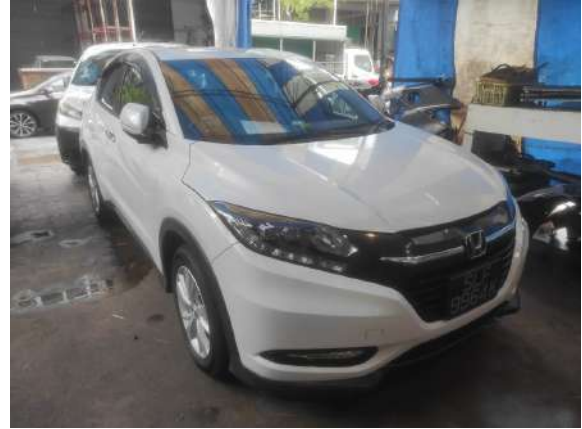
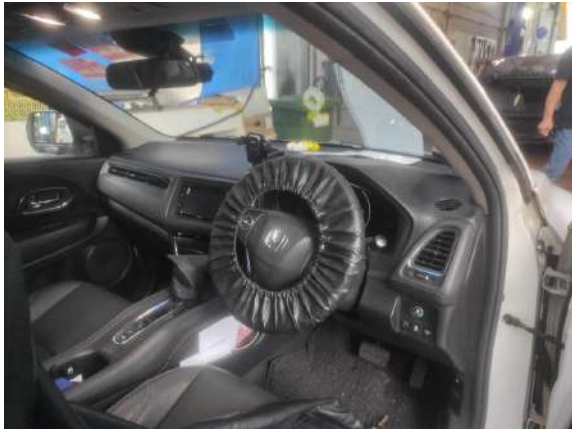
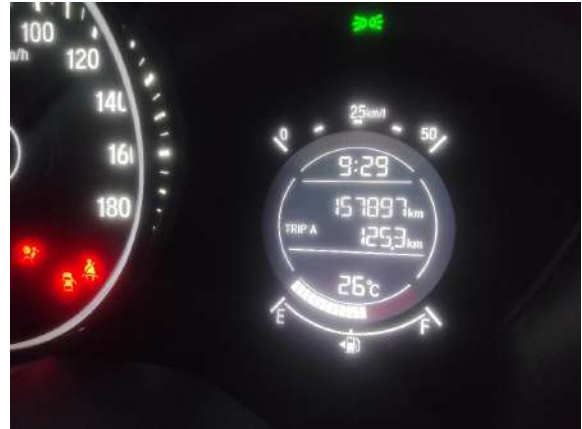
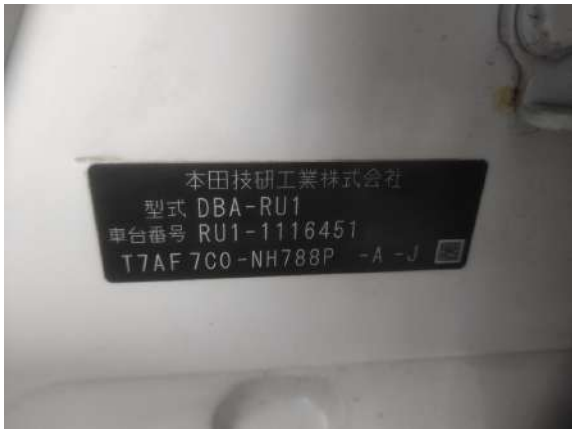
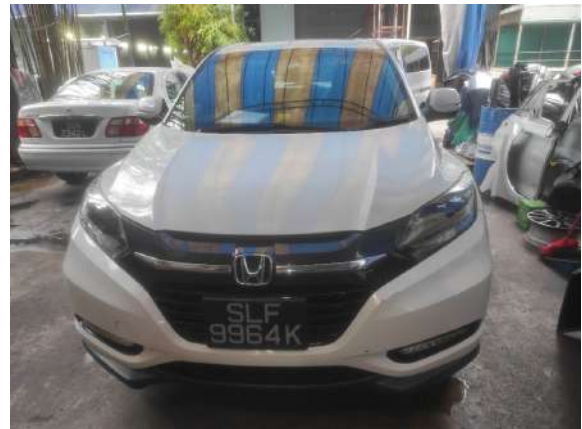
INSPECTION

4. Description of Damages				
THE VEHICLE SUSTAINED DAMAGES AT THE FRONT PORTION. DAMAGES SEE DETAILS.				
5. General Information				
Accident Date	05/02/2022	Inspection Date	10/02/2022	
Survey held at	WAH HONG MOTORS & CREDIT PTE LTD 38 TOH GUAN ROAD EAST #01-57 ENTERPRISE HUB SINGAPORE 608581			
5a. Remarks

RECOMMENDED COST OF LUMP SUM REPAIRS (TO ITS PRE-ACCIDENT CONDITION)			750.00
---	--	--	---------------
