VEHICLE REGISTRATION NO : SLK6263T  
VEHICLE MAKE/MODEL : Volkswagen Jetta 1.4 TSI

**Re: Third Party Claim  
Vehicle Registration No. : SLK6263T**

**VEHICLE INSPECTION REPORT**

## PRO PLUS AUTOMOBILE ENGINEERS (Inspection photographs)

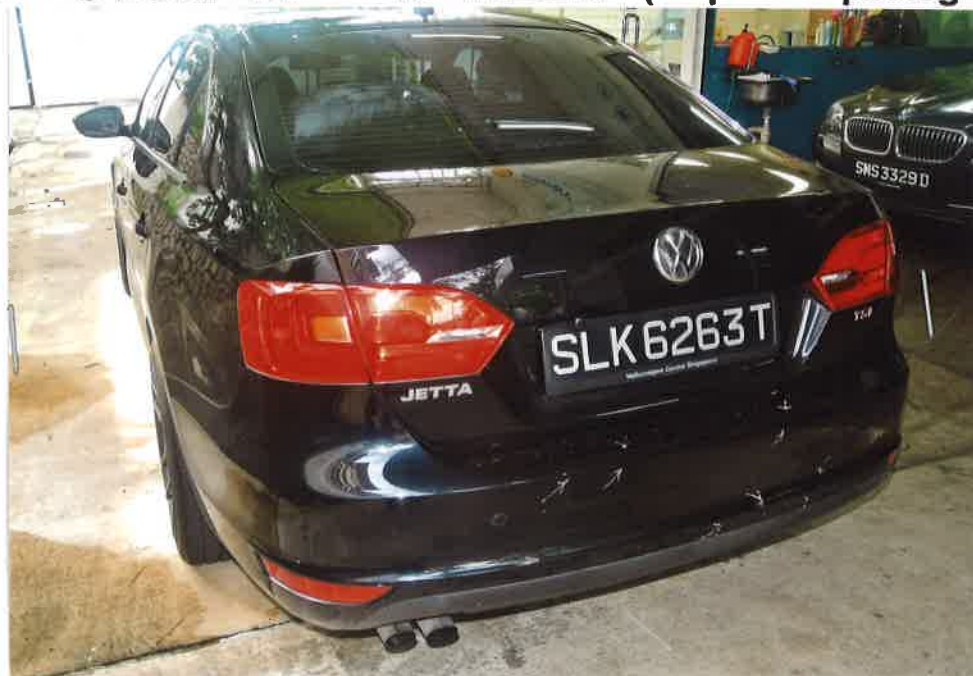
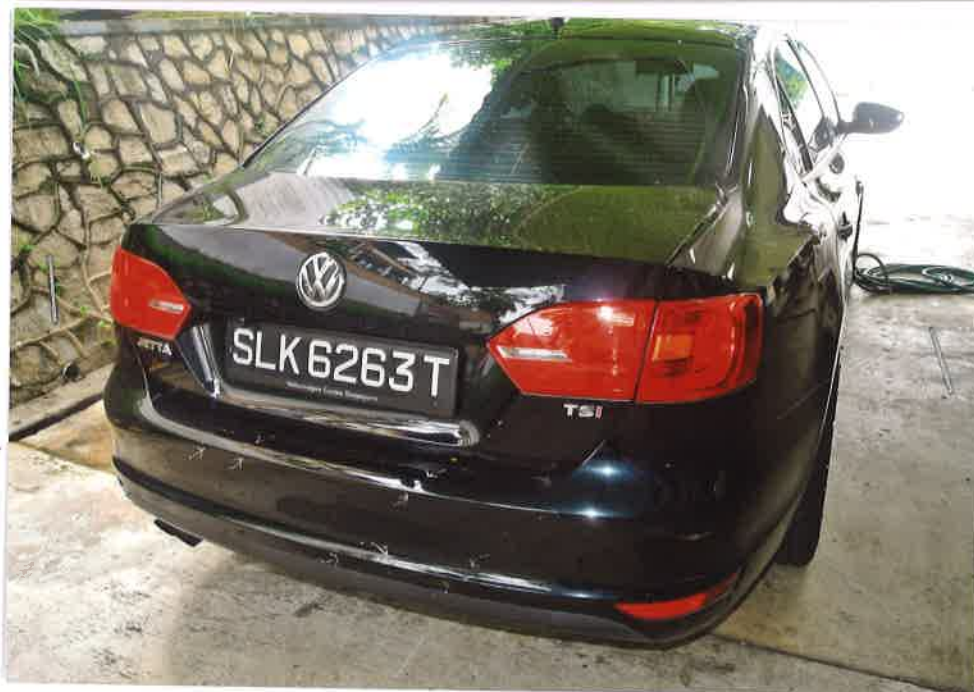
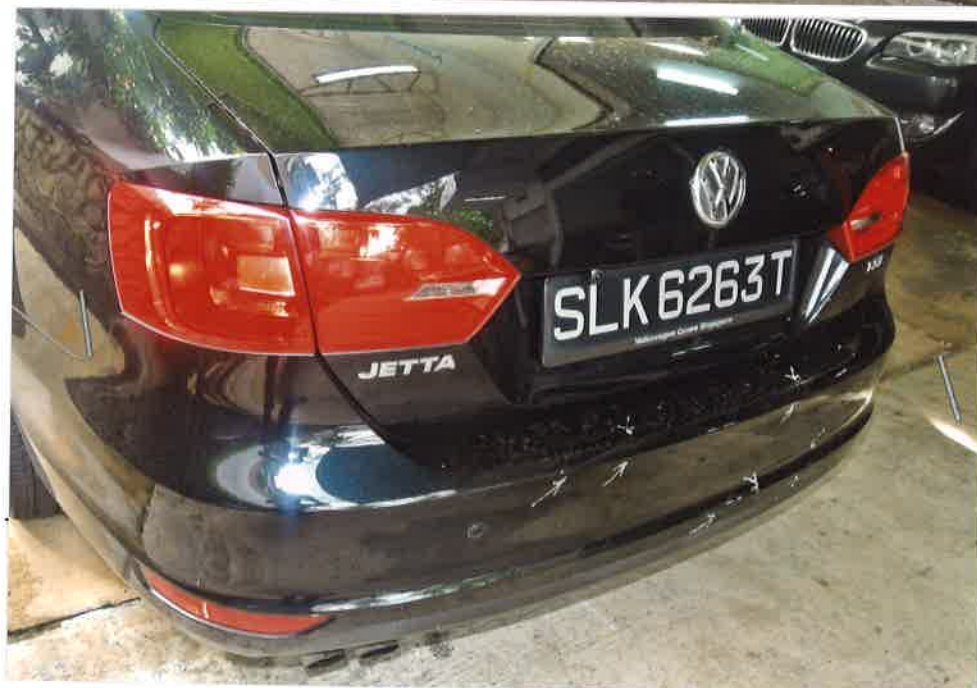
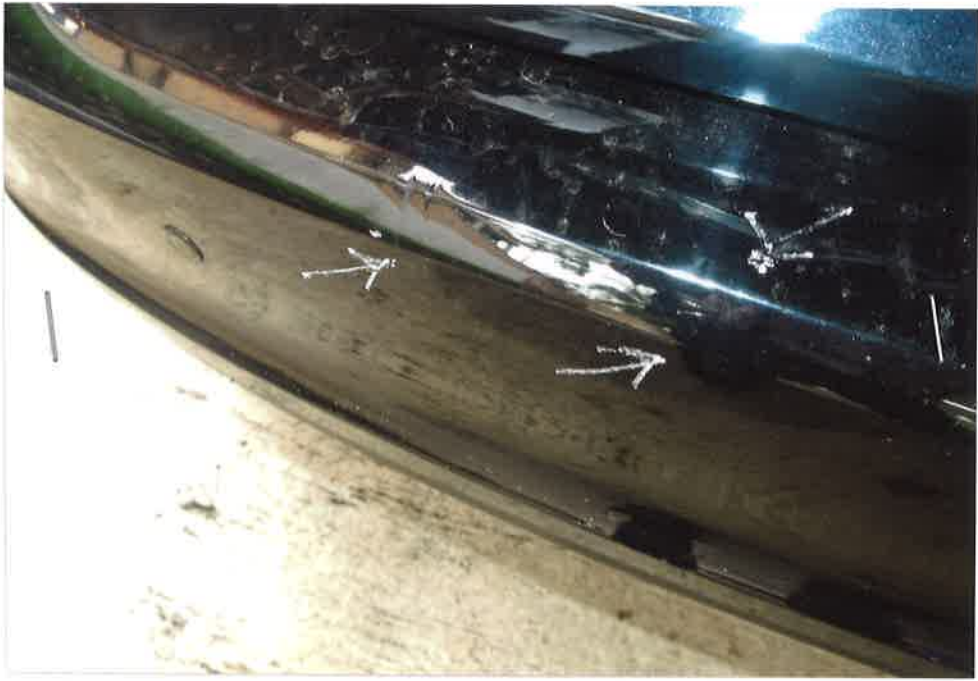
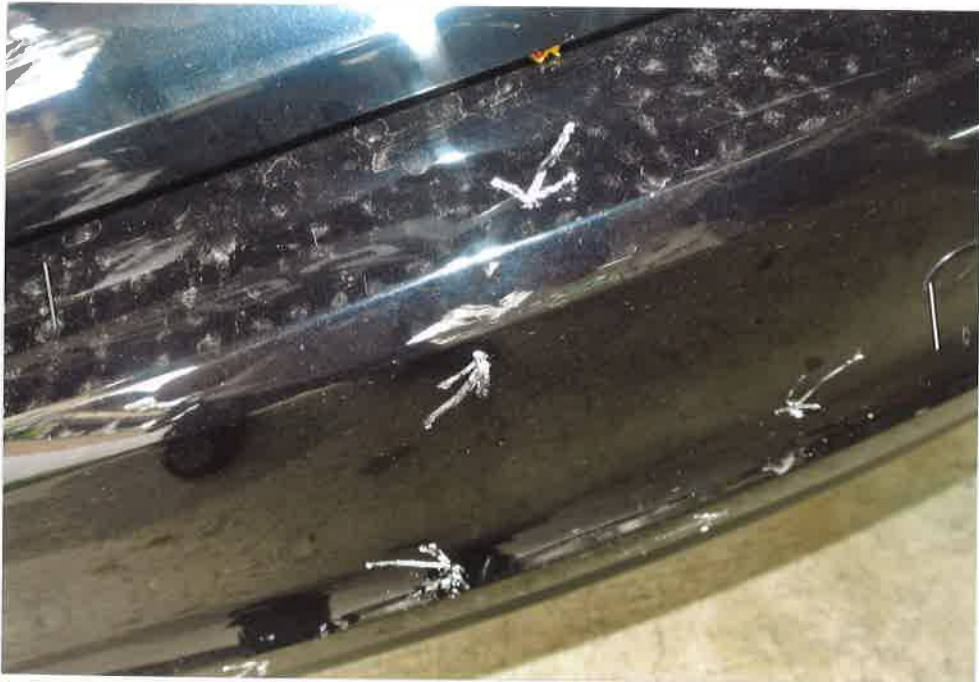
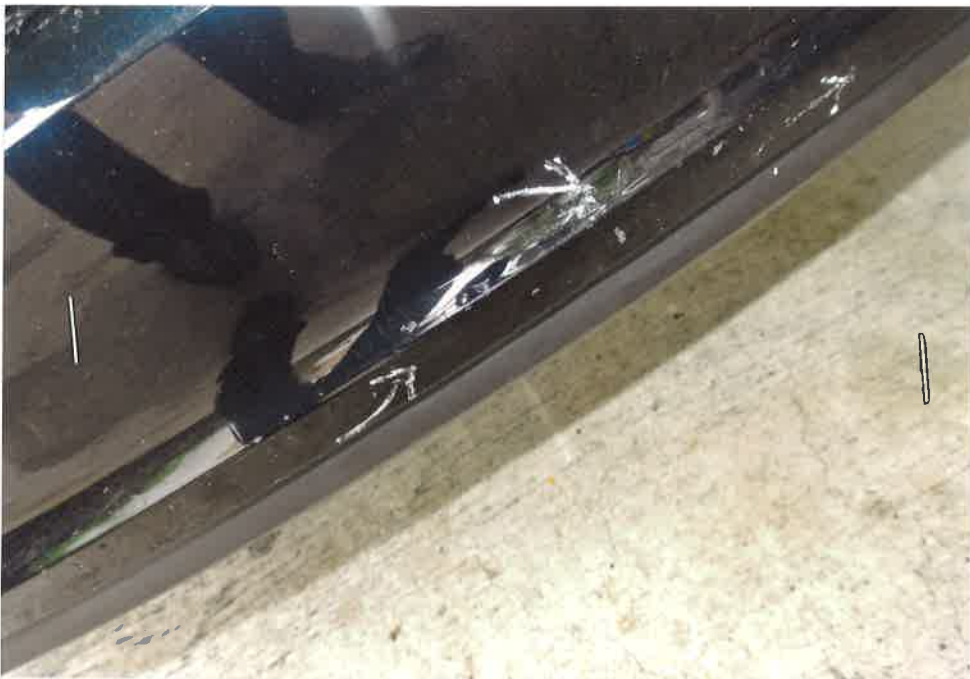
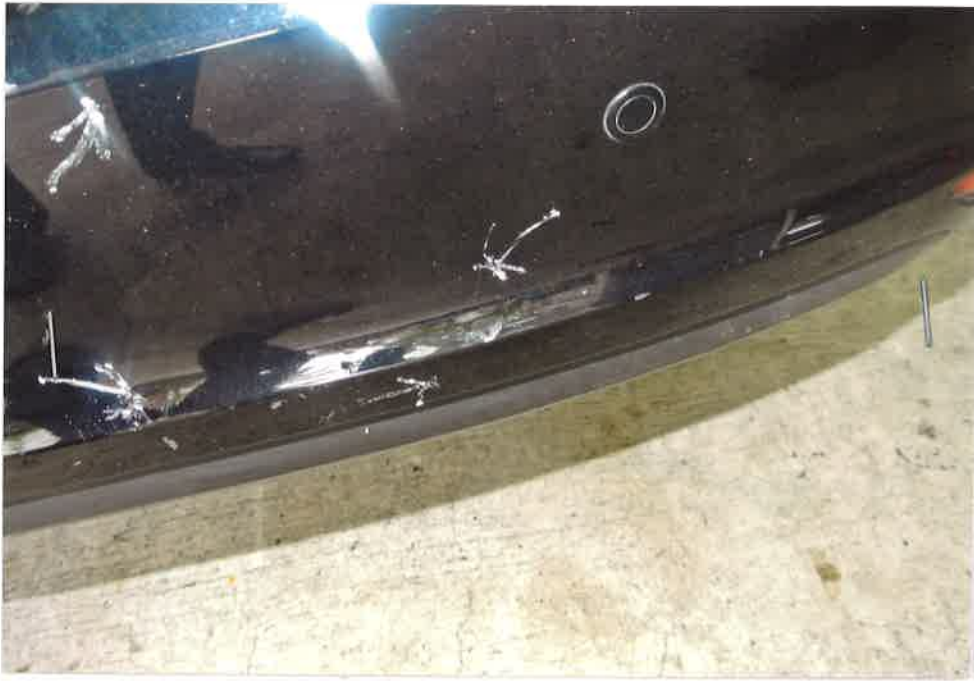
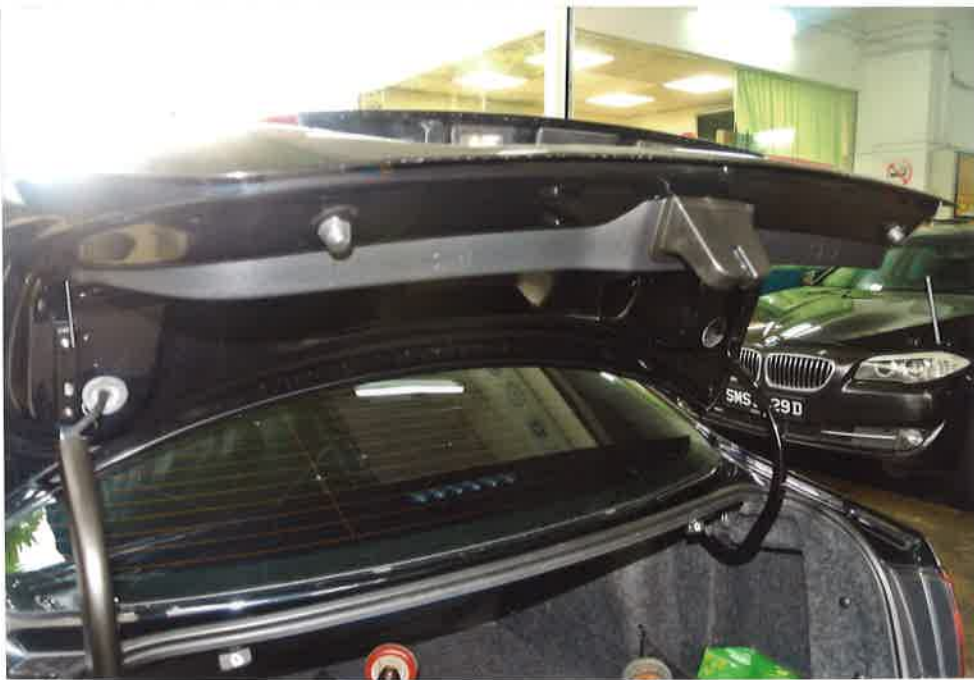
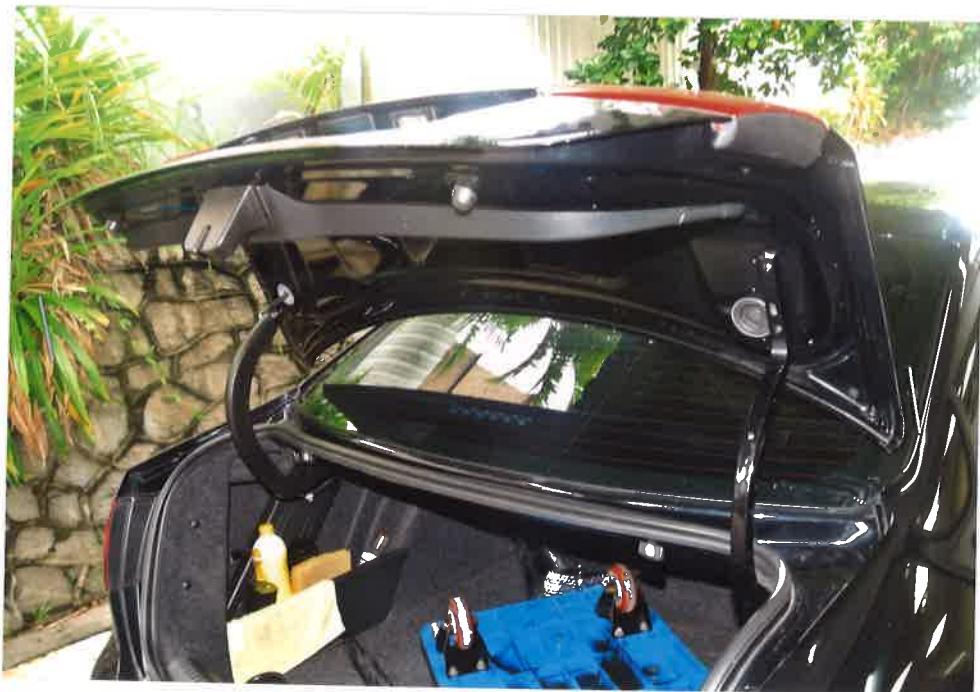
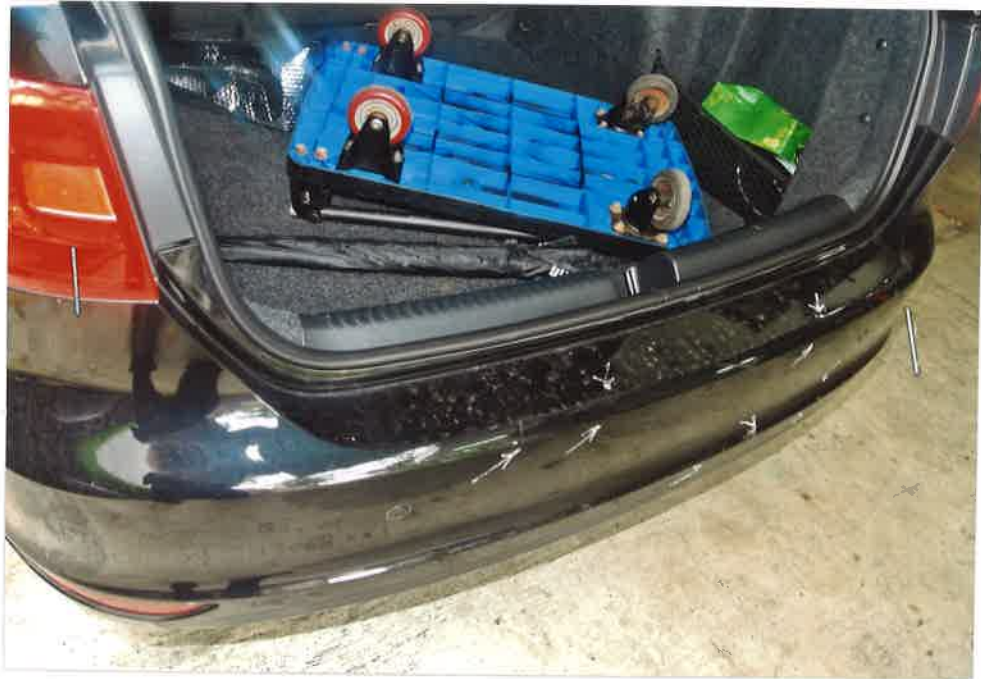
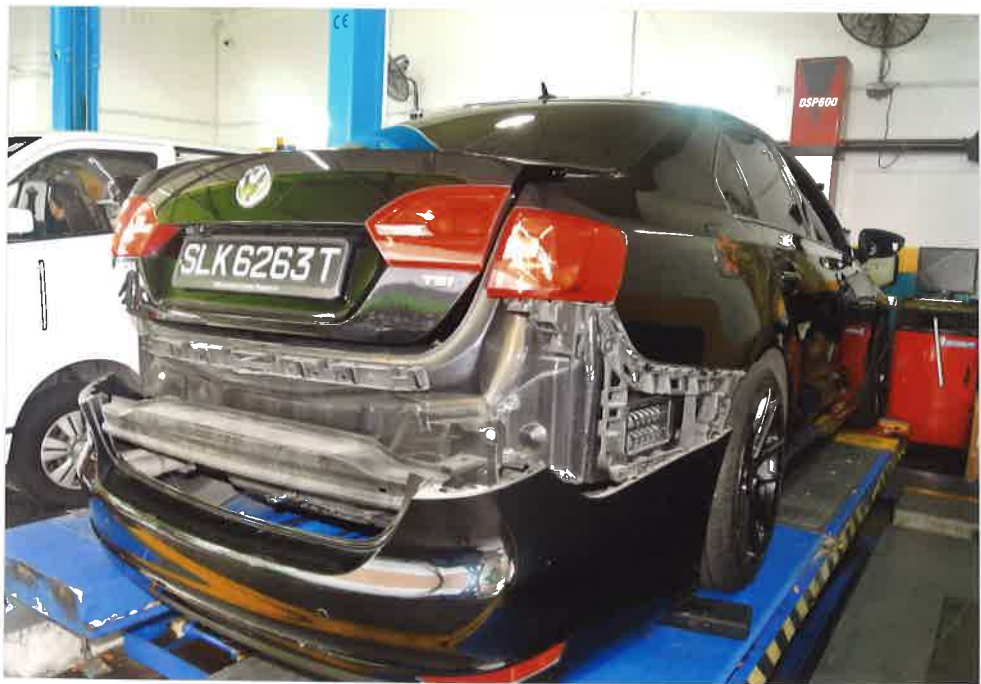
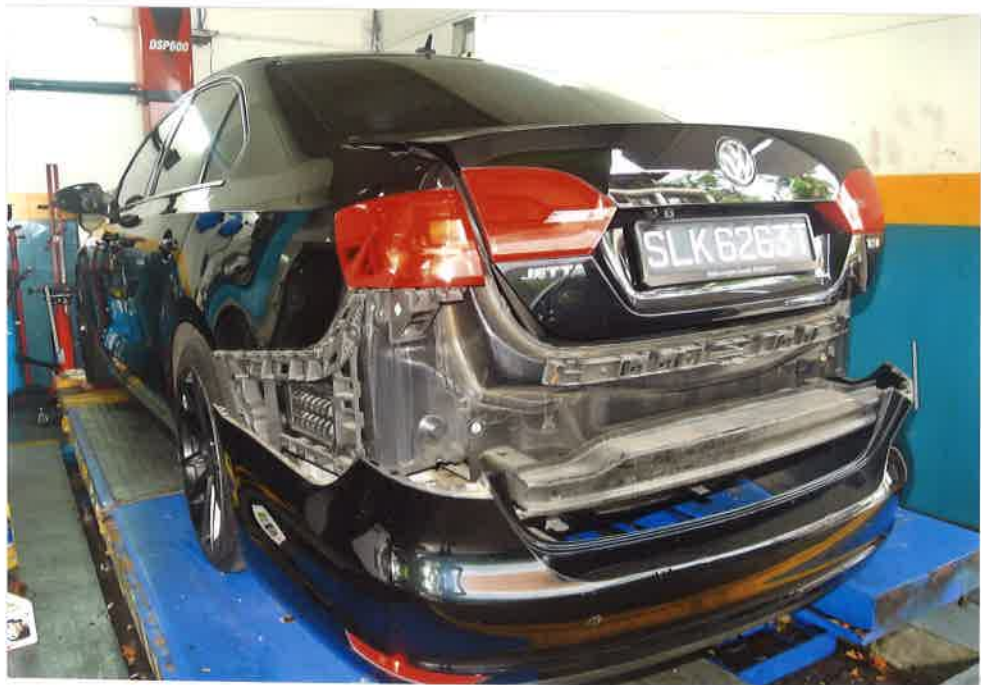
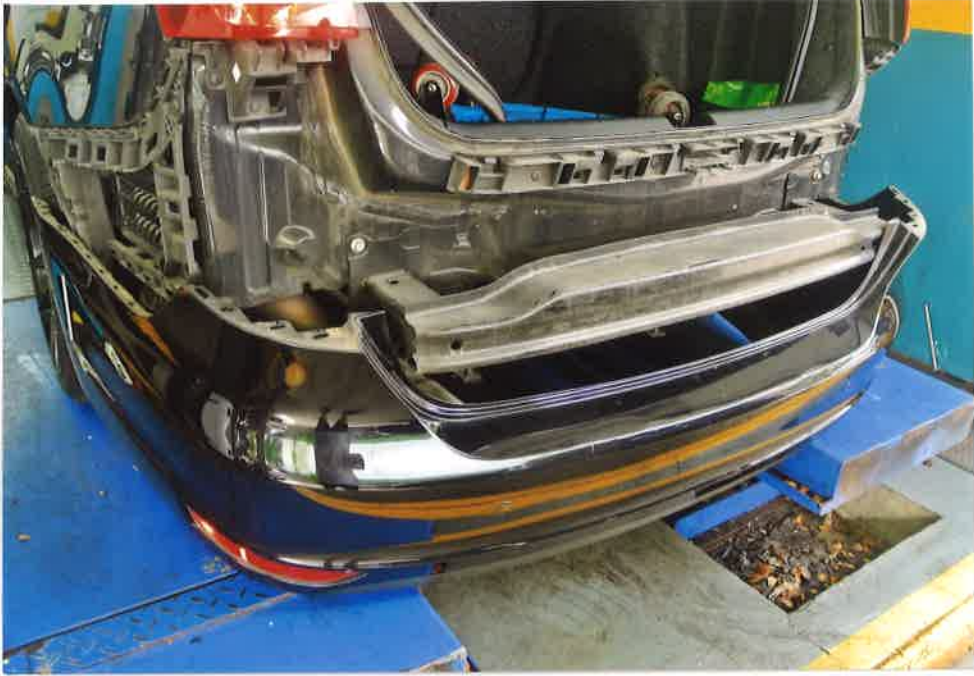
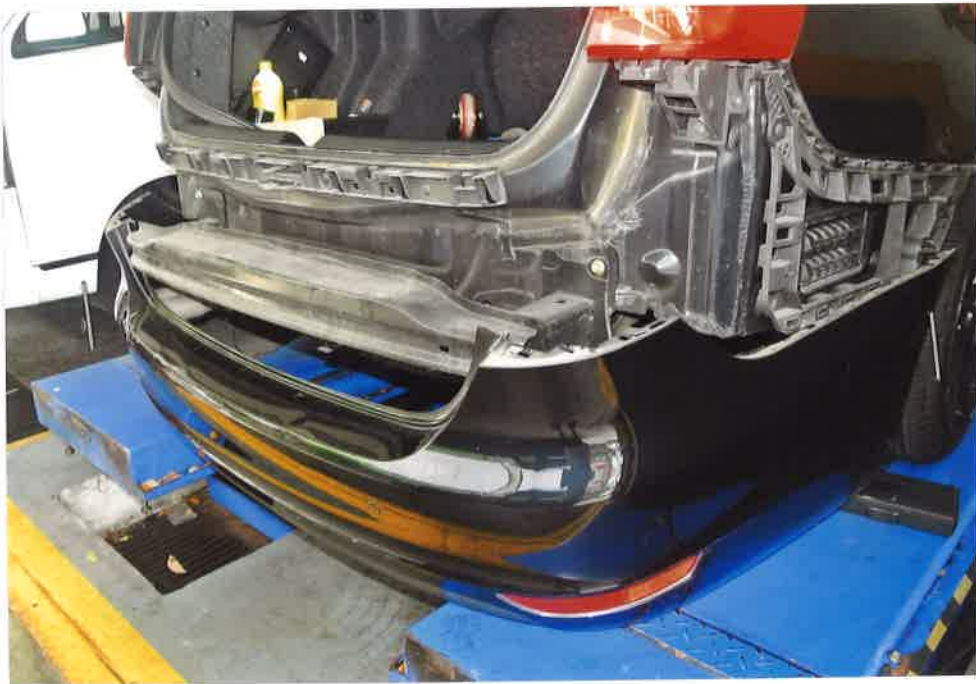
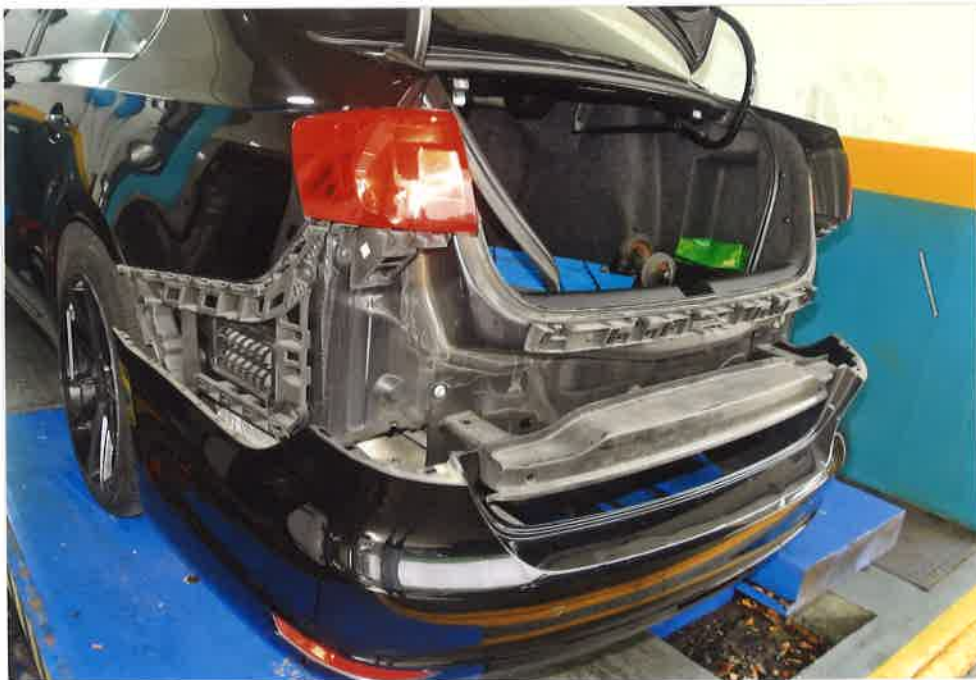
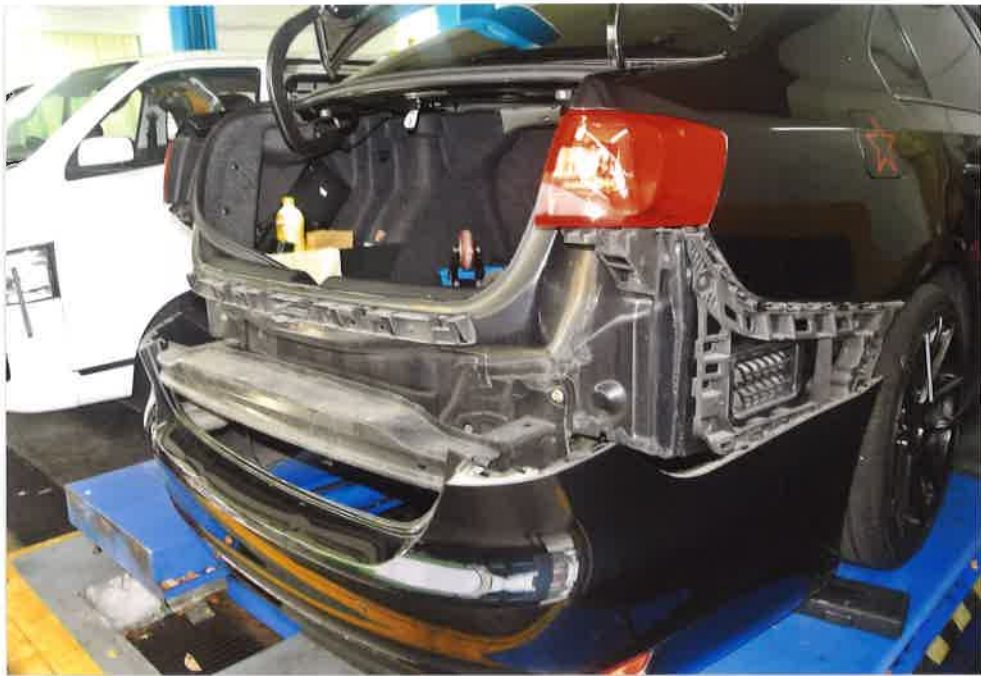
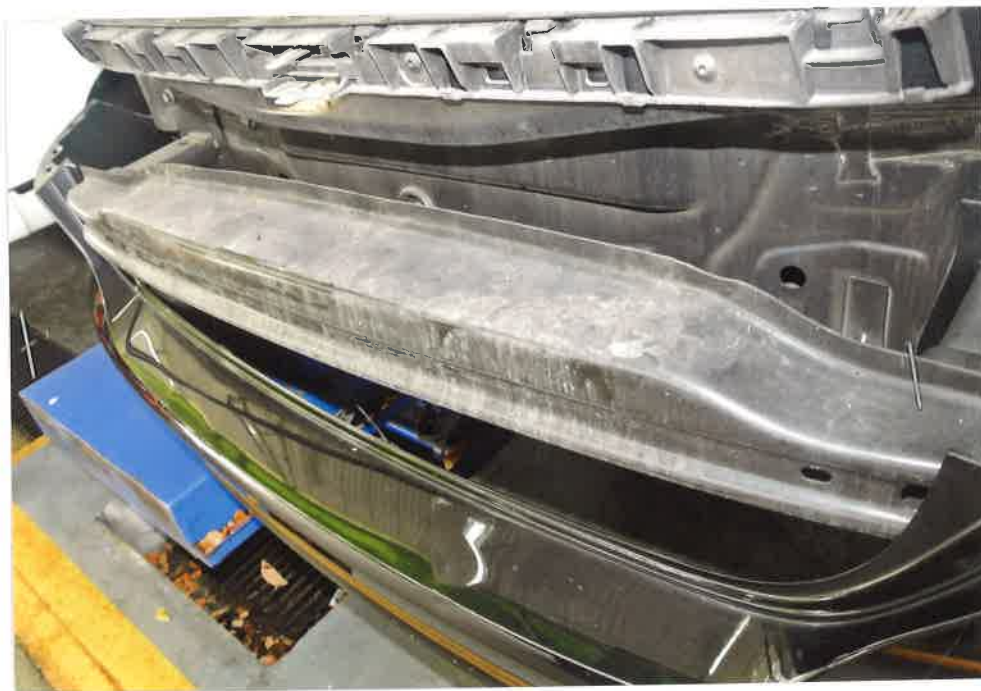
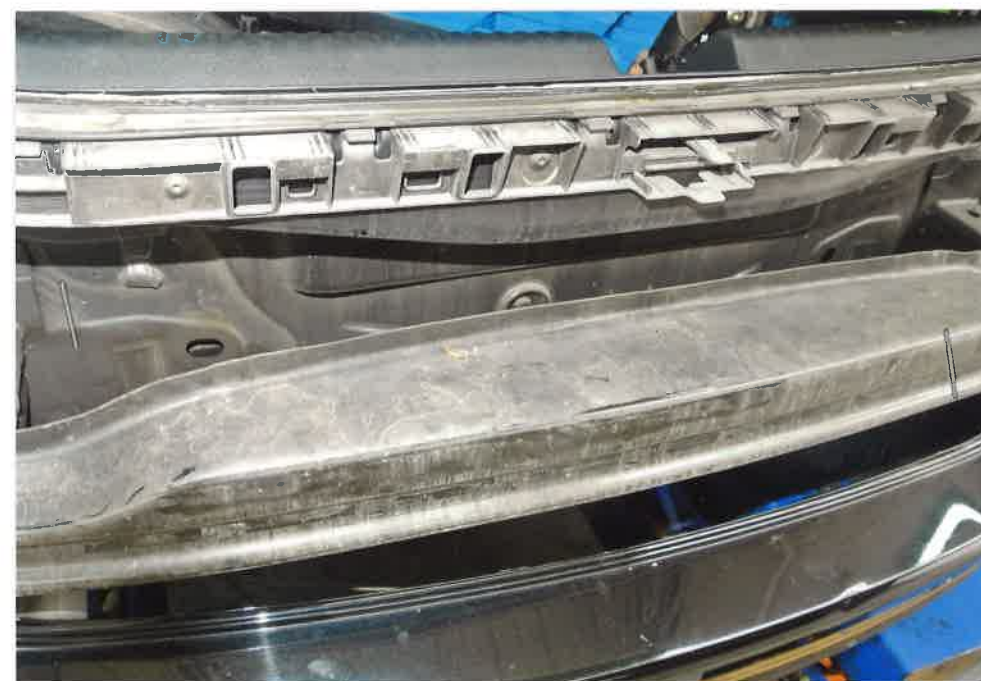
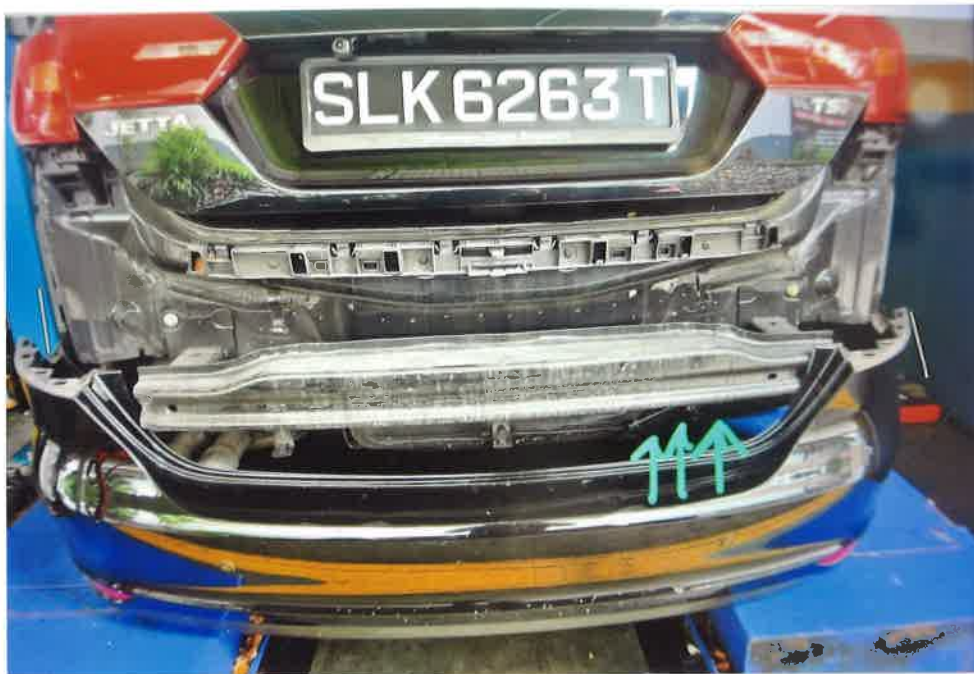
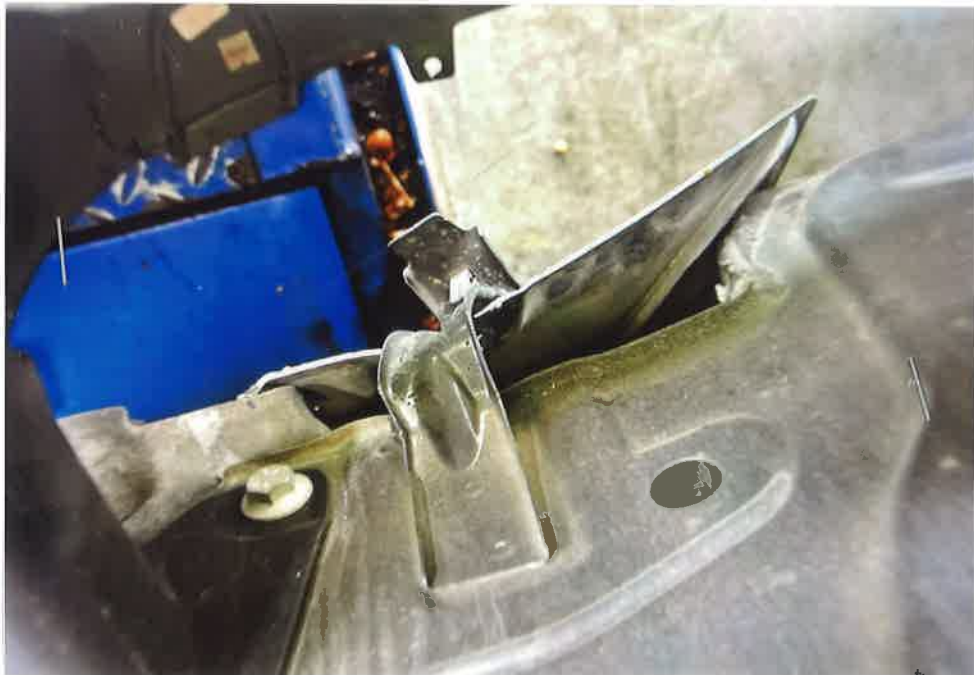
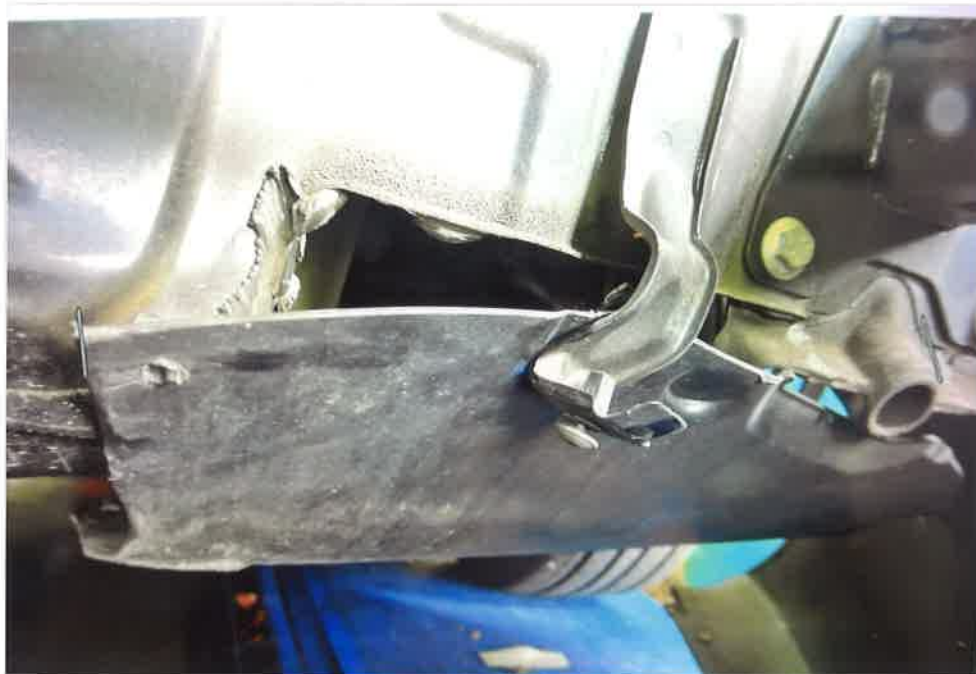
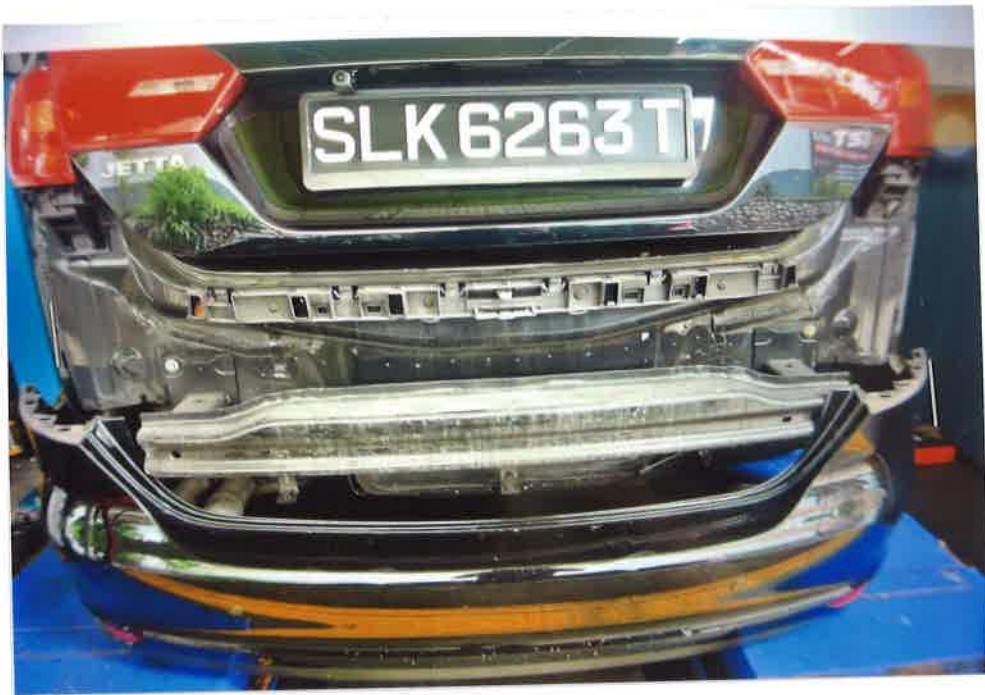
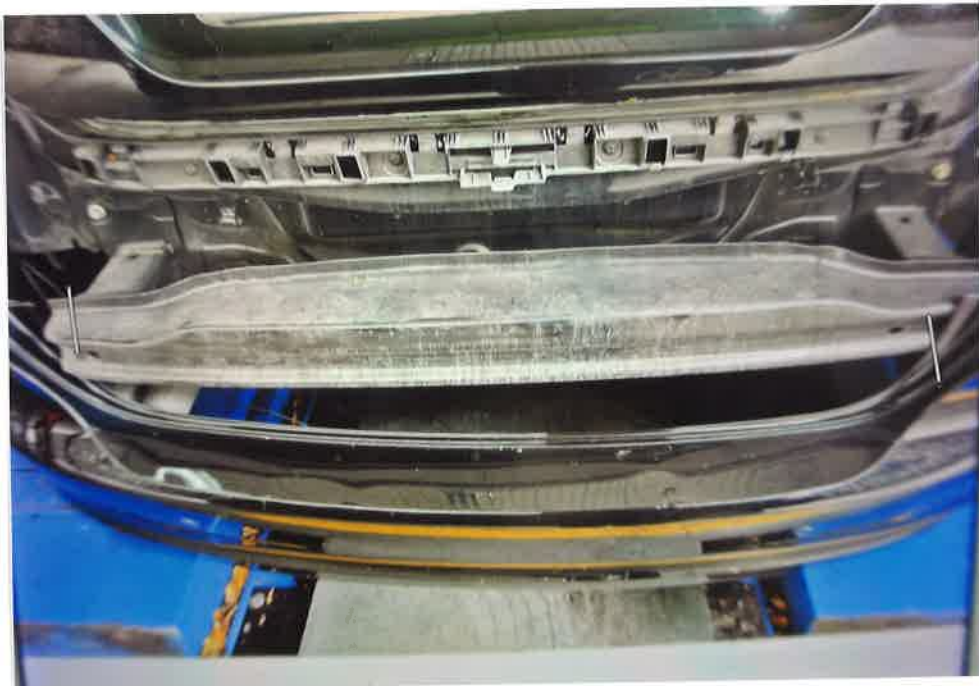
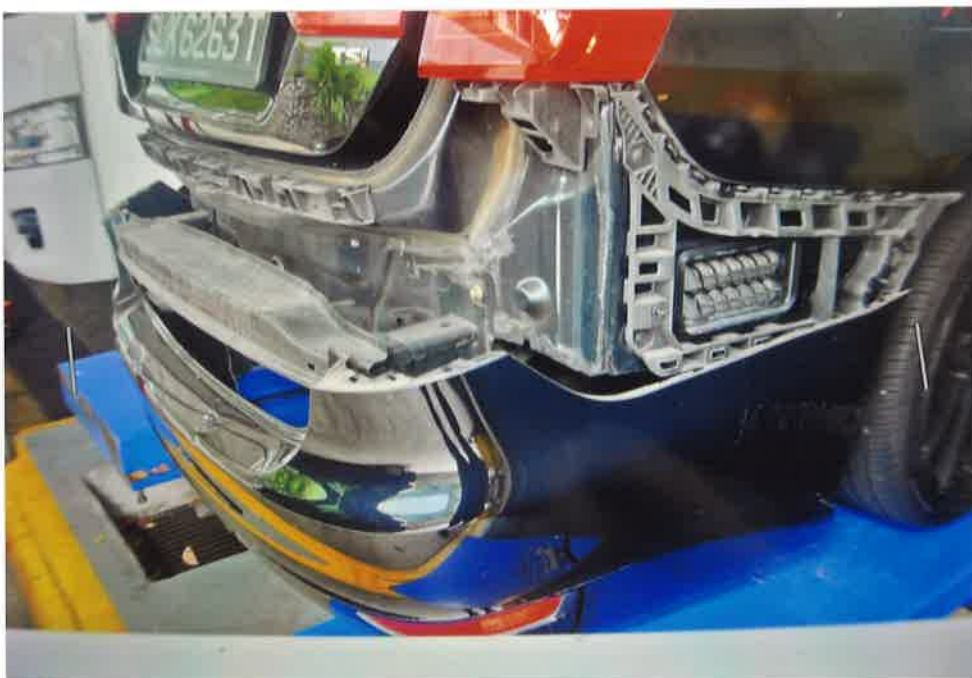
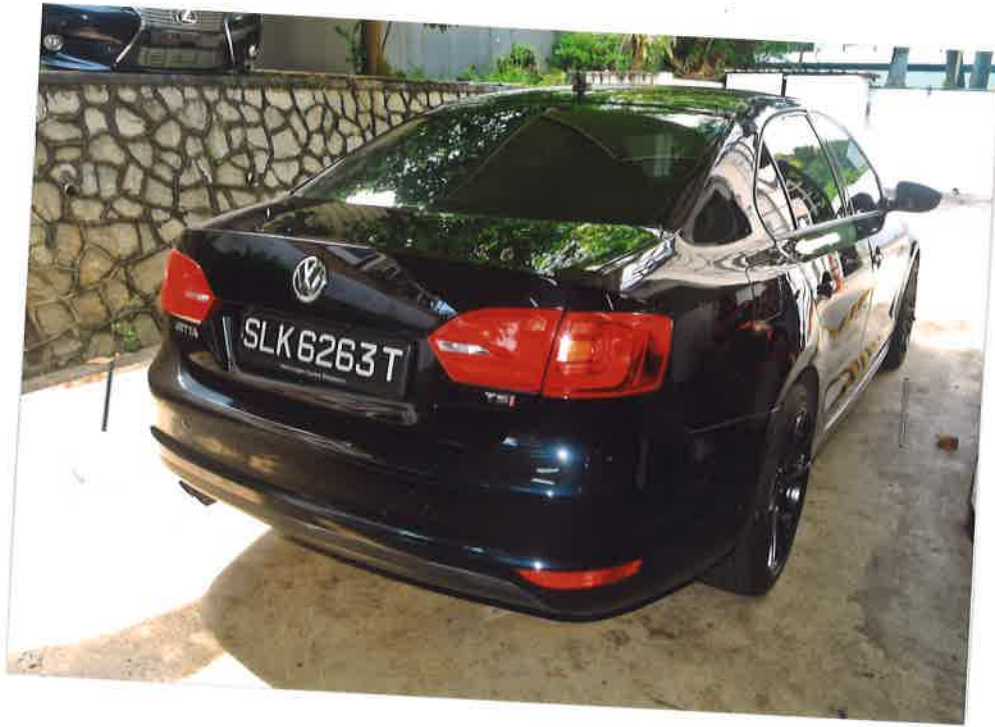
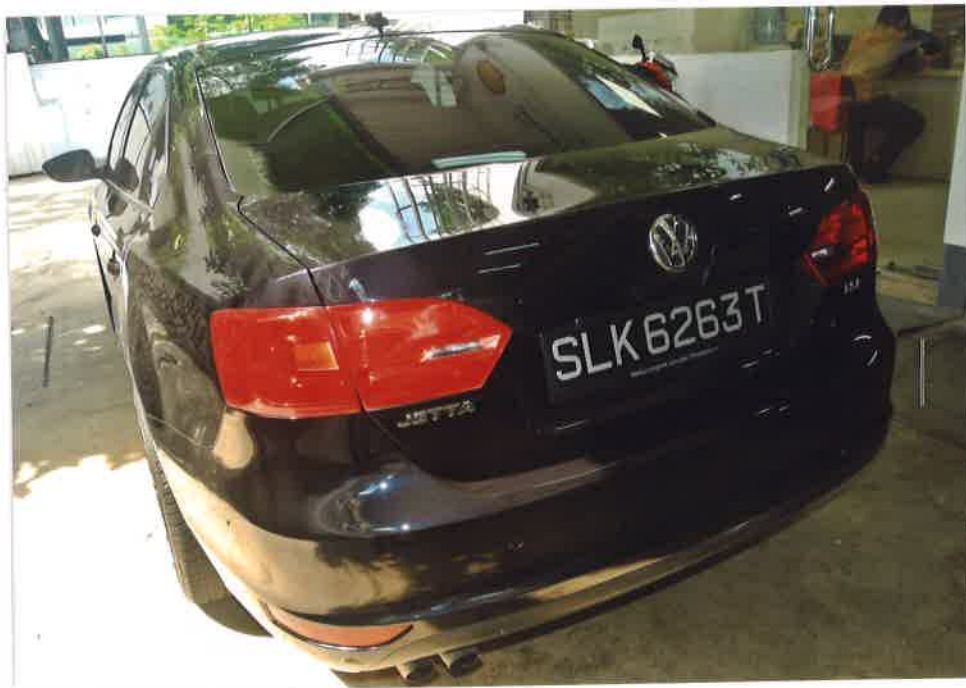
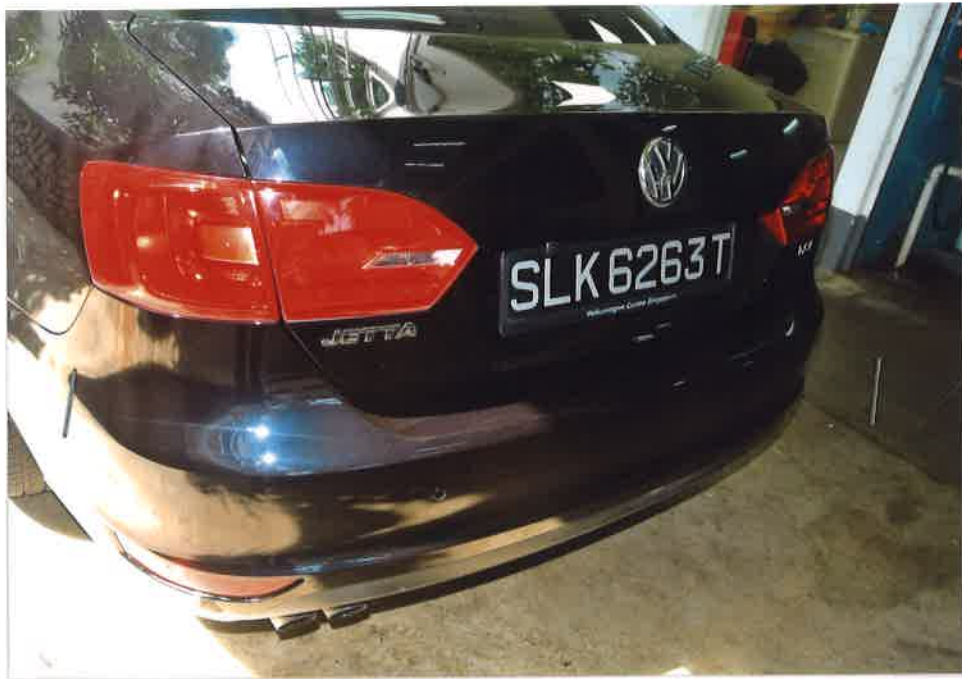
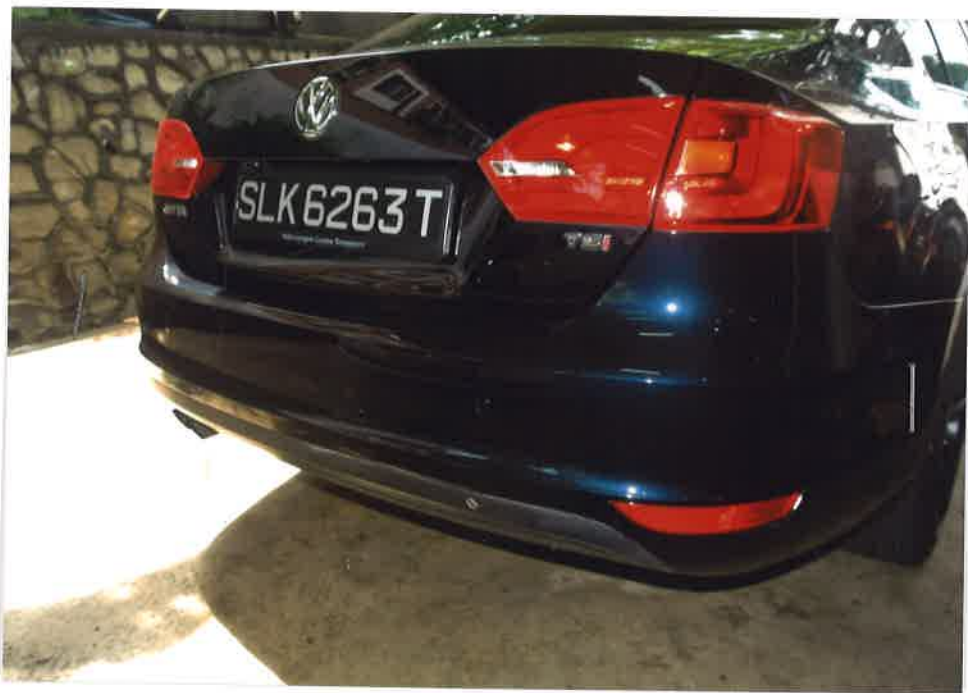
Damages sustained were consistent with the subject vehicle being involved in a collision with another vehicle, sustaining damages to the rear portion of the vehicle.

Damages sustained were the bootlid & its inner reinforcement - dented/bent, bootlid inner lock/striker - bent inwards/shifted, rear end panel - thrust inwards/buckled, rear bumper assembly, rear fender o/s & n/s - buckled, rear compartment floor/tyre well panel - buckled, etc.

Follow-up reinspection of vehicle on 21/12/2021 after spray painting & noted that the listed components as per our recommendations were replaced and repaired accordingly.

**Remarks:** The repairer has agreed to undertake the repairs on a contract lump sum of S\$3,100.00 NETT corresponding to supply of parts, labour and spray painting charges. Invariably, the motor repairer has the prerogative/option for the recommended replacement components to either be repaired or be replaced.
