VEHICLE REGISTRATION NO : SLK6263T  
VEHICLE MAKE/MODEL : Volkswagen Jetta 1.4 TSI

**Re: Third Party Claim  
Vehicle Registration No. : SLK6263T**

**VEHICLE INSPECTION REPORT**

## PRO PLUS AUTOMOBILE ENGINEERS (Inspection photographs)

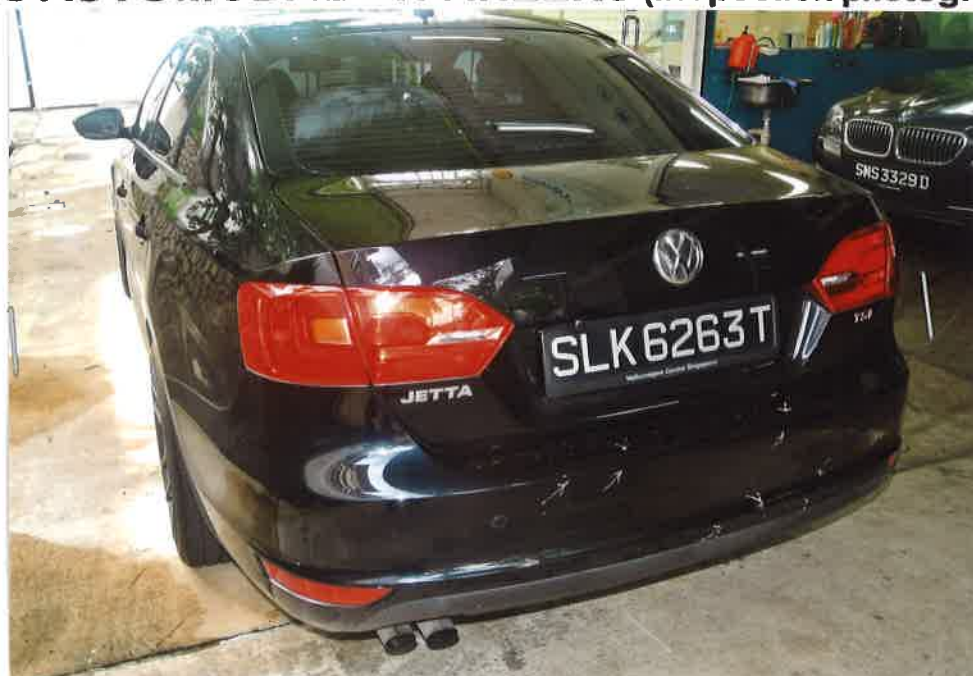
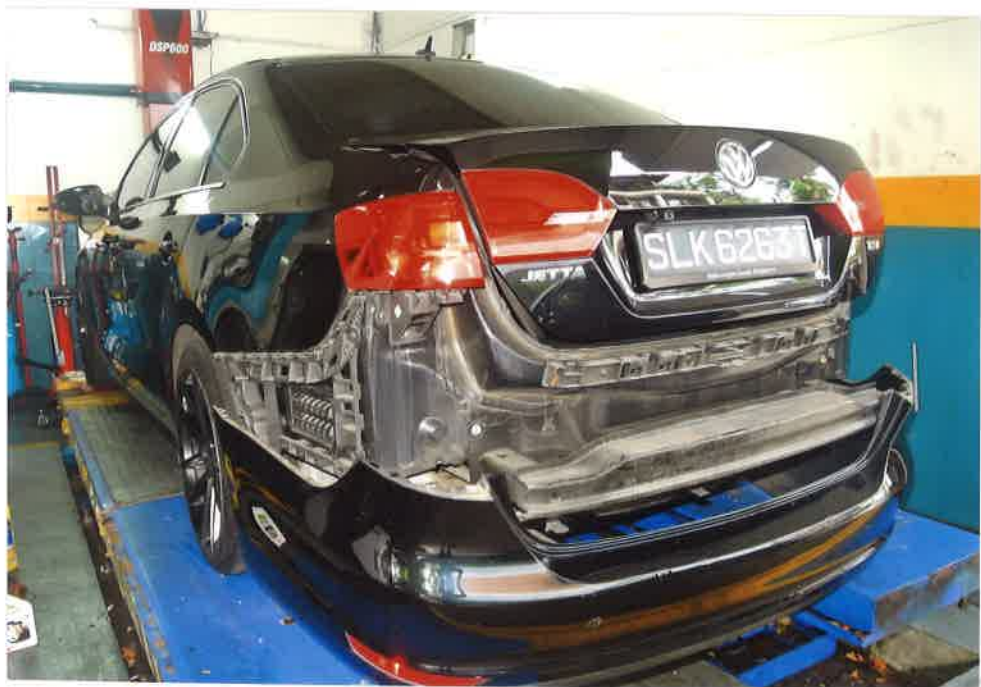
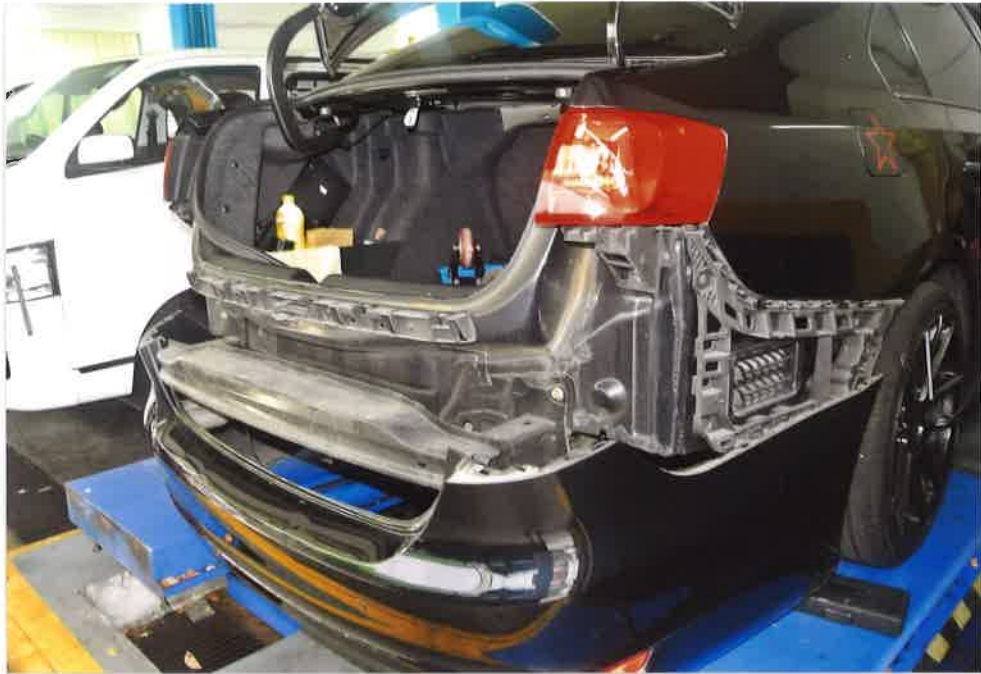
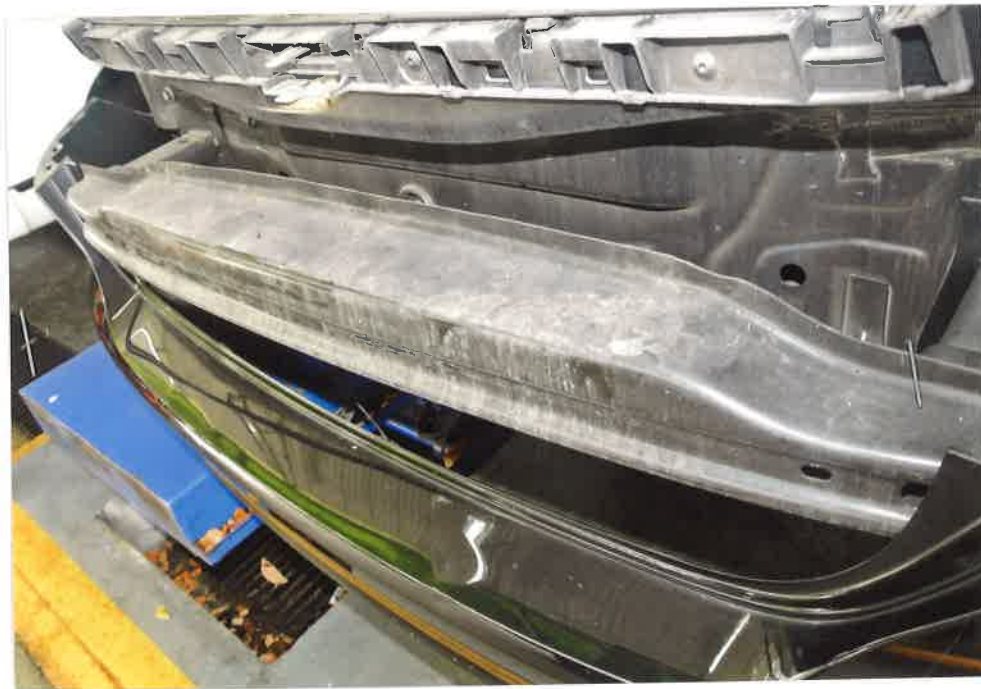
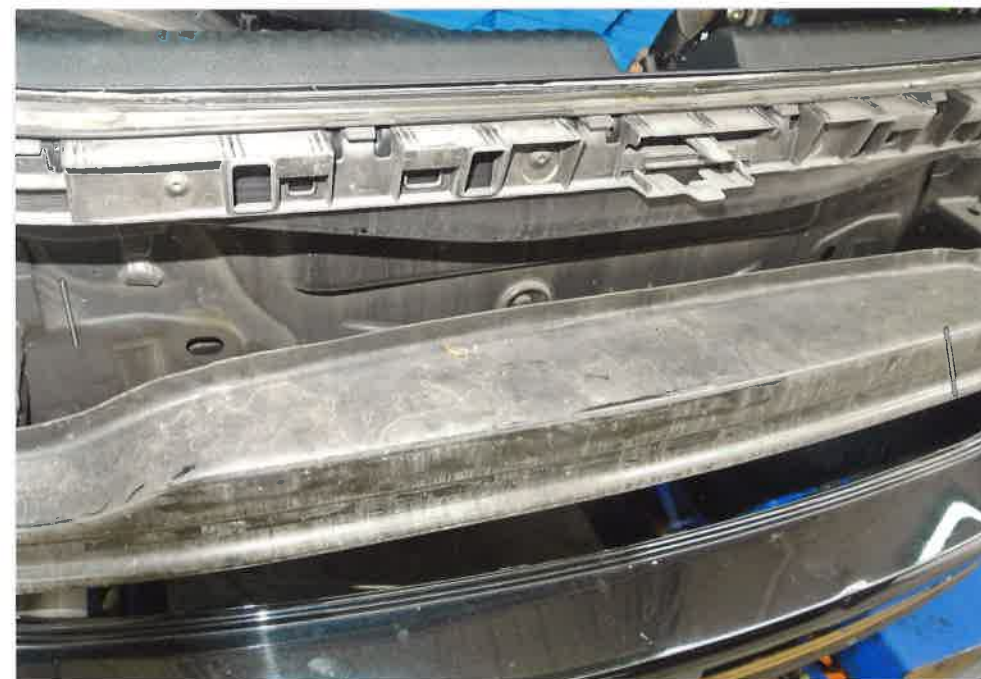
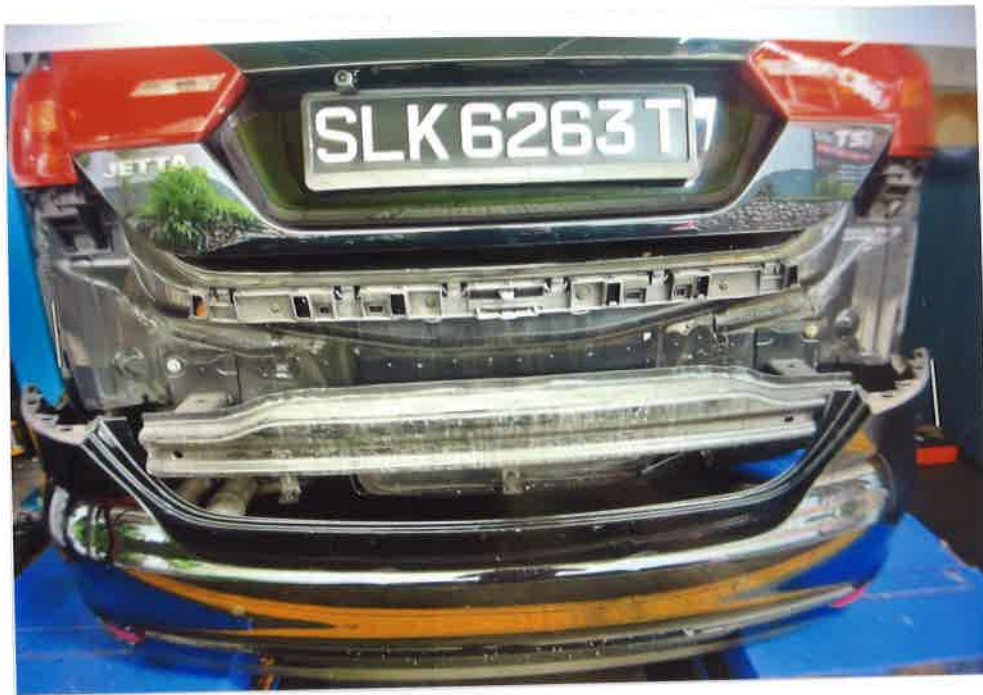
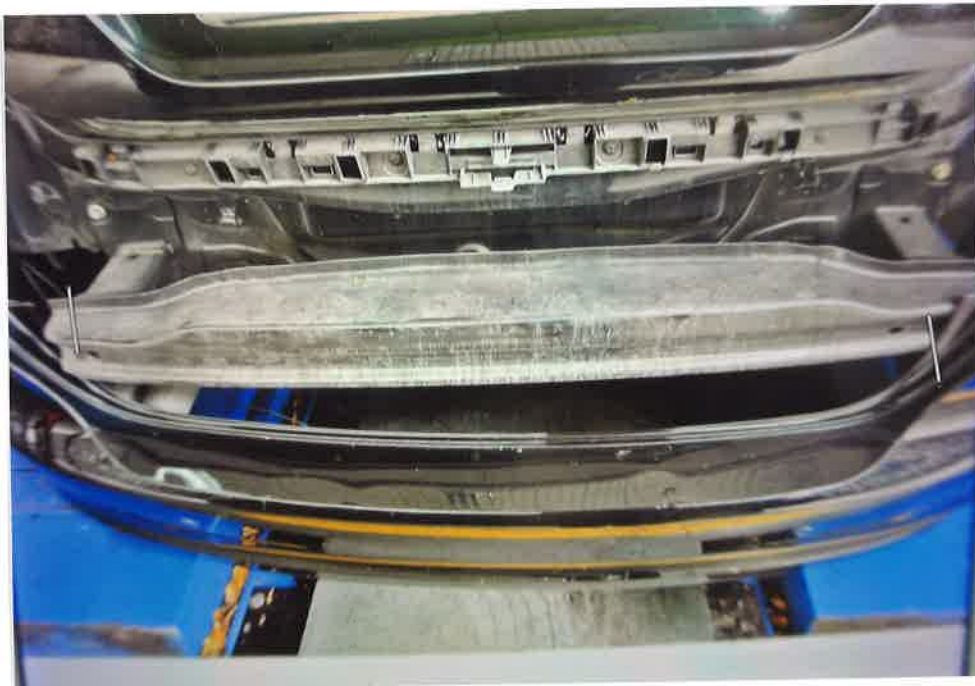
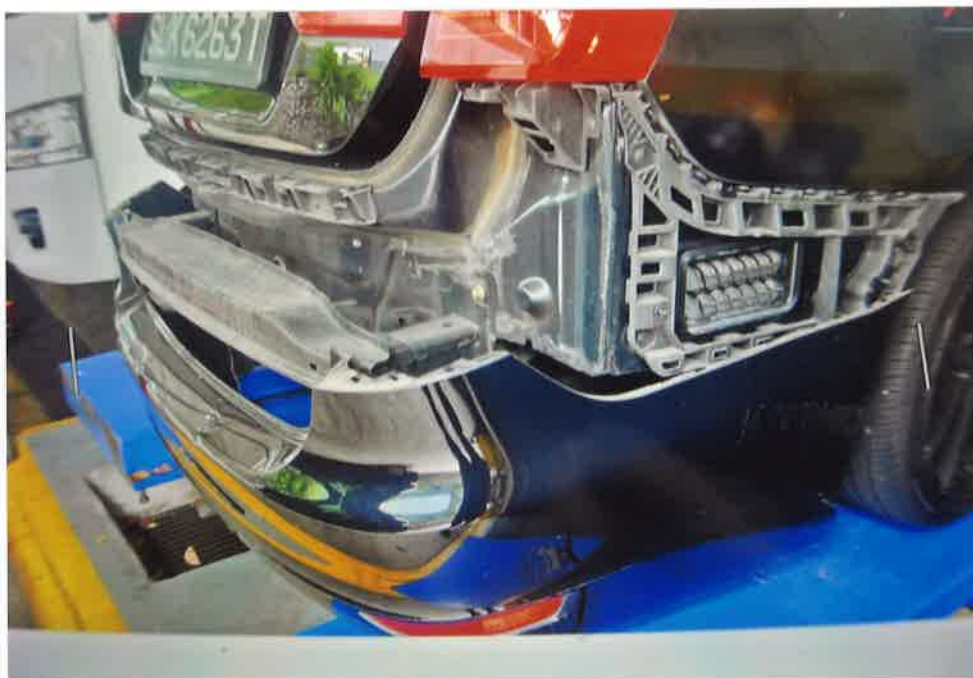
Damages sustained were consistent with the subject vehicle being involved in a collision with another vehicle, sustaining damages to the rear portion of the vehicle.

Damages sustained were the bootlid & its inner reinforcement - dented/bent, bootlid inner lock/striker - bent inwards/shifted, rear end panel - thrust inwards/buckled, rear bumper assembly, rear fender o/s & n/s - buckled, rear compartment floor/tyre well panel - buckled, etc.

Follow-up reinspection of vehicle on 21/12/2021 after spray painting & noted that the listed components as per our recommendations were replaced and repaired accordingly.

**Remarks:** The repairer has agreed to undertake the repairs on a contract lump sum of S\$3,100.00 NETT corresponding to supply of parts, labour and spray painting charges. Invariably, the motor repairer has the prerogative/option for the recommended replacement components to either be repaired or be replaced.
