# AUTOMAX SURVEY

Report Ref : TP21080072

## THIRD PARTY SURVEY ACCIDENT OCCURED ON 04 AUG 2021

Registration No : GBD2456K	Engine No : 1KD2414175
Model : TOYOTA DYNA 150	Mileage : 140 271km
Year / Capacity : Aug 2014 / 2982 cc	Colour : Metallic Silver
Chassis No : KDY2318016275

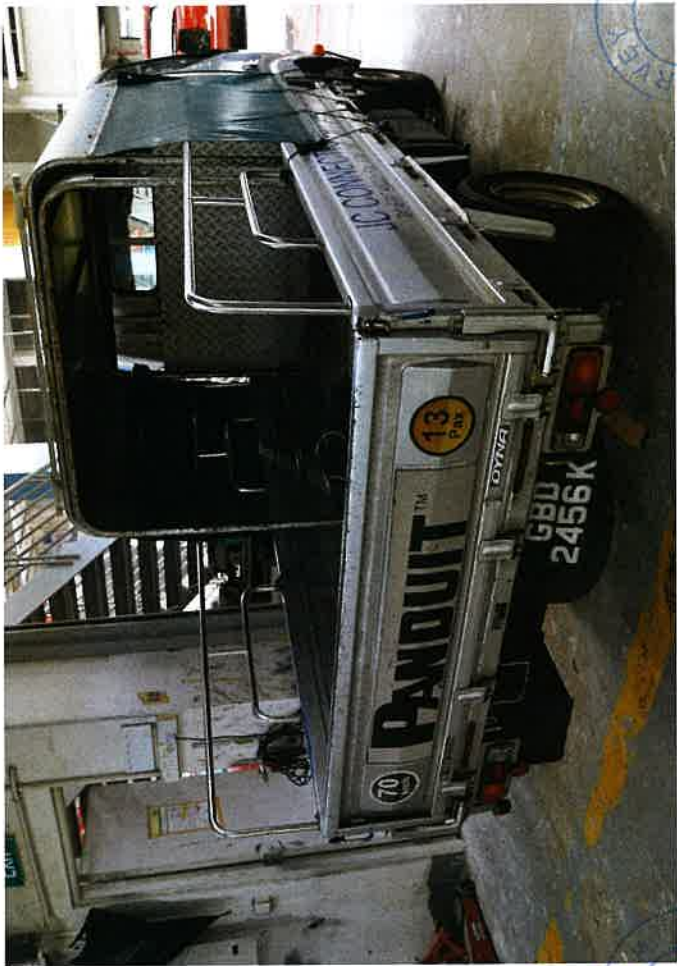
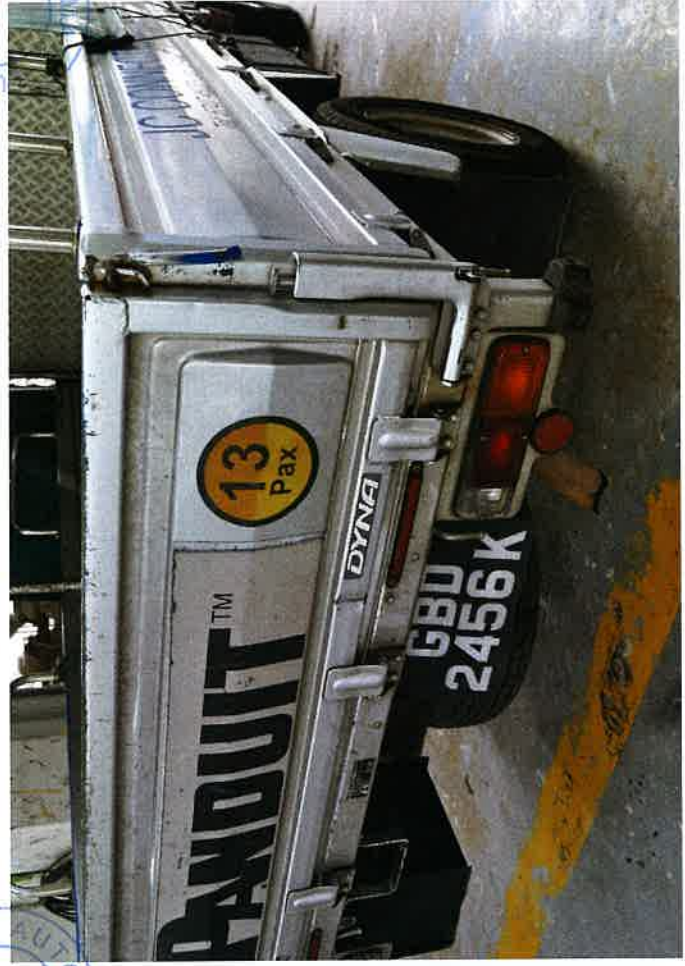
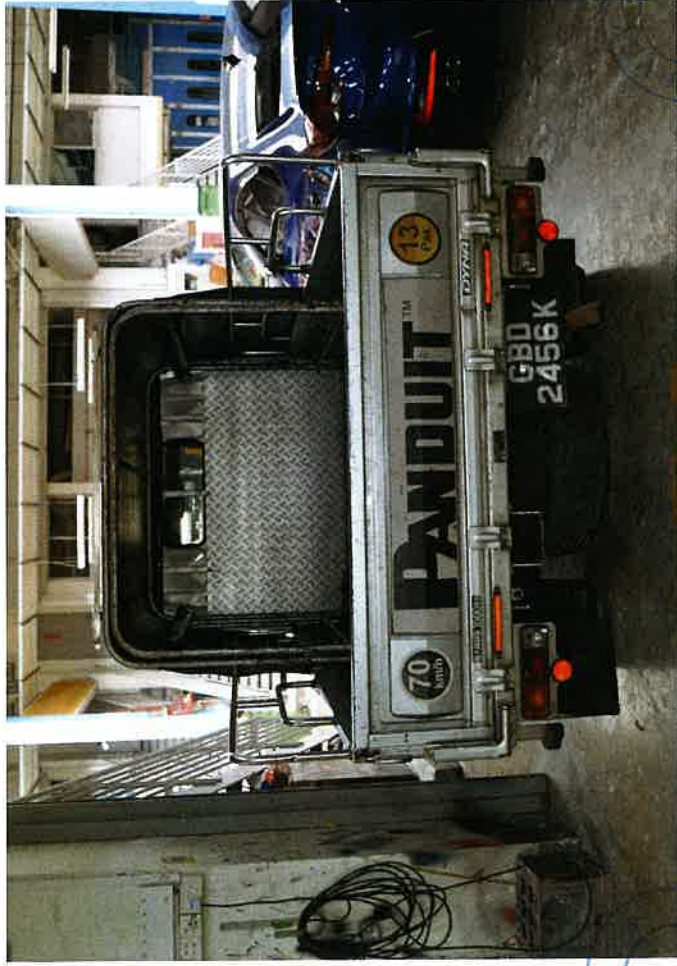
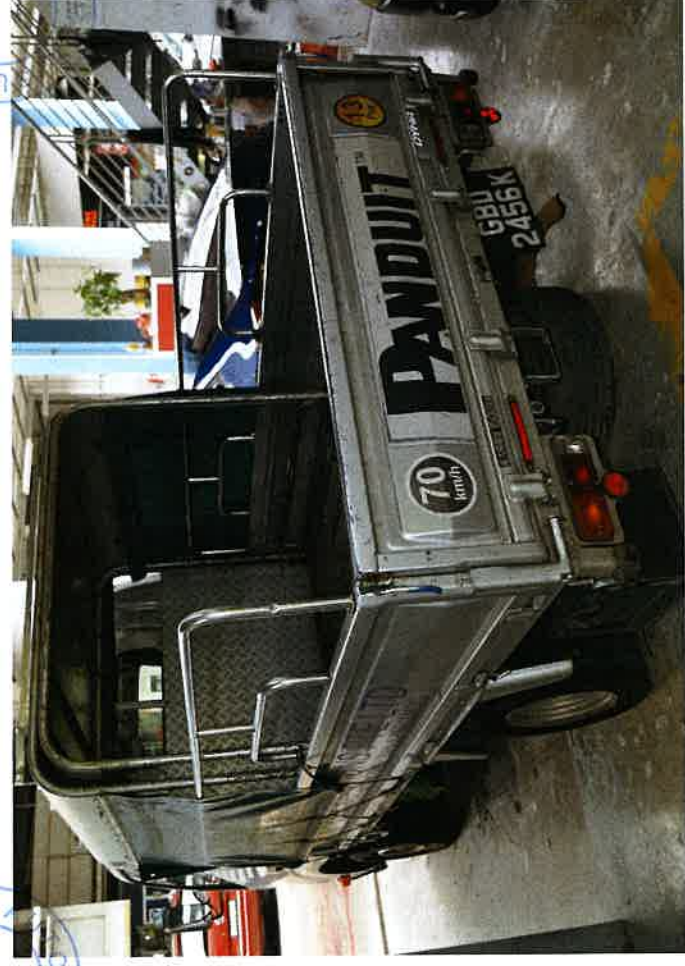
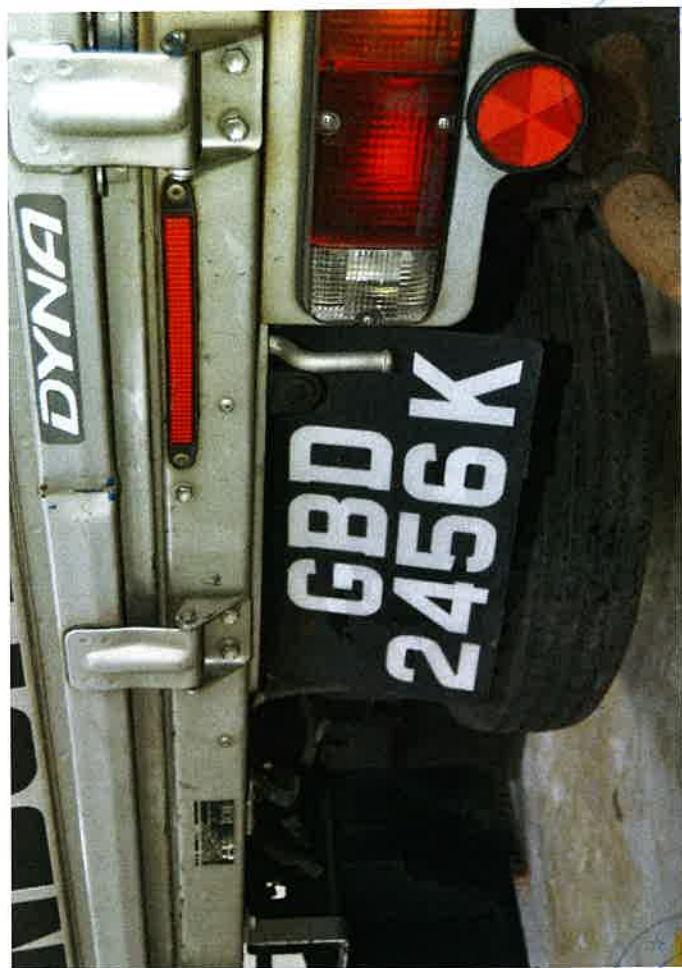
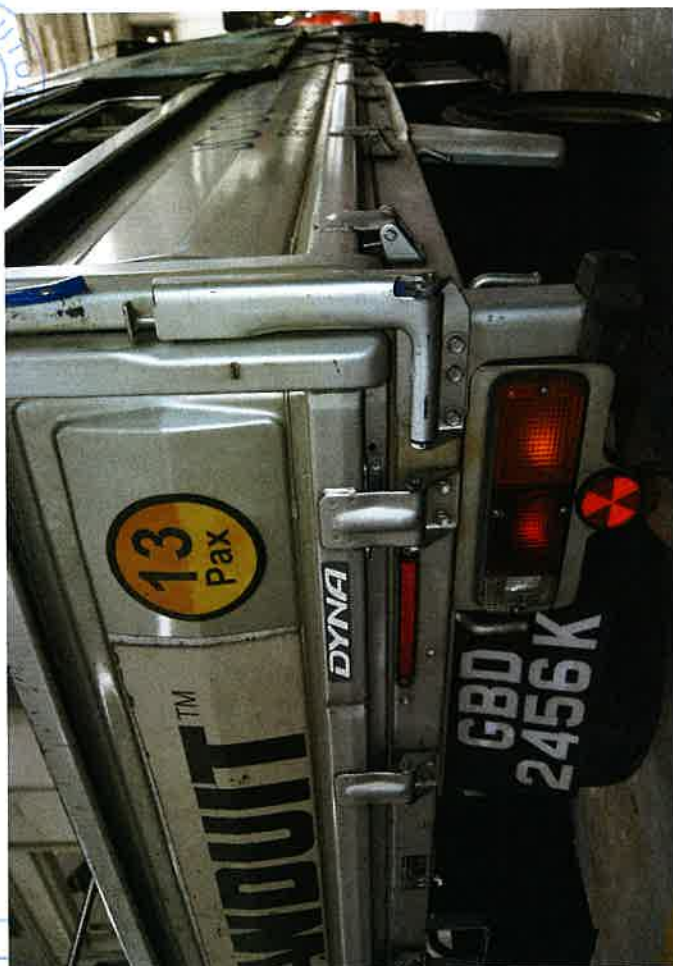
At the time of inspection, we noted that the vehicle has sustained an impact damages on the Rear & side portion(s). For more detail of the damages, please see photograph attached.

S/No	JOB DESCRIPTIONS	Workshop Estimation (S\$)	Our Revised Estimation (S\$)
	Spare PartsTotal c/f	\$ 3,700.38	\$ 3,700.38
1	Labour charges to repair and panel beat the tailboard lower support, rear cargo deck and replace the above mentioned parts.	\$ 1,400.00	\$ 1,200.00
2	To check wiring functions & conduct water leakage test.	\$ 180.00	\$ 150.00
3	To putty, apply primer & spray-paint the affected areas.	\$ 1,400.00	\$ 1,200.00
4	To apply rust-proofing on repaired/replaced panels.	\$ 180.00	\$ 150.00
	Total	\$ 6,860.38	\$ 6,400.38
