# AUTOMAX SURVEY

Report Ref : TP21090041

## THIRD PARTY SURVEY ACCIDENT OCCURED ON 22 Sept 2021

Registration No : SMJ4042X  
Model : VOLVO S60 T4 1.6  
Year / Capacity : Oct 2012 / 1599 cc  
Chassis No : YV1FS48HBD2186216

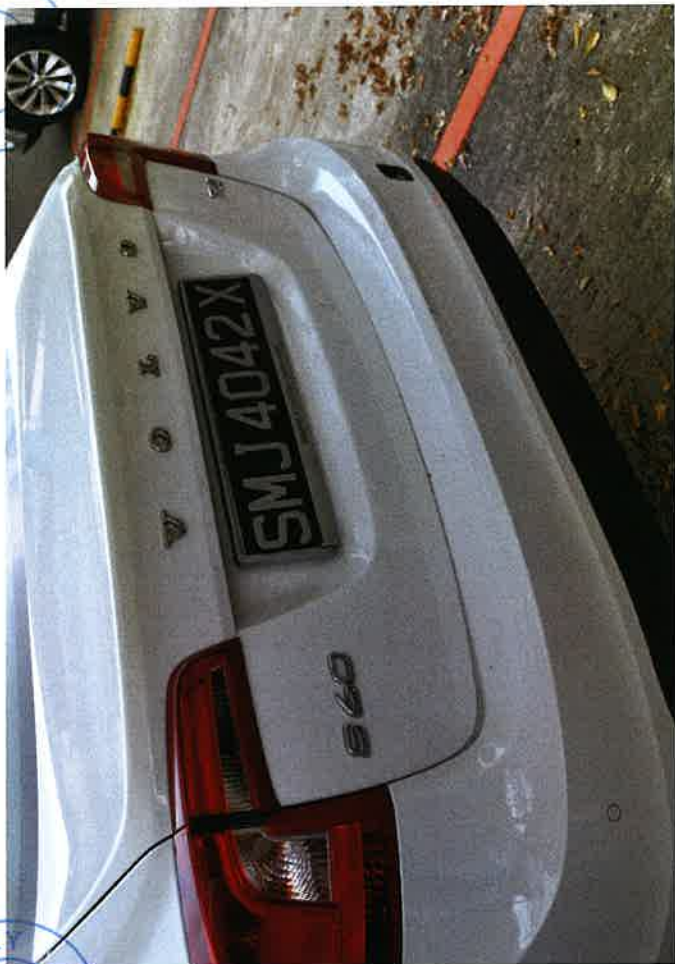
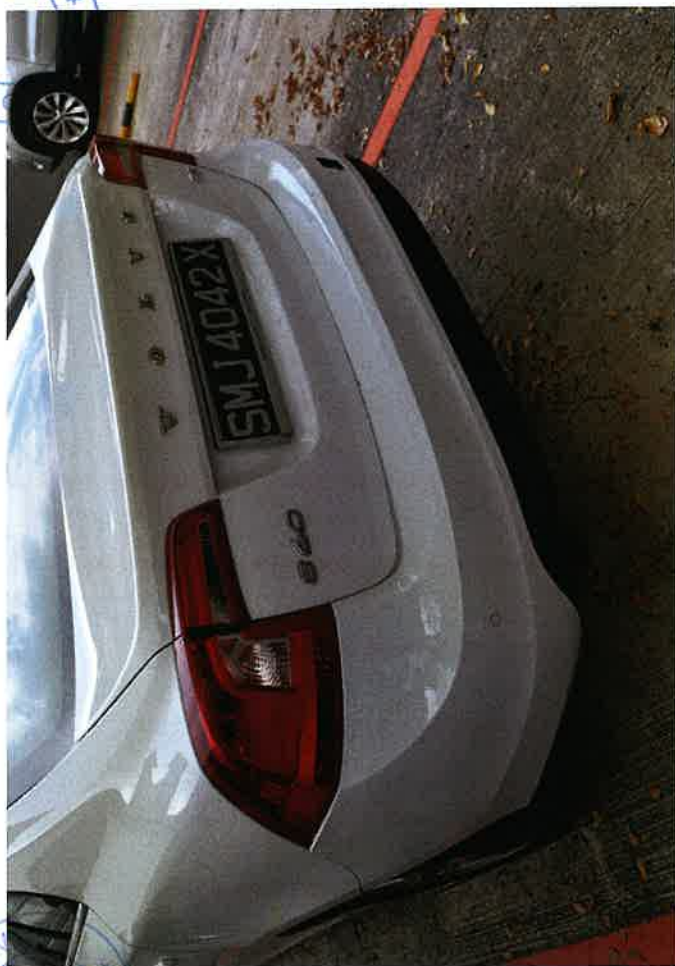
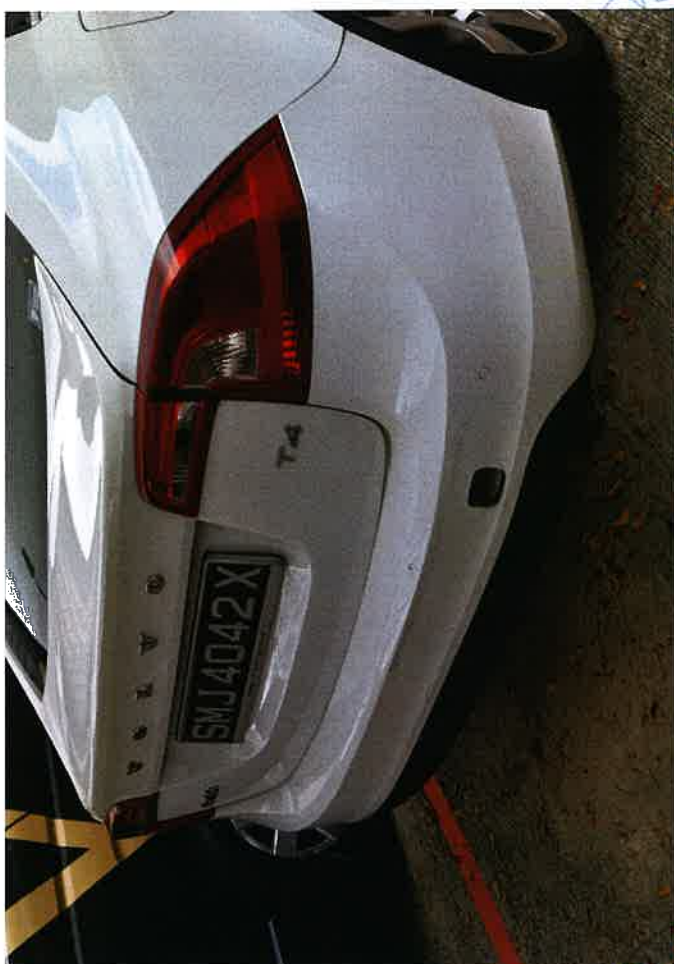
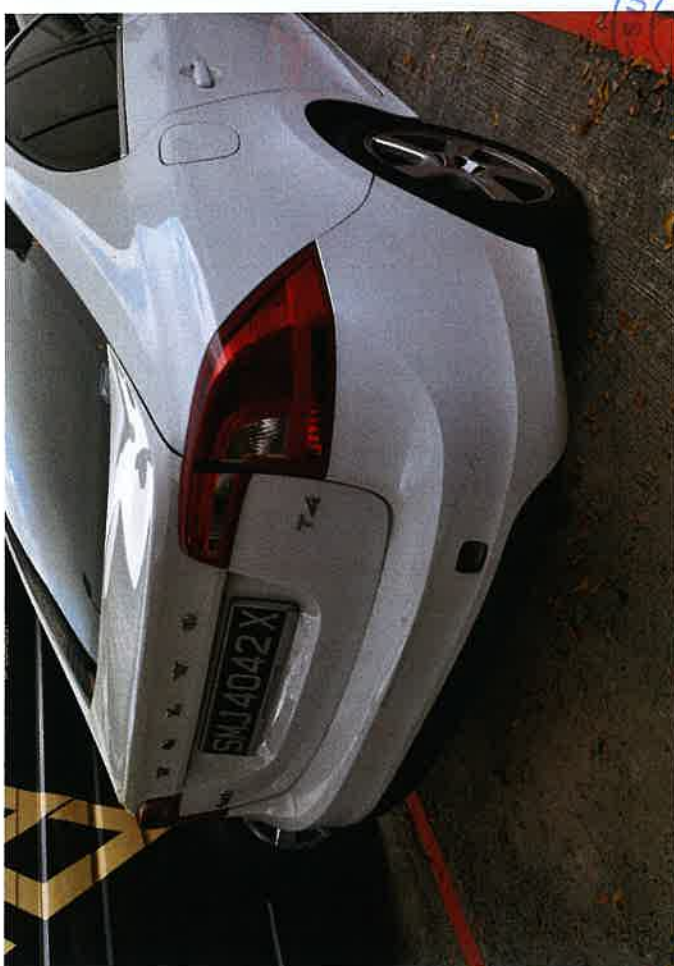
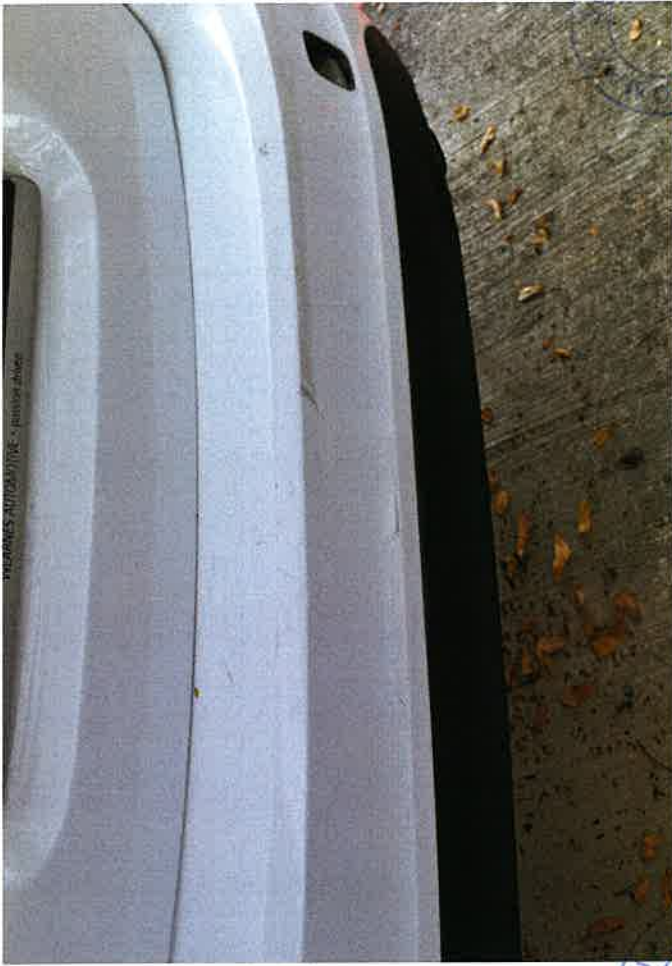
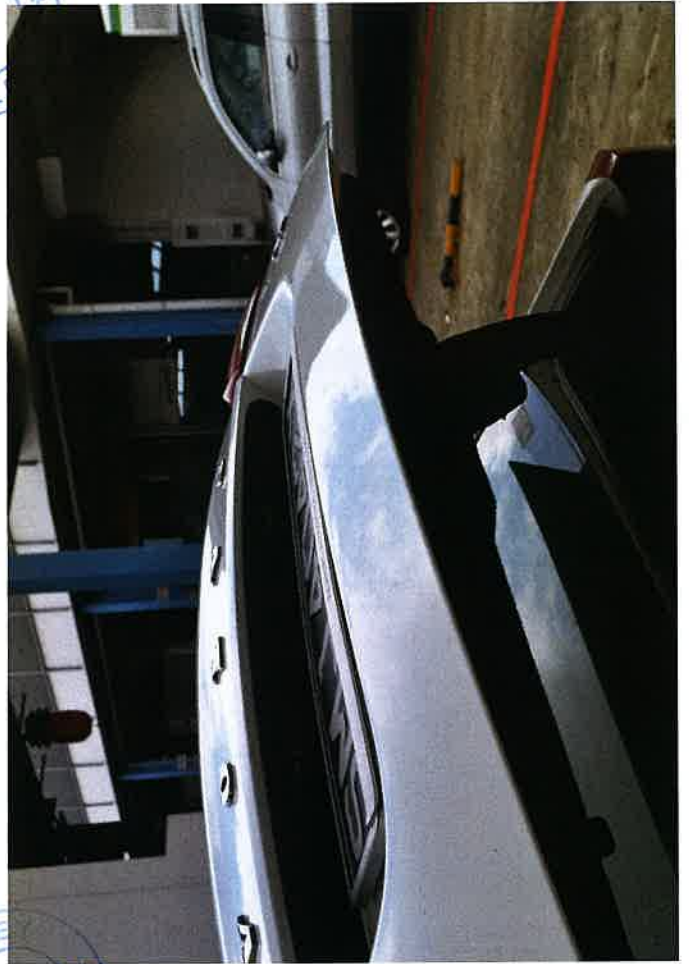
At the time of inspection, we noted that the vehicle has sustained an impact damages on the rear portion(s). For more detail of the damages, please see photograph attached.

| S/No | JOB DESCRIPTIONS | Workshop Estimation (S\$) | Our Revised Estimation (S\$) |
|---|---|---|---|
| 5 | To renew damaged parts, straighten and repair rear chassis member, rear fender inner panel , rear door and aligned all parts. | \$ 1,800.00 | \$ 1,600.00 |
