Affiliated to Federation Internationale Des Experts En Automobile				
CHINA TAIPING INSURANCE (S) PTE LTD 3 ANSON ROAD #16-00 SPRINGLEAF TOWERSINGAPORE 079909			Ref: CC3/CTI22003119/Vpa3q2 Date: 25/11/2022 Code: CTI

ADJUSTMENT ON REPAIR COST FOR VEHICLE NO. SH 8773H

PHOTOGRAPHS FOR VEHICLE NO. SH 8773H

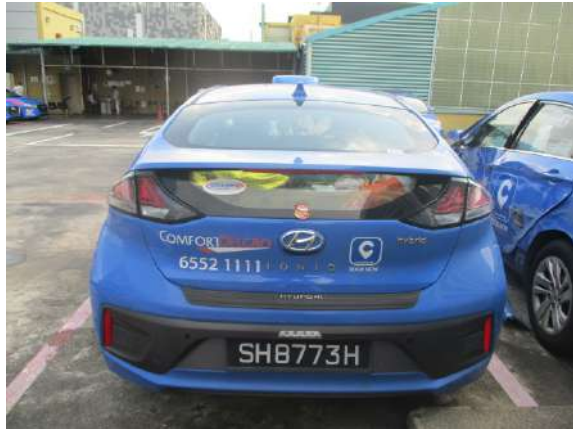
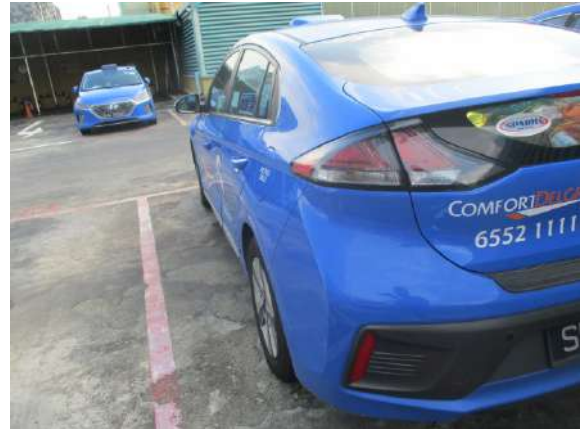
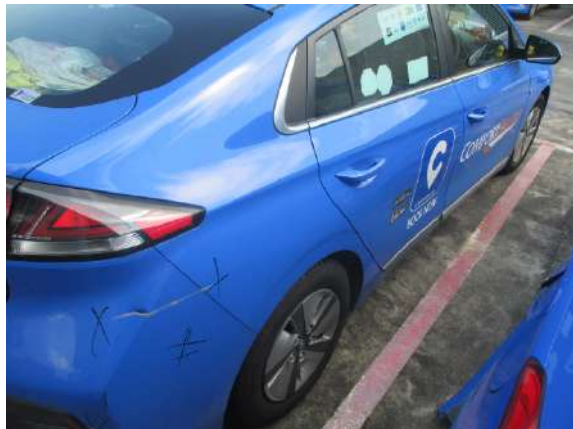
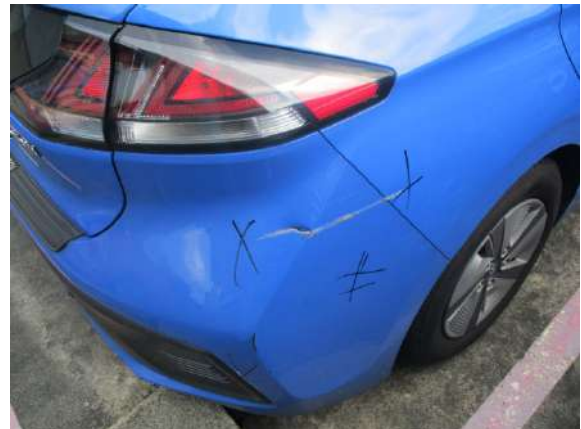
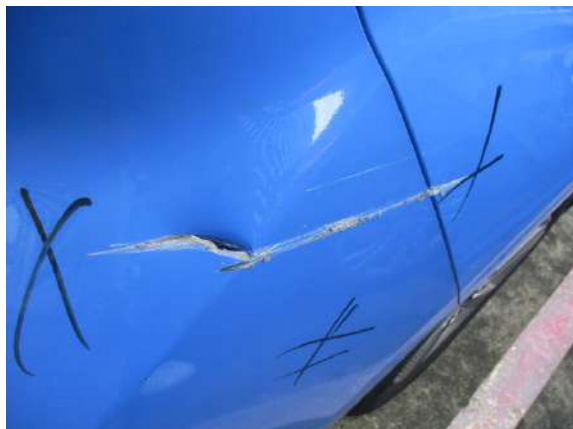
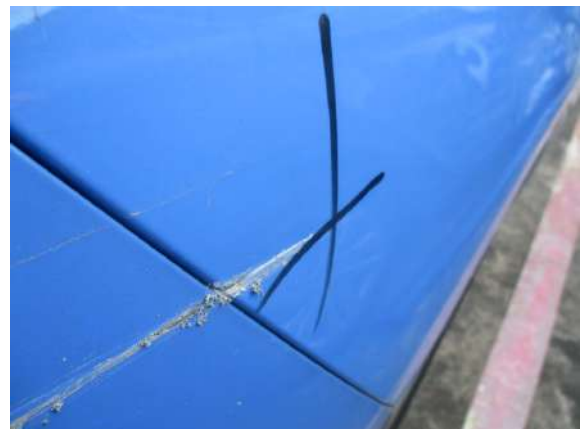
4. Description of Damages				
THE VEHICLE SUSTAINED DAMAGES AT THE REAR PORTION. DAMAGES SEE DETAILS.				
5. General Information				
Accident Date	31/03/2022	Inspection Date	01/04/2022	
Survey held at	COMFORTDELGRO ENGINEERING PTE LTD 59 LOYANG DRIVE SINGAPORE 508969			
5a. Remarks				
A)THE INSPECTION WAS CONDUCTED ON A"WITHOUT PREJUDICE" BASIS. B)IN ACCORDANCE TO YOUR INSTRUCTIONS, WE HAVE NOT AUTHORISED REPAIRS.				
5b. Estimate Days of Repair				
ESTIMATED NORMAL PERIOD FOR REPAIR:		4 Working Days

Qty	Description of Parts	Condition	Estimate By Workshop (\$)	Our Adjusted (\$)
	<u>REPLACEMENT OF PARTS</u>			
1	REAR BUMPER	CRACKED	459.40	459.40
1	REAR BUMPER SIDE BRACKET RH	SERVICEABLE	55.80	-
1	REAR BUMPER CENTRE MOULDING	SERVICEABLE	451.25	-
10	REAR BUMPER CLIPS @\$2.20	NECESSARY	22.00	22.00
	LESS 20% DISCOUNT		-197.69	-96.28
			790.76	385.12
	<u>SPECIAL NETT ITEMS</u>			
1	REAR REVERSE SENSOR (SN)	SERVICEABLE	180.00	-
1	BOOT LID COMFORT & TEL NUMBER (SN)	NOT NECESSARY	55.00	-
			235.00	-
	<u>LABOUR</u>			
	PANEL BEATING.		450.00	350.00
	SPRAY PAINTING CHARGE.		600.00	250.00
	REMOVE/REFIX REVERSE SENSOR .		60.00	30.00
			1,110.00	630.00
GRAND TOTAL			2,135.76	1,015.12
RECOMMENDED COST OF REPAIRS				1,015.12
