## ASSIGNMENT

FRN O/S

Estimate No: ES2290418/AMK  
Date: 27 Apr 2022  
Policy No: 5074943539-05 DC  
Veh Reg No: SKW320A  
Make/Model: TOYOTA COROLLA  
FIELDER  
Chassis No: NRE1618000977  
Engine No: 2NR8498784  
Reg. Date: 14/10/2015

## Estimate Repair Cost to Vehicle No :SKW320A

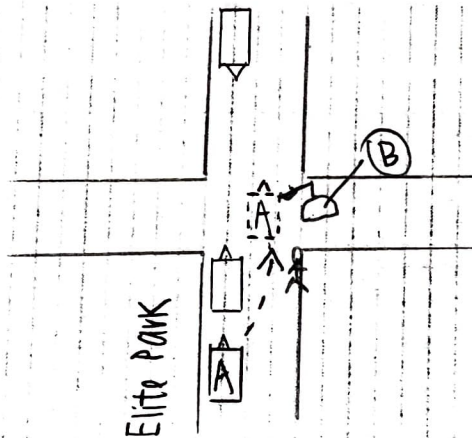
# Sketch Plan

A: SKW320A  
(Alone)

B: WD4605K

I was guided by Worker to proceed to move forward, a few seconds later, I saw the Sweeper arm swinging towards my direction and hit onto the front RH portion of my car. I put my car to the roadside, took some scene photos and exchange particulars with the Worker in charge of the Sweeper (WD4605K). My car was arranged to tow to NTUC authorized workshop for accident report and damage assessment.
