CS/GRB22004594/RV3

To Inspect Vehicle No: SHC 4018Mat Workshop m/s STRINGS CSMRTof 60, NORMAN'S IND PK 64Insured: III

Case Reference Number : TAX/05/22/2040
Type of Repair : Accident Repair
Vehicle Registration Number : SHC4018M

ACCIDENT STATEMENT

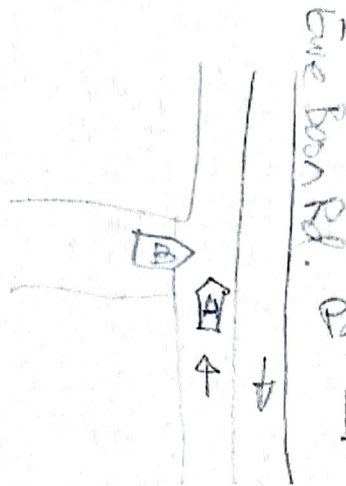
SKETCH PLAN

I WAS TRAVELLING STRAIGHT ALONG EWE BOON ROAD (NEAR PALM SPRING CONDO) WITH ONE PASSENGER (MALE CHINESE) ON BOARD. SUDDENLY A VEHICLE SNC8738X CAME OUT FROM MY LEFT WITHOUT STOPPING AT THE STOP LINE AND COLLIDED ONTO THE LEFT REAR PORTION OF MY TAXI.

Palm Spring condo

A : SHC 4018 M

③ : SNC 8738 X
