Affiliated to Federation Internationale Des Experts En Automobile				
CHINA TAIPING INSURANCE (S) PTE LTD 3 ANSON ROAD #16-00 SPRINGLEAF TOWERSINGAPORE 079909			Ref: CC3/CTI22004820/Gpa3q2 Date: 06/02/2023 Code: CTI

ADJUSTMENT ON REPAIR COST FOR VEHICLE NO. SHB 3389D

PHOTOGRAPHS FOR VEHICLE NO. SHB 3389D

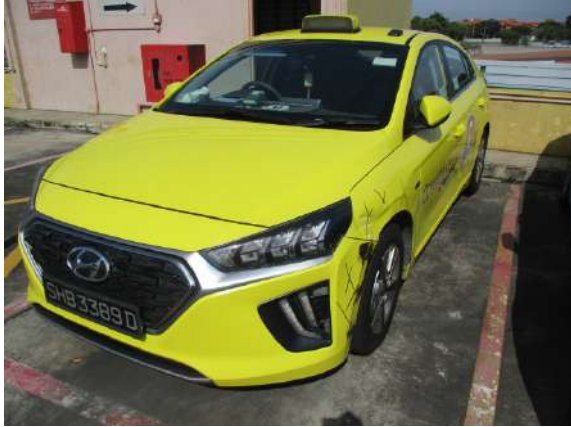
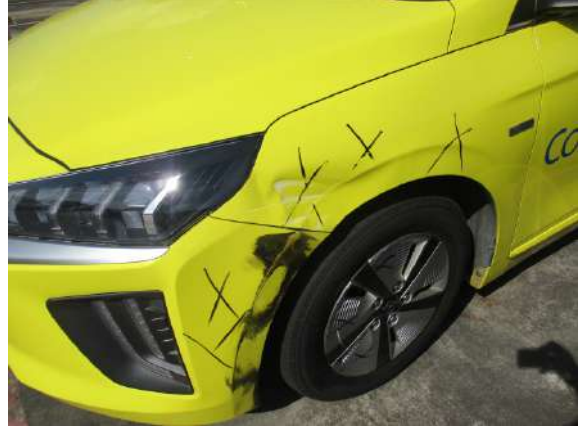
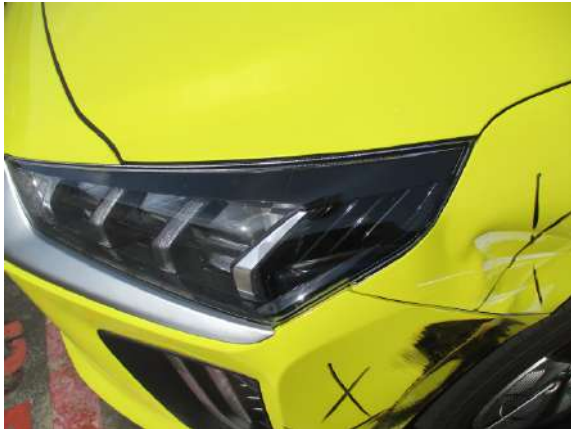
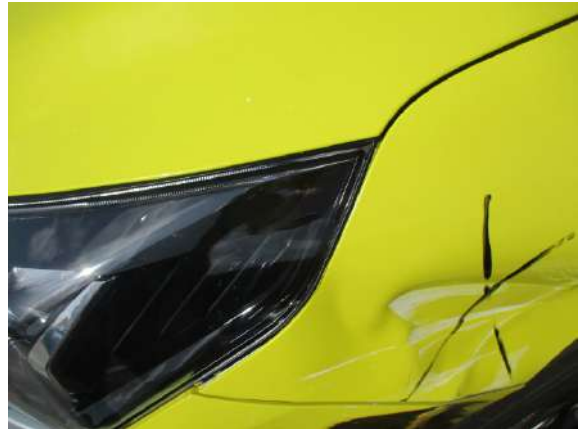
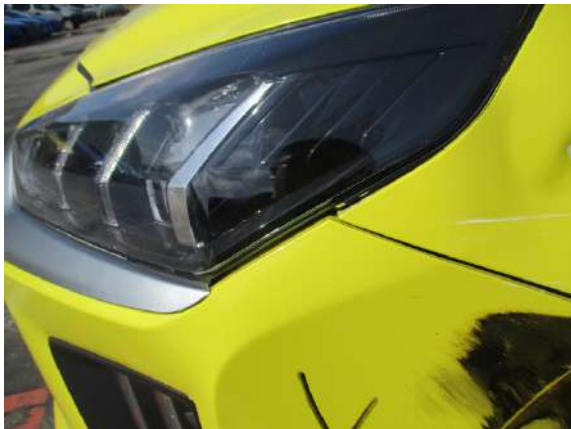
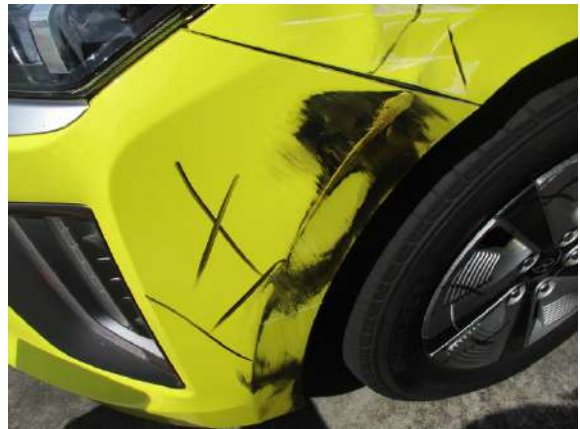
4. Description of Damages				
THE VEHICLE SUSTAINED DAMAGES AT THE N/S FRONT PORTION. DAMAGES SEE DETAILS.				
5. General Information				
Accident Date	14/05/2022	Inspection Date	17/05/2022	
Survey held at	COMFORTDELGRO ENGINEERING PTE LTD 59 LOYANG DRIVE SINGAPORE 508969			
5a. Remarks				
A)THE INSPECTION WAS CONDUCTED ON A"WITHOUT PREJUDICE" BASIS. B)IN ACCORDANCE TO YOUR INSTRUCTIONS, WE HAVE NOT AUTHORISED REPAIRS.				
5b. Estimate Days of Repair				
ESTIMATED NORMAL PERIOD FOR REPAIR:			3 Working Days

Qty	Description of Parts	Condition	Estimate By Workshop (\$)	Our Adjusted (\$)
	<u>REPLACEMENT OF PARTS</u>			
1	FRT BUMPER COVER	TO REPAIR SEE LABOUR	481.10	-
10	FRT BUMPER CLIPS	NOT NECESSARY	22.00	-
1	FRT BUMPER SIDE BRACKET LH	NOT NECESSARY	28.00	-
1	HEADLAMP LH	NOT NECESSARY	2,110.30	-
1	FRT FENDER LH	BUCKLED	588.80	588.80
1	EMBLEM-BLUE DRIVE LH	NECESSARY	26.60	26.60
1	FRT WHEEL HUB CAP LH	CUT	346.40	346.40
	LESS 20% DISCOUNT		-720.64	-192.36
			2,882.56	769.44
	<u>LABOUR</u>			
	PANEL BEATING.INCLUSIVE OF THE REPAIR OF FRT BUMPER COVER.		800.00	350.00
	SPRAY PAINTING CHARGE.		600.00	500.00
	TUFF KOTE.		60.00	40.00
	CHECK ALL LIGHTING.	NOT NECESSARY	60.00	-
			1,520.00	890.00
GRAND TOTAL			4,402.56	1,659.44
RECOMMENDED COST OF REPAIRS				1,659.44
