EQ INSURANCE COMPANY LTD Ref: CS/EQI22004914/Ety3e2 5 MAXWELL ROAD Date: 16/06/2022 #17-00 TOWER BLOCK MND COMPLEXSINGAPORE 069110 Code: EQI 1. Policy Particulars: - THIRD PARTY CLAIM Insured Veh. SLS 9464T Veh. Inspected SW 54Z Policy No. Coverage (\$) 0.00 Claim No. DM22H000784 Excess (\$) 0.00 Assign From NEO JIE SI Assign Date 20/05/2022 Vehicle Particulars & Condition Make & Model B.M.W. 330I c.c 1998 Engine No. HIDDEN Year of Reg. 2019 Chassis No. WBA5R12000AK72151 Colour GREY Odometer 23336 KM Steering IN ORDER Brakes IN ORDER Modification SPORTS RIM General GOOD 3. Conditions of Tyres Make Balance	Affiliated to Federation Internationale Des Experts En Automobile

ADJUSTMENT ON REPAIR COST FOR VEHICLE NO. SW 54Z

PHOTOGRAPHS FOR VEHICLE NO. SW 54Z

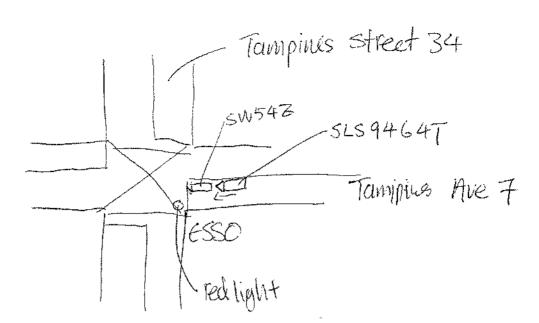
SKETCH PLAN

I am driving on Tampines Ave 7 towards tampine central. At aroud
8.50 am at Junction Tampines Street 34, 1 was waiting
for the red light to turn green. While waiting for about I min
suddenly a red Audi car SLS 9464 bang to my rear bumpor
I am driving on Tampines Ave 7 towards tampine central. At aroud 8.50 am at Junction Tampines Street 34, I was waiting for the red light to turn green. While waiting for about I min suddenly a red Audi car SLS 9464 bang to my rear bumper with a loud boing. (Photos Attached)
As both of us is rushing for appointment, the the owner agreed to bear the damax with What's app agresunt.
agreed to bear the damage with What's app agresunt.
DEC! ARATION
