SURVEY REPORT

Vehicle No. : SHC7708K Chassis No. : KMHC851CVLU180858

Make : HYUNDAI Engine Cap. : 1580 CC

Model : IONIQ (G3) Transmission : AUTO

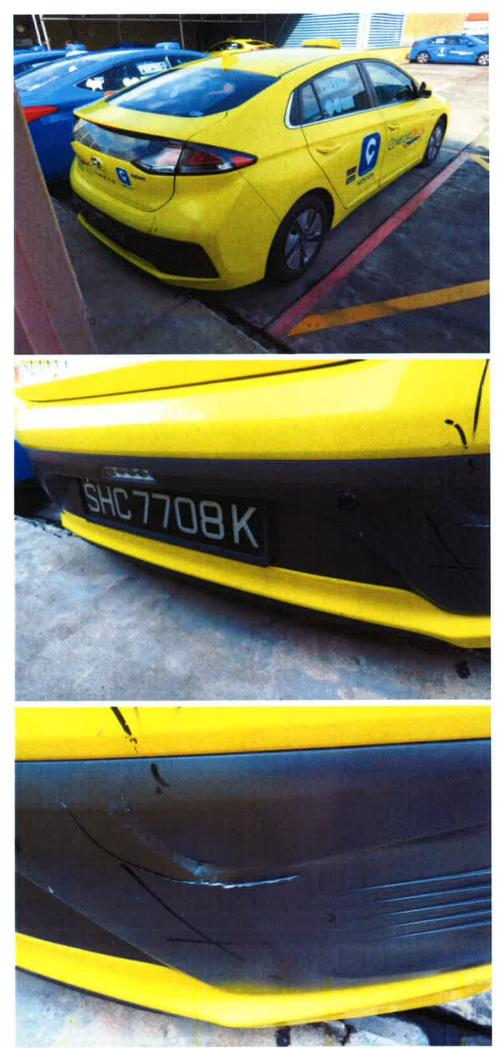
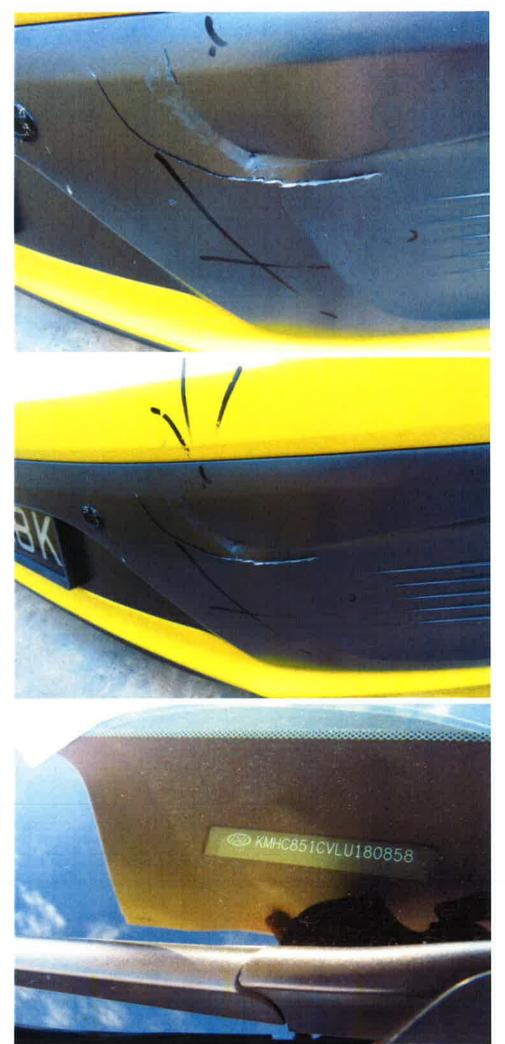
VICOM ASSESSMENT CENTRE VEHICLE No.: SHC7708K ACCIDENT DATE: 16/10/2021

At the place of inspection, we saw this vehicle sustained rear damage.

The damages seen during our survey were at rear bumper and surrounding areas. A fuller detailed description of the damages is in Annex A of this survey report.

Accordingly, we recommend repairs to this vehicle be carried out on a part-by-part basis at \$\$1,021.00.
