ACCIDENT INVOLVING MOTOR VEHICLES NO. SKV9845Z AND SHB1233H ALONG PIE TOWARDS CHANGI ON 15.03.2022 AT ABOUT 0945 HOURS.

ACCIDENT DAMAGED VEHICLE INSPECTION REPORT

Registration No : SKV9845Z
Make : NISSAN
Model : SYLPHY 1.6 CVT ABS D/AIRBAG 2WD 4DR
Year : 2015

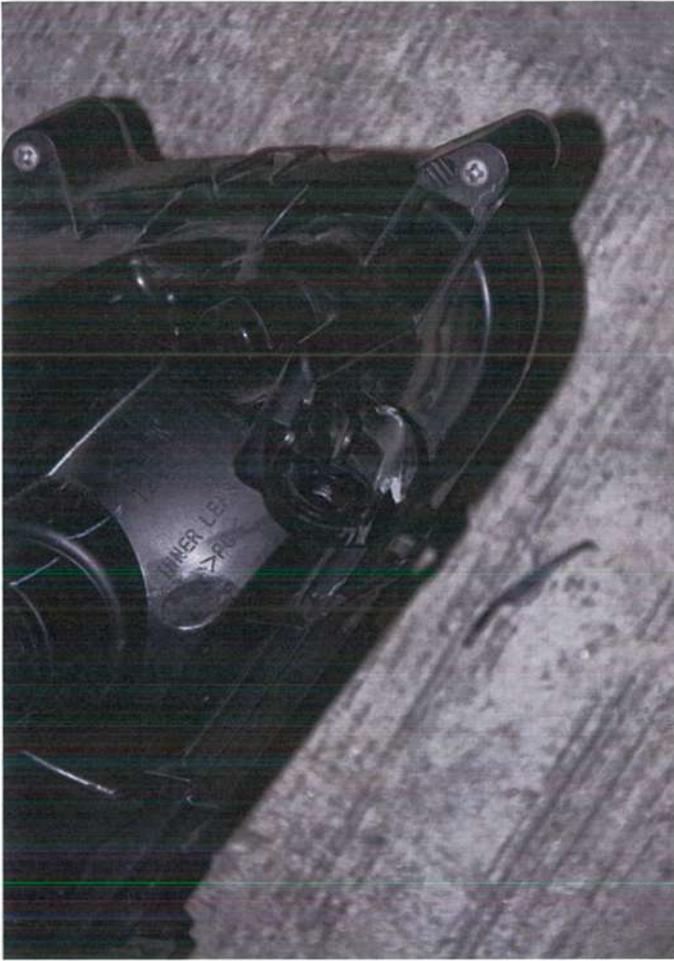
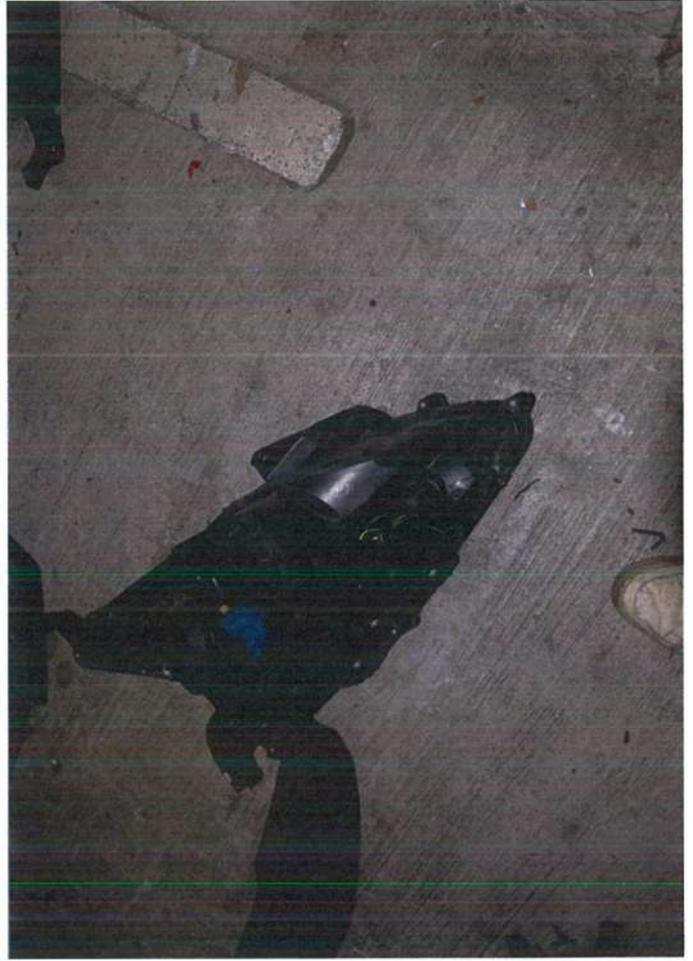
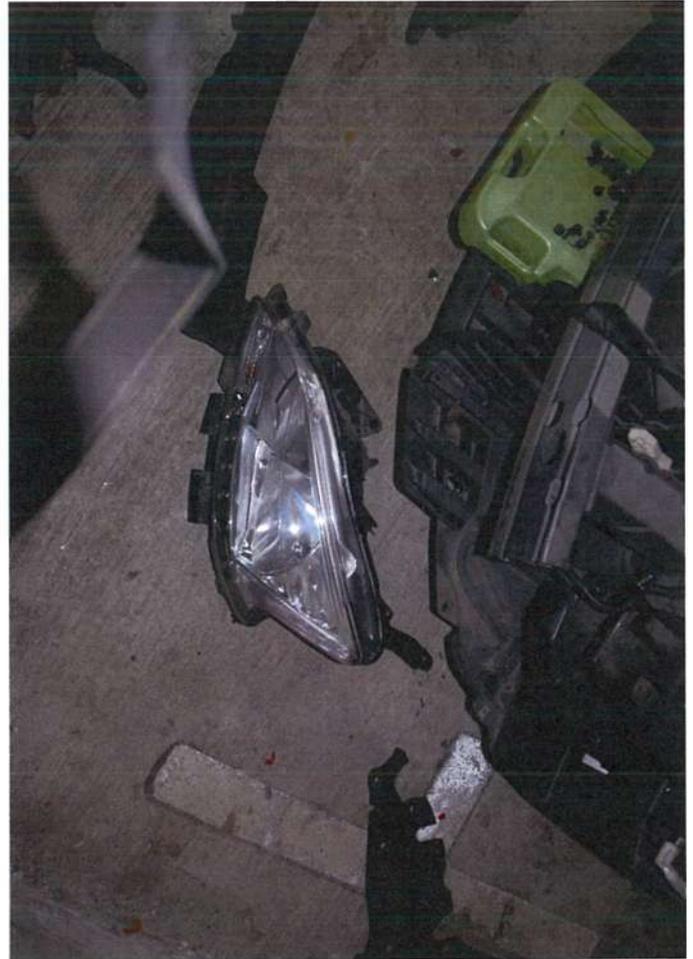
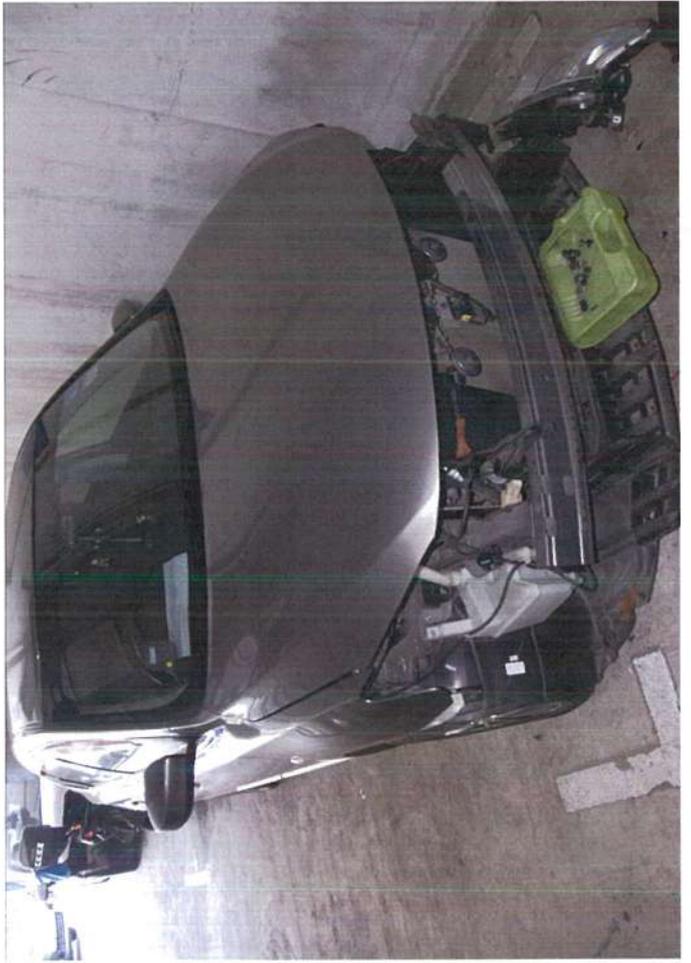
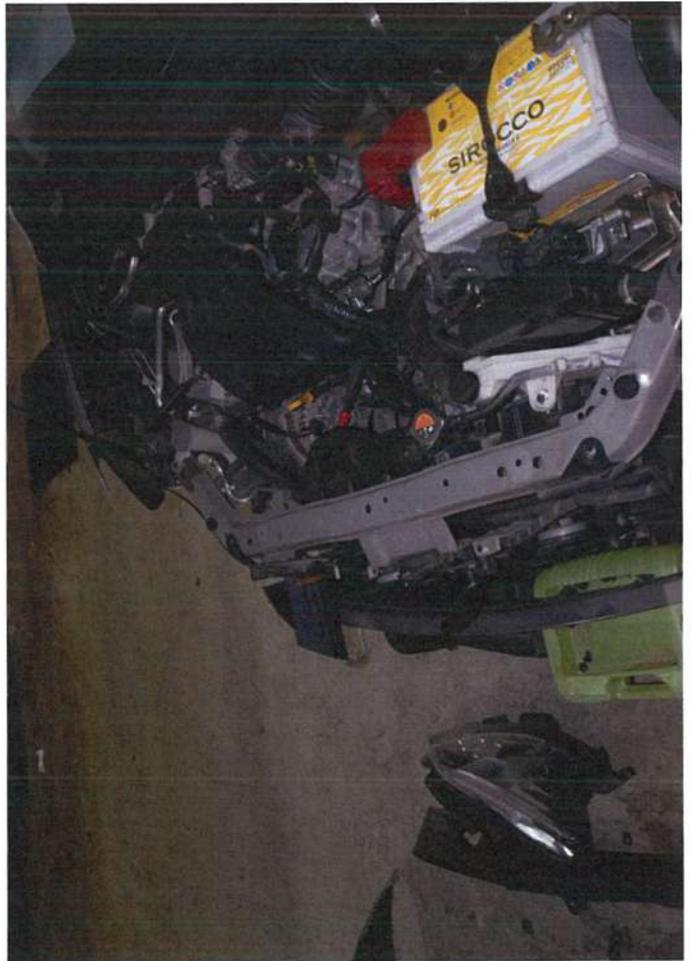
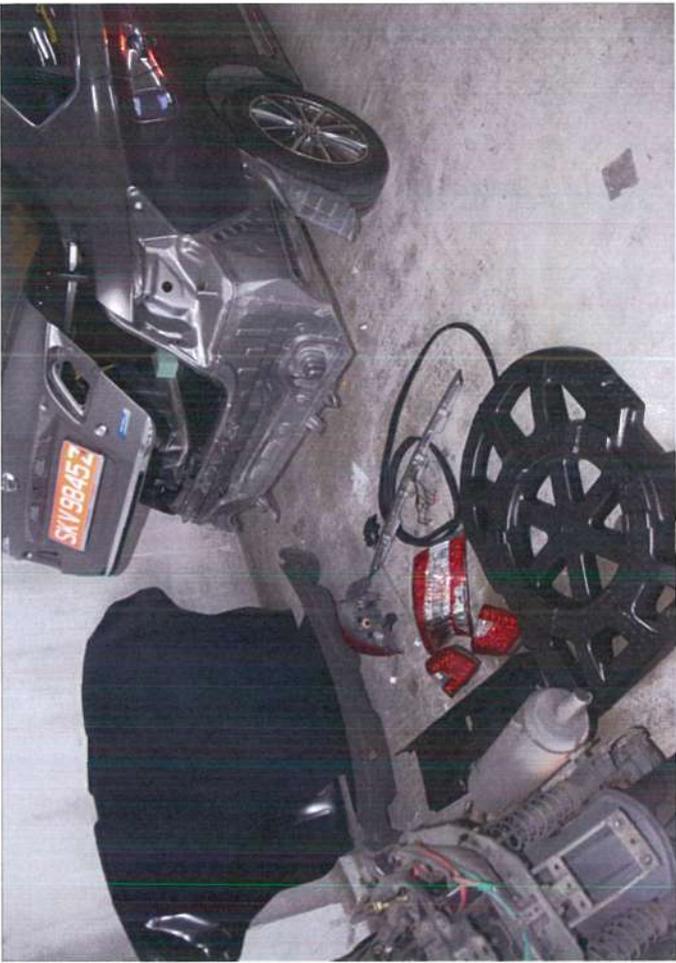
The vehicle sustained damage at the front and rear portions.
For details, refer to assessment for repairs and photographs attached.

The impact was confined to the front and rear portion of the vehicle.
The damages appeared to be consistent as per the accident report statement.
Please refer the attached schedule and photographs for details.

The repairer has agreed to undertake repair the vehicle at a lump sum basis of **SS\$11,650.00 nett** corresponding to replacement of parts, spray painting and labour charges. We now revert for your decision on the above claim.
