## AUTOMOBILE ASSESSMENT REPORT

**Assessment of Vehicle No** : **SLU 2768C**  
**Date of Accident** : **03-June-2019**  
**Date of Inspection** : **07-June-2019**  
**Address of Inspection** : **1 KB Ave 6 #02-34 Autobay@Kaki Bukit S'417883**

Registration No. : SLU 2768C  
Make & Model : BMW Z4 2.5  
Year of Registration : 2010  
Engine Capacity : 2497 cc  
Chassis No. : WBALM32020E355879  
Engine No. : 07297227N52B25AF  
Colour : White  
Mileage (km) : 13520

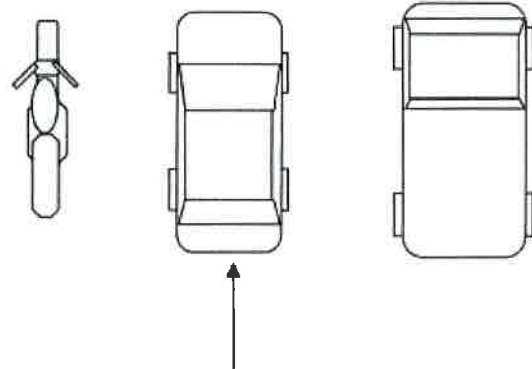
At the time of inspection, this vehicle sustained damages to the **Rear** portion. Please see attached scheduled for details.
