## **ACCIDENT INVOLVING GBC 3825C & SLH 8837R ALONG CTE TOWARDS SLE BEFORE ANG MO KIO AVENUE 3 EXIT ON 8 MAY 2022 @ 1355HRS**

### **DAMAGED VEHICLE (GBC 3825 C) INSPECTION REPORT (WITHOUT PREJUDICE)**

## ASSESSMENT OF REPAIRS AND SPARE PARTS COSTS FOR VEHICLE NO: GBC 3825 C

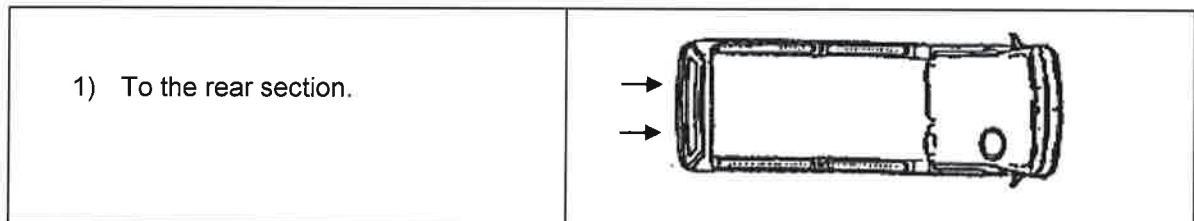
**(E) Point of Impact**

The impact of the collision has damaged/affected the tail gate, rear bumper, rear end panel, tail lamp, parking sensor and etc.

Our adjusted cost of lump sum repair is **\$7,300.00** and an estimated **7** days is required to repair the vehicle. Please refer to the Annex for a detailed account of the cost estimates.

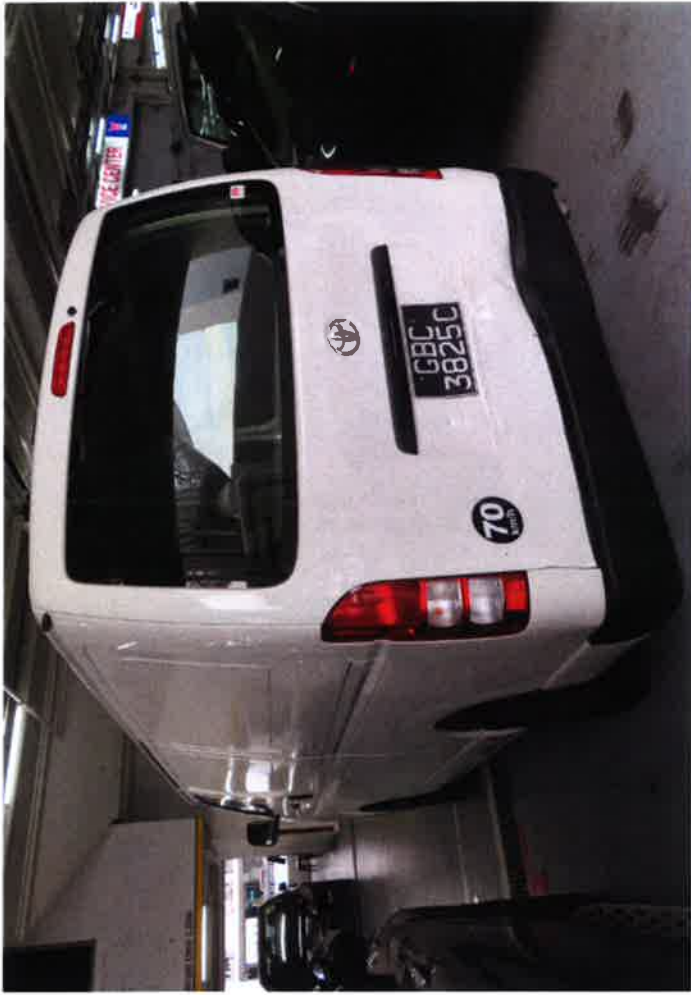
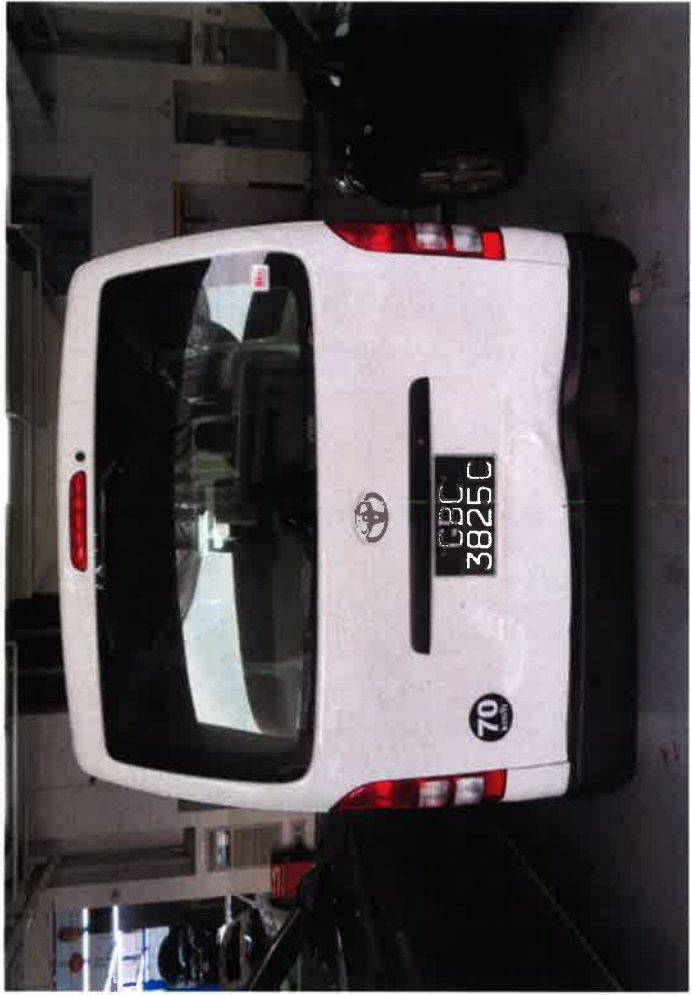
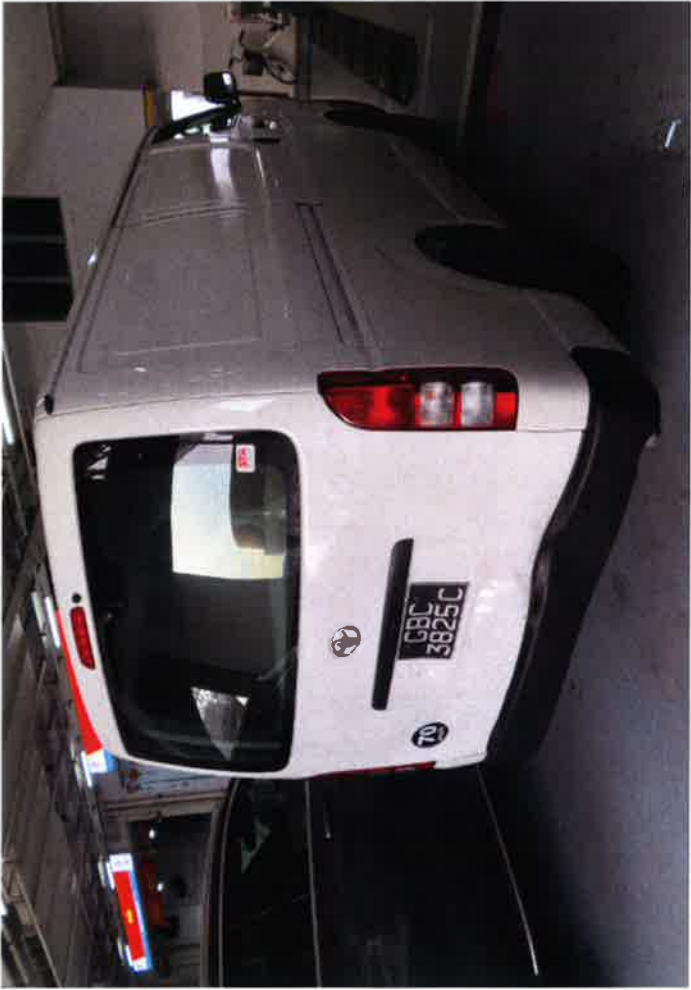
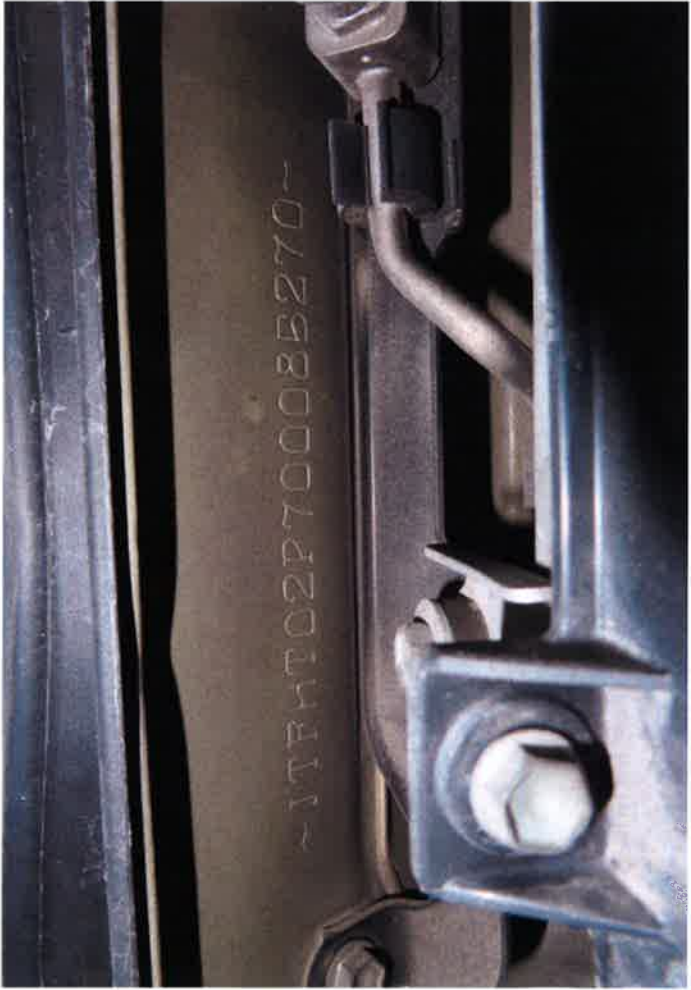
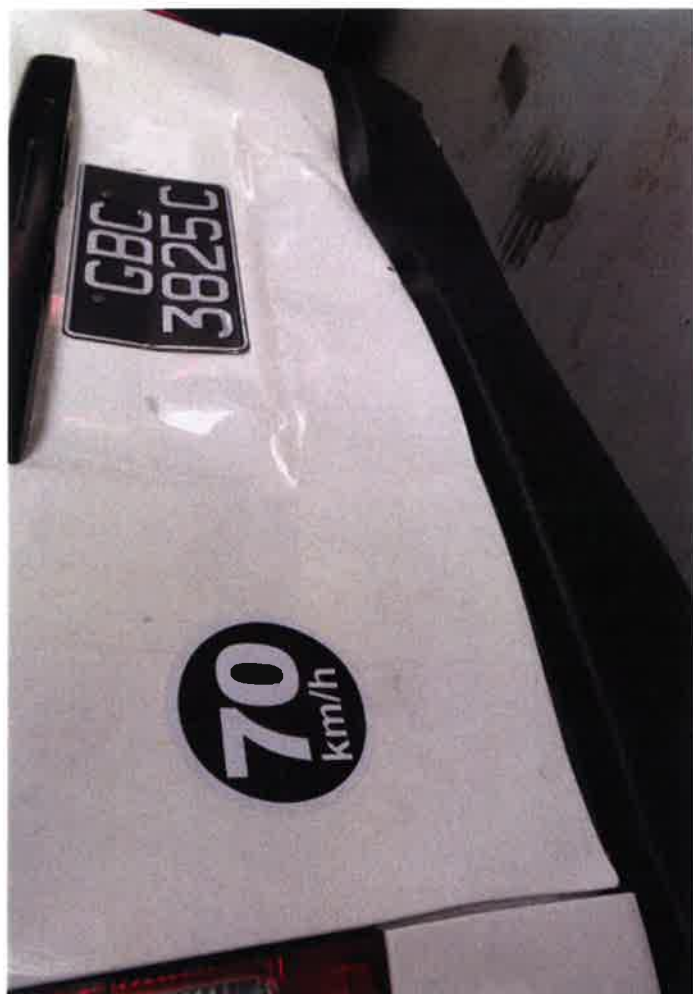
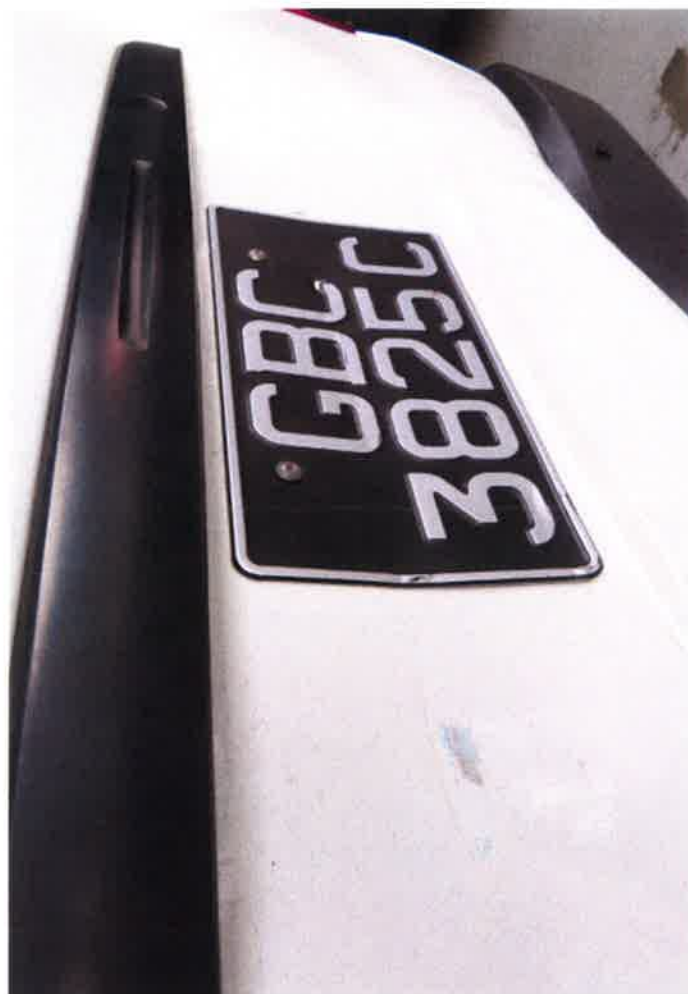
Please refer to the Annex for a detailed account of the damages and photographs taken.
