LKK Auto Consultants Pte Ltd

Vehicle No. SHC 1151E
Insured Veh. YP 9162B
Claim No. 21/22/22/VC05/026129
Policy No. Z21VC05007920
Accident Date 09/08/2022
Inspection Date 10/08/2022

ADJUSTMENT ON REPAIR COST FOR VEHICLE NO. SHC 1151E

PHOTOGRAPHS FOR VEHICLE NO. SHC 1151E

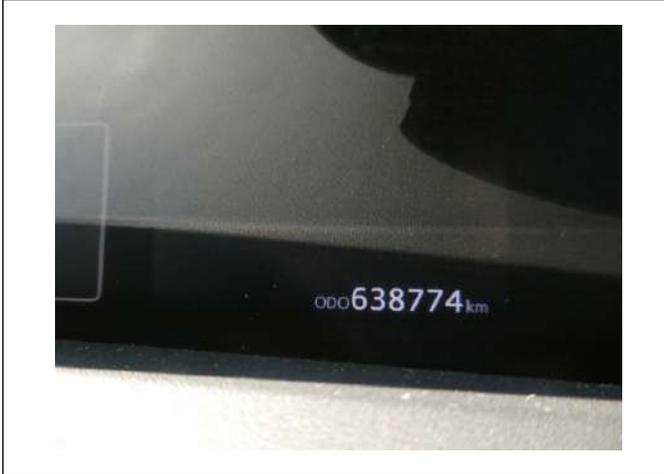
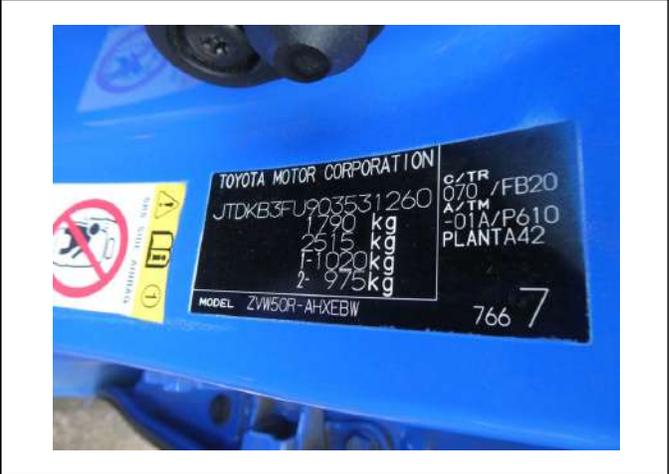
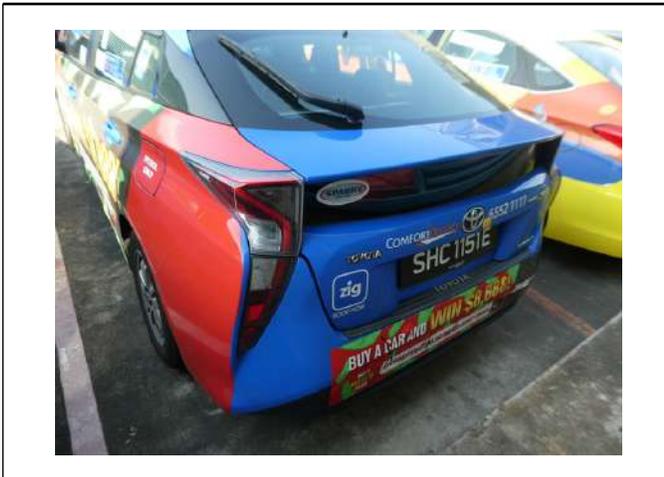
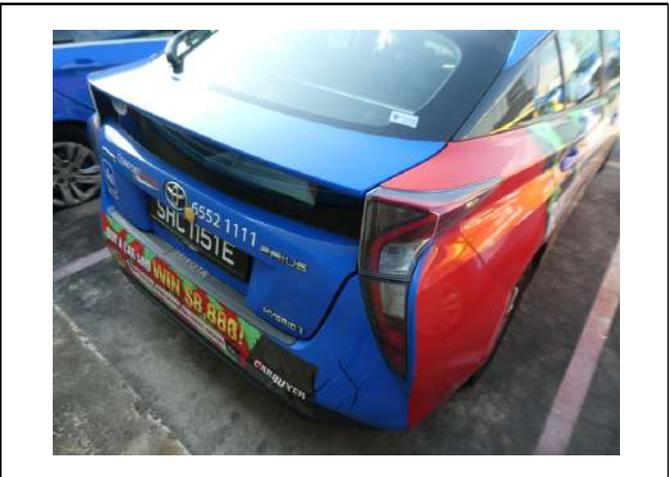
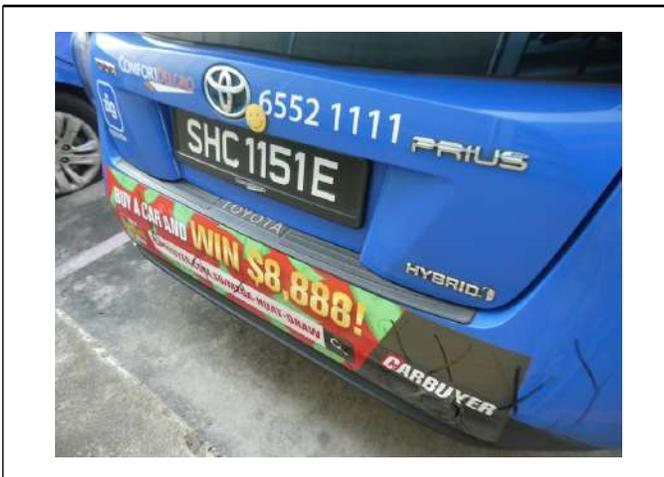
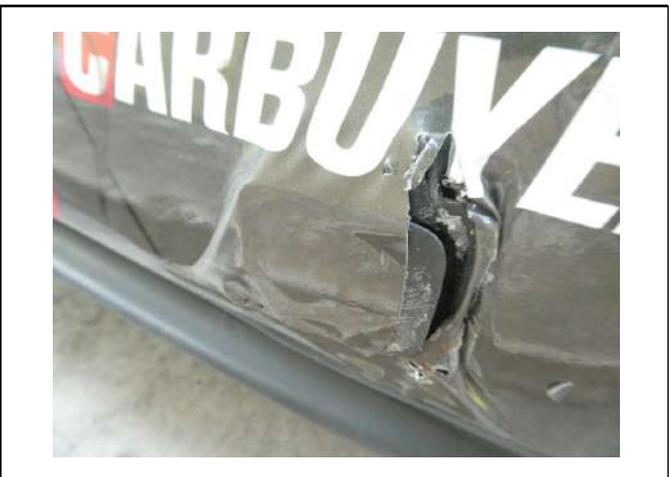
INSPECTION

THE VEHICLE SUSTAINED DAMAGES AT THE REAR PORTION.
DAMAGES SEE DETAILS.

Qty	Description of Parts	Condition	Estimate By Workshop (\$)	Our Adjusted (\$)
REPLACEMENT OF PARTS				
1	REAR BUMPER ASSY	TO REPAIR SEE LABOUR	503.04	-
1	REAR BUMPER CENTRE MLDG	TORN	654.96	654.96
1	REAR BUMPER BEAM	BENT	378.33	378.33
10	REAR BUMPER CLIPS	NECESSARY	22.00	22.00
1	REAR BUMPER TOW COVER	DEFORMED	82.70	82.70
	LESS 25% DISCOUNT		-410.26	-284.50
			1,230.77	853.49
SPECIAL NETT ITEMS				
1	REVERSE SENSOR (SN)	NOT WORKING	135.70	135.70
1	REAR BUMPER MAT (SN)	NOT NECESSARY	50.00	-
1	ADVERTISEMENT LOGO -BUMPER (SN)	CUT	50.00	50.00
1	ADVERTISEMENT LOGO-FENDER (SN)	NECESSARY	200.00	200.00

435.70	385.70
LABOUR				
	PANEL BEATING.INCLUSIVE OF THE REPAIR OF REAR BUMPER ASSY .		400.00	350.00
	SPRAY PAINT.		300.00	250.00
	REMOVE/REFIX REVERSE SENSOR .		50.00	30.00

750.00	630.00
GRAND TOTAL			2,416.47	1,869.19
RECOMMENDED COST OF LUMP SUM REPAIRS (TO ITS PRE-ACCIDENT CONDITION)				1,500.00
