ASSIGNMENT

Remark: The veh had commenced its repair at the time of inspection.

Estimated cost of repair for vehicle no : SLG6339E Honda Vezel
 Accident involving vehicle no: SLG6339E & SLR2981T on 08.08.2022

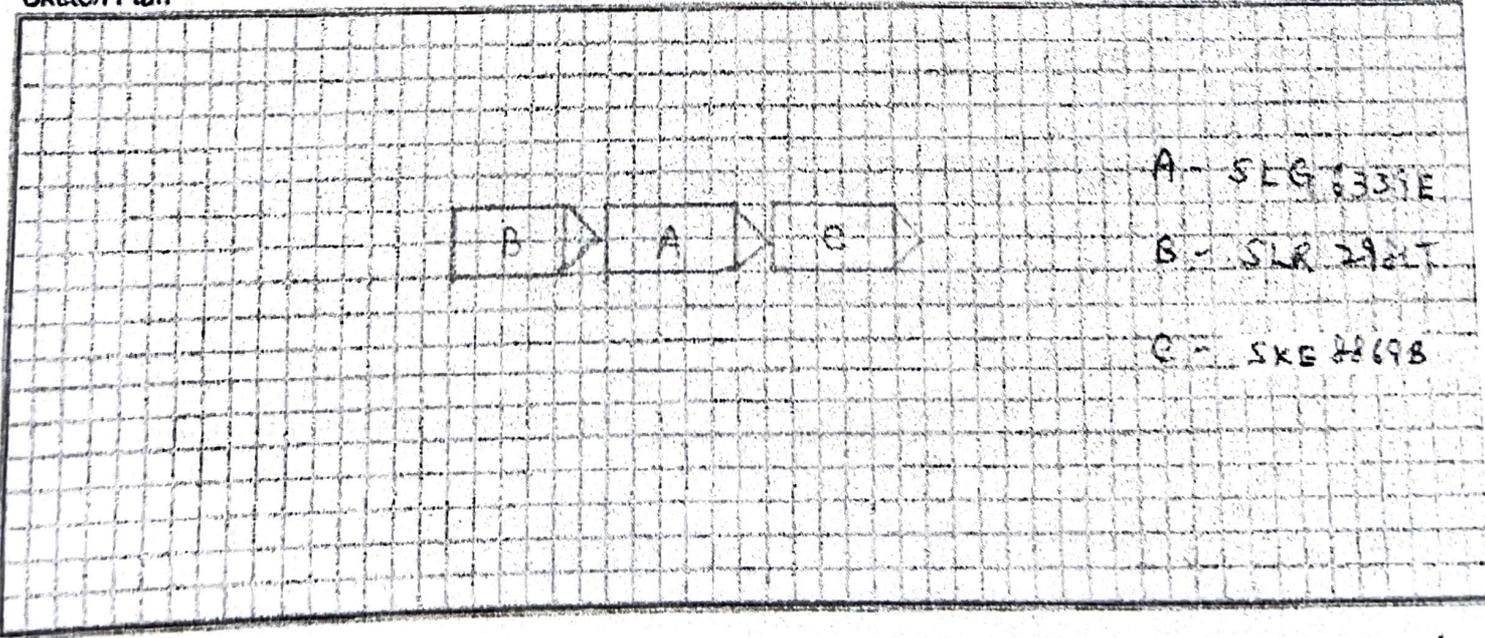
Sketch Plan

Date of Submission 08/08/2022 16:20 (SGT)
Reported by Both
Date of Accident 08/08/2022 09:05 (SGT)
Exact Location of Accident Upper Cross St, Singapore
Additional Location Information Upper Cross Street after traffic light to CTE
Country/State of Loss Singapore
