## ACCIDENT INVOLVING SKD 3666H / SHC 2987D ON 11.09.2021 ALONG GEYLANG ROAD

## VEHICLE SURVEY REPORTS

## Vehicle Assessment Reports

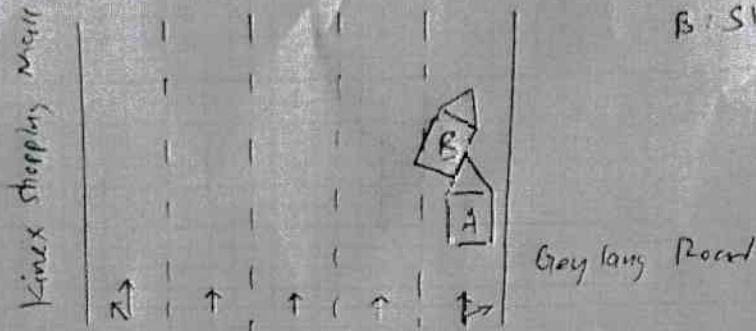
SKETCH PLAN

A: SKD2660H  
B: SHC2987D

I was travelling on first lane along Grey lang Road. While I was driving straight on my lane, vehicle B suddenly make an abrupt lane change from my left and filter into my lane and collided onto my vehicle.

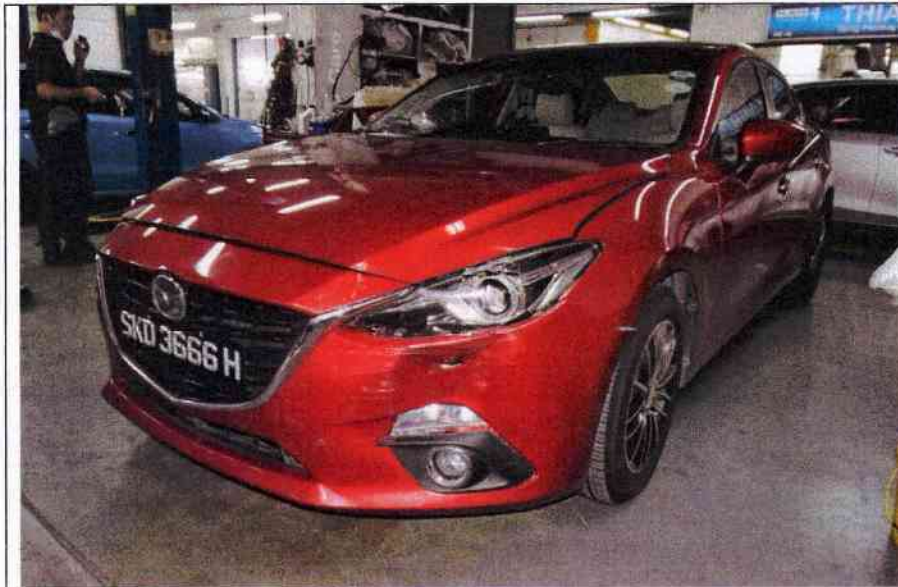
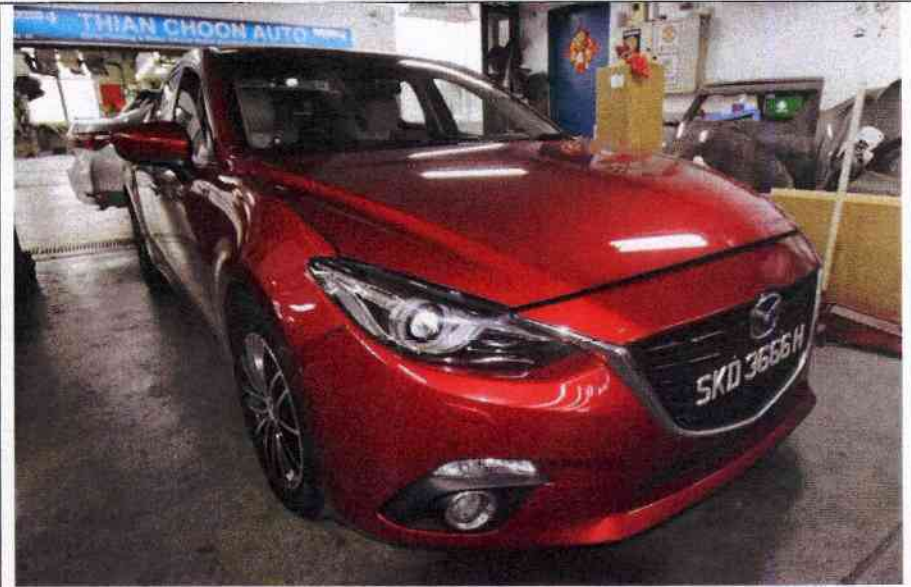
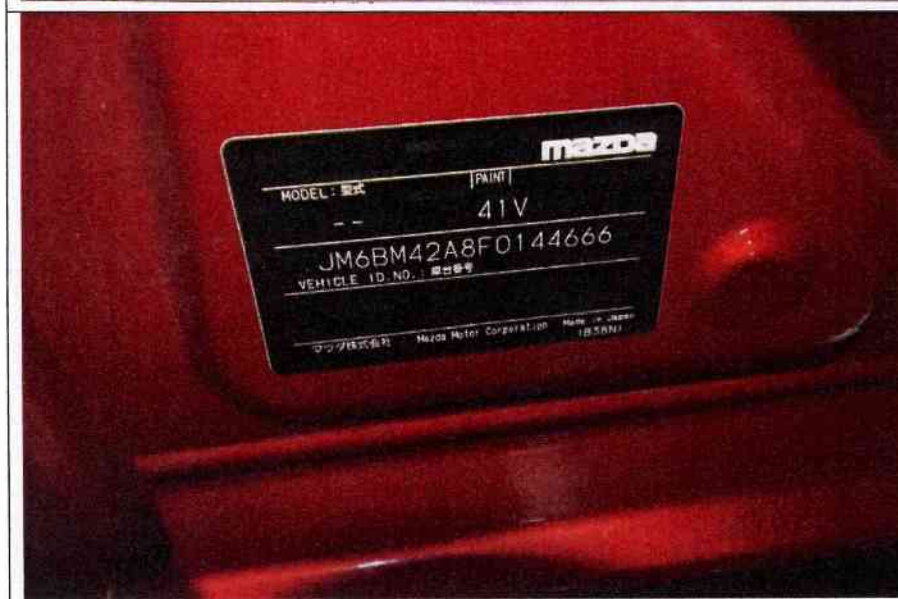
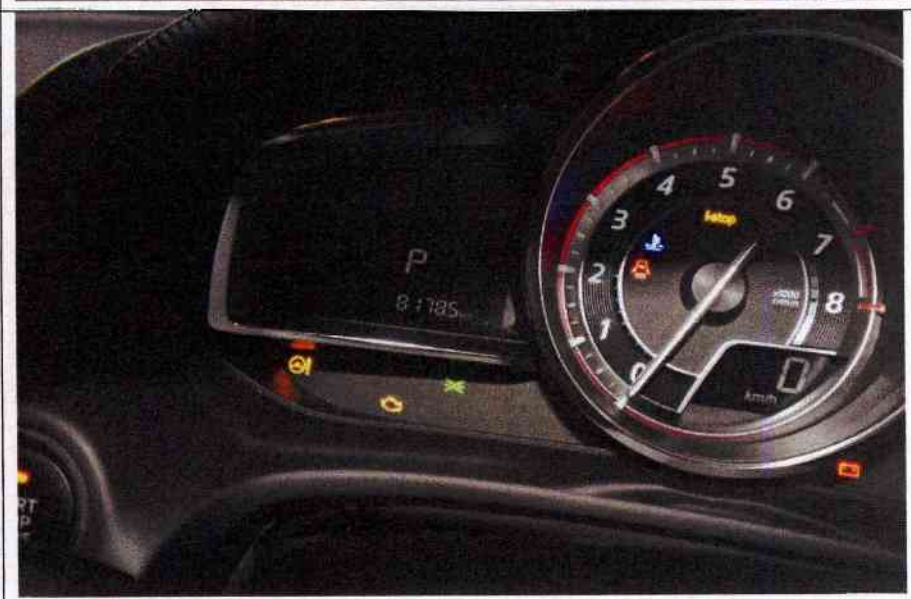
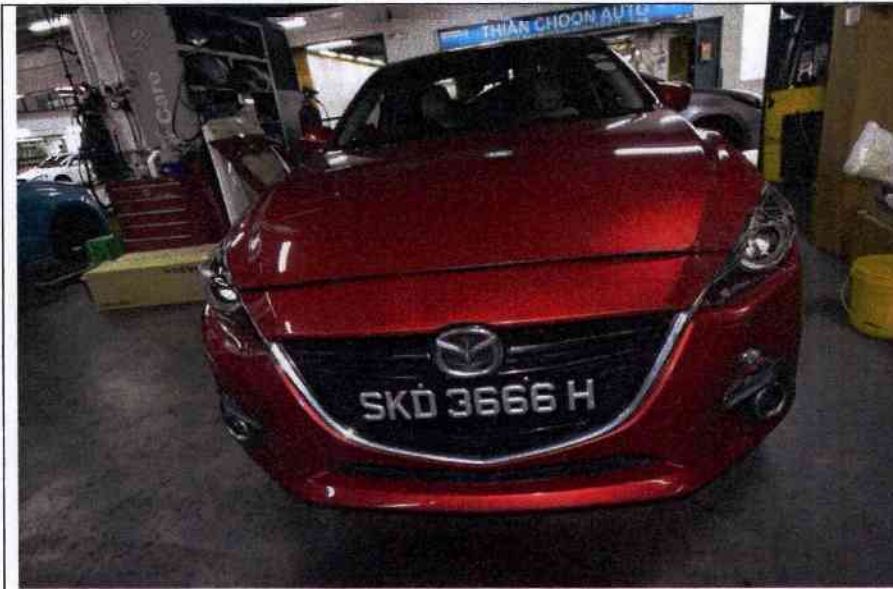
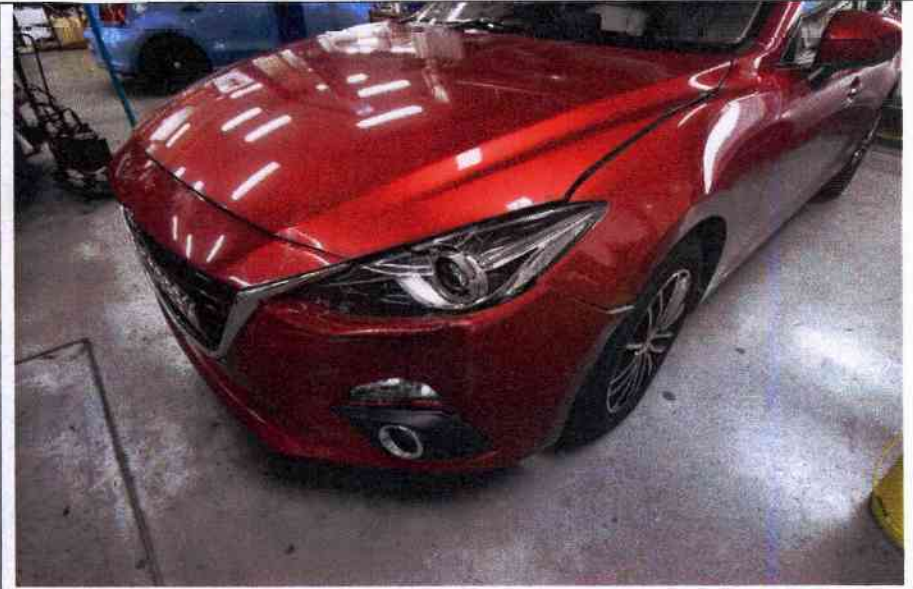
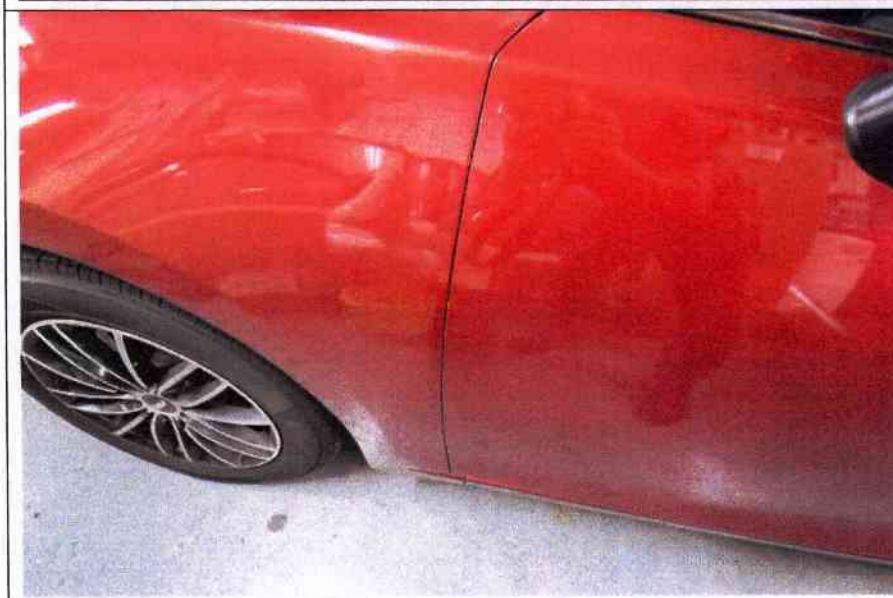
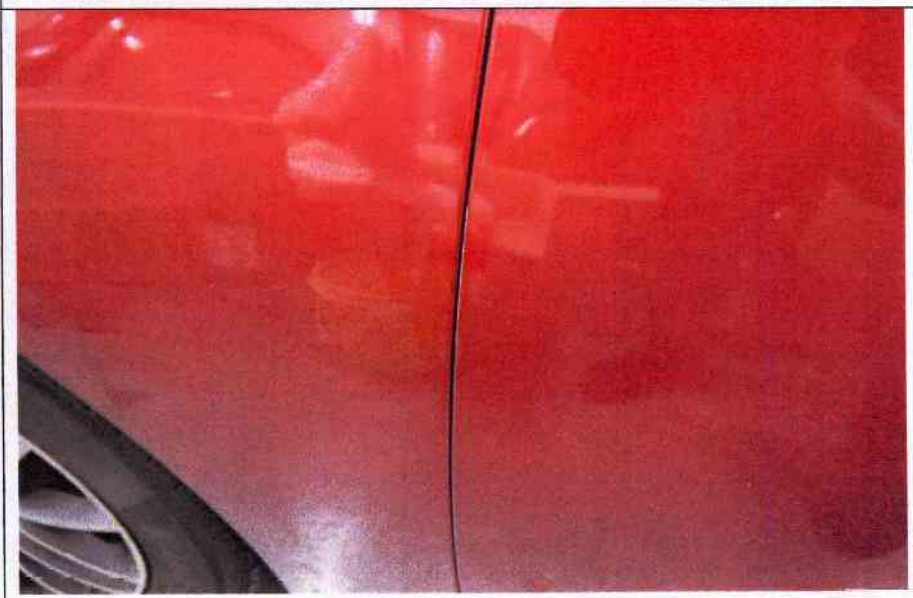
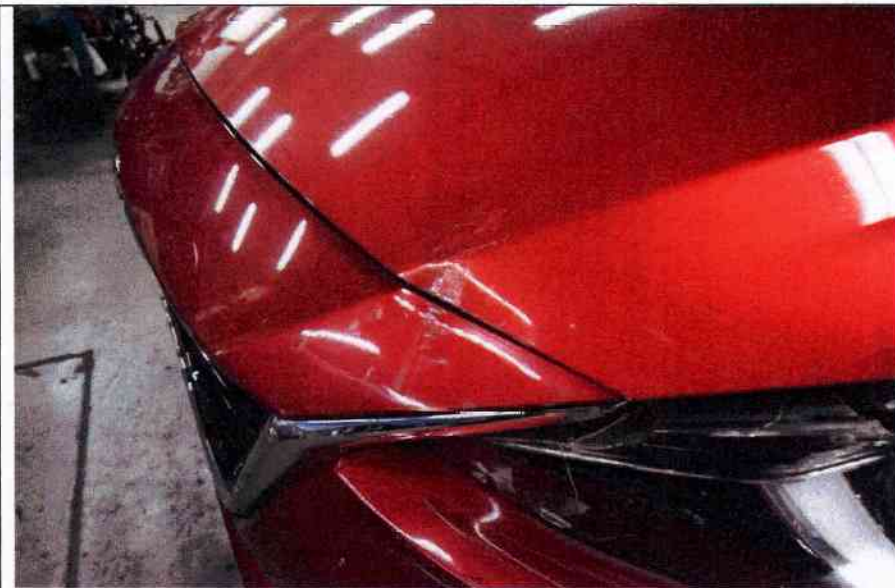
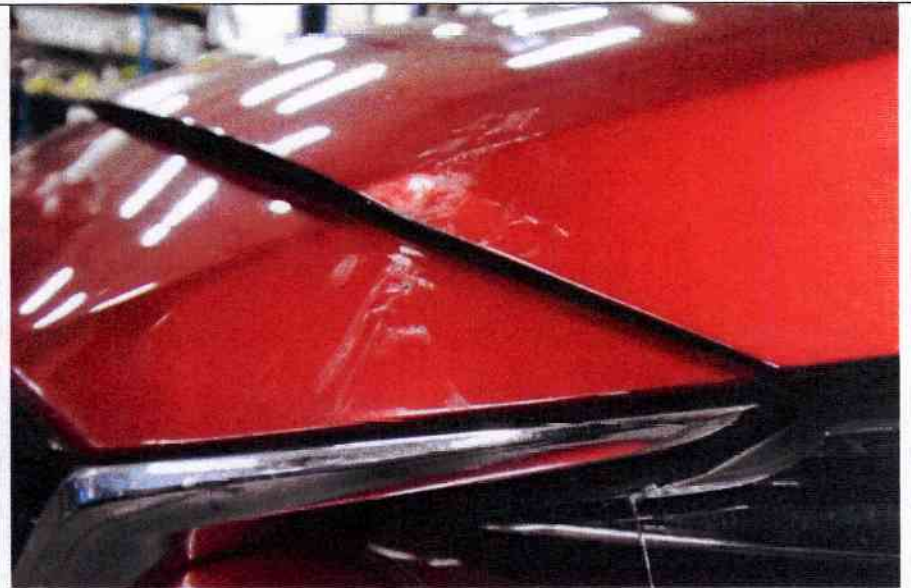
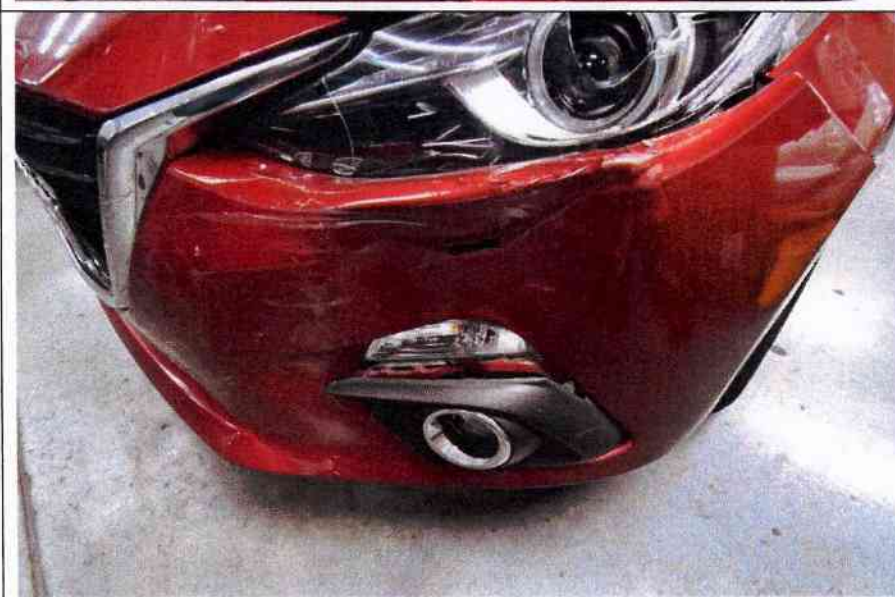
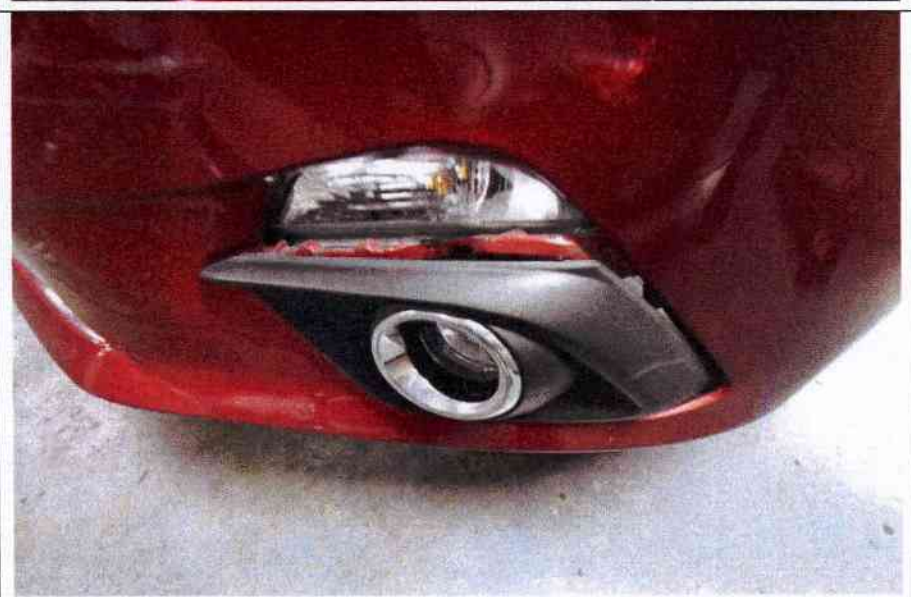
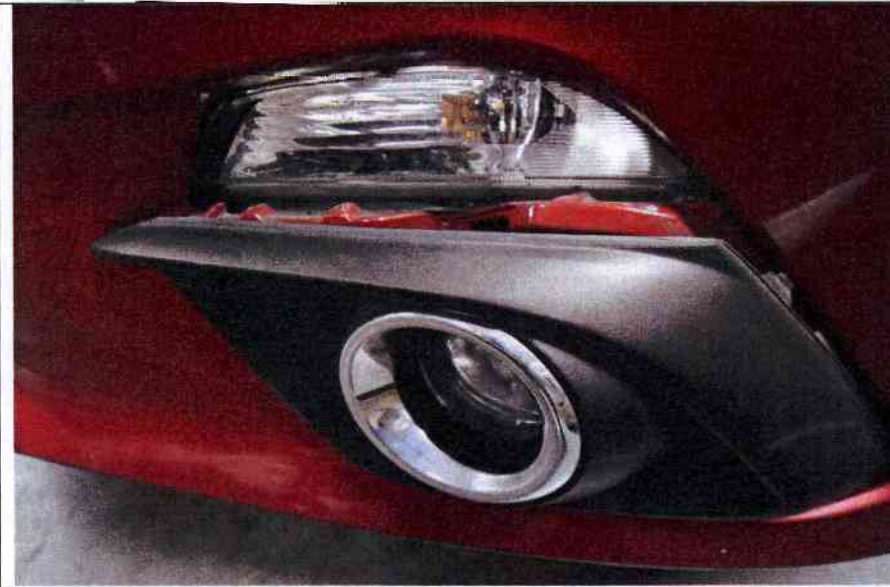
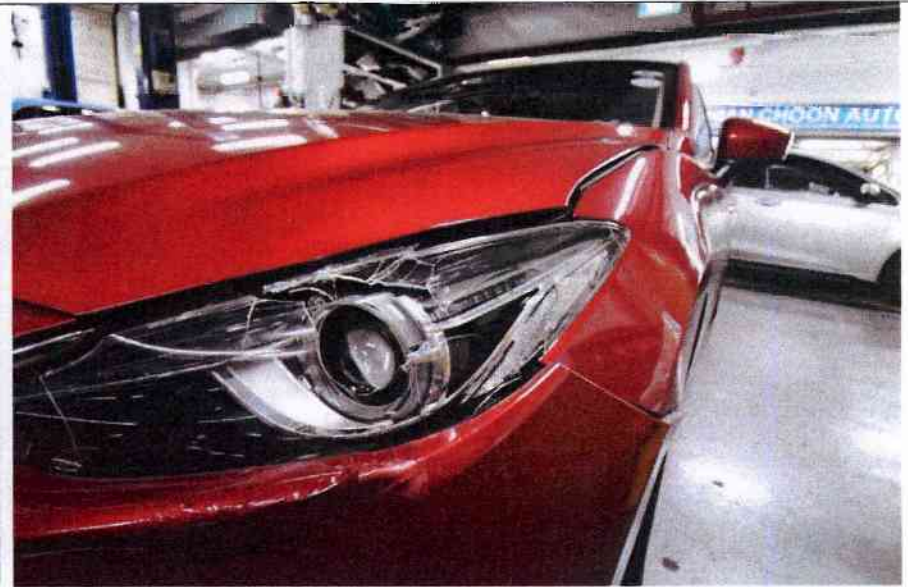
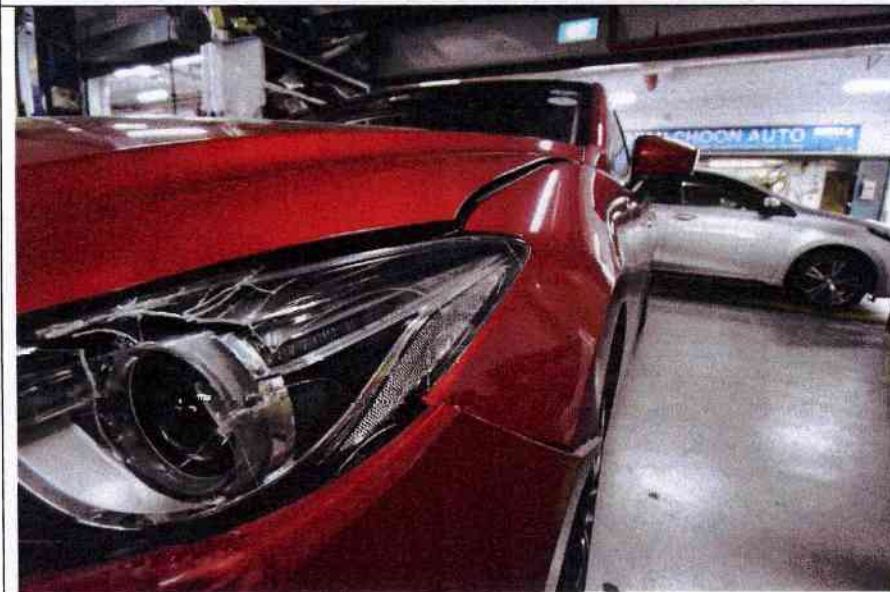
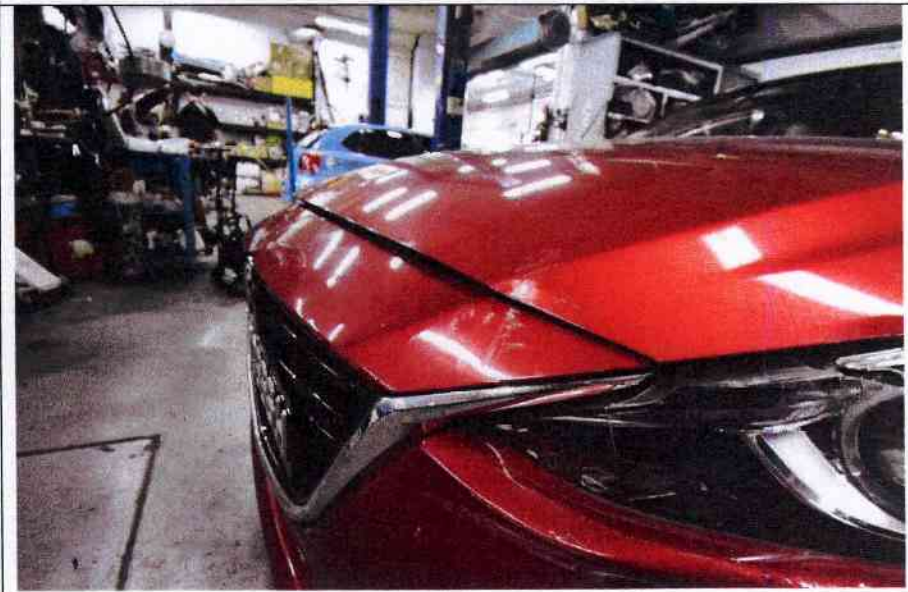
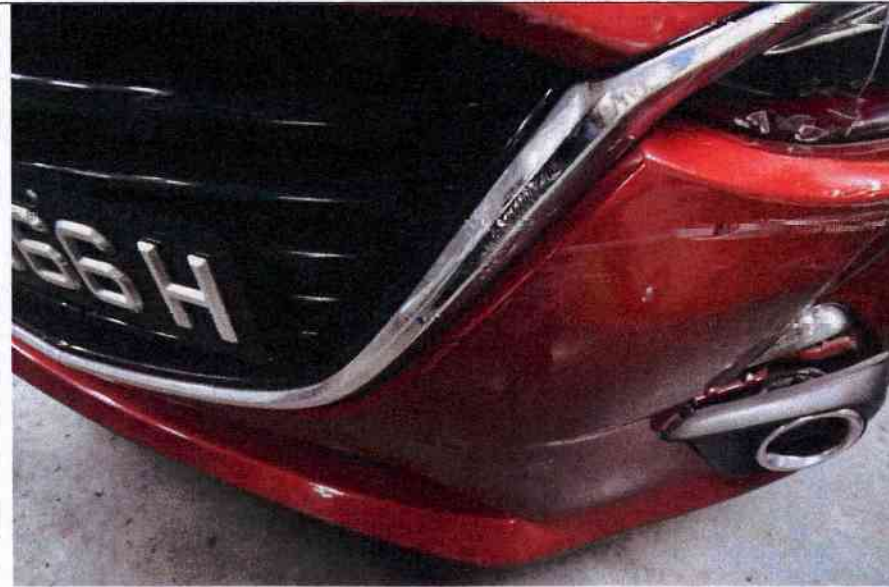
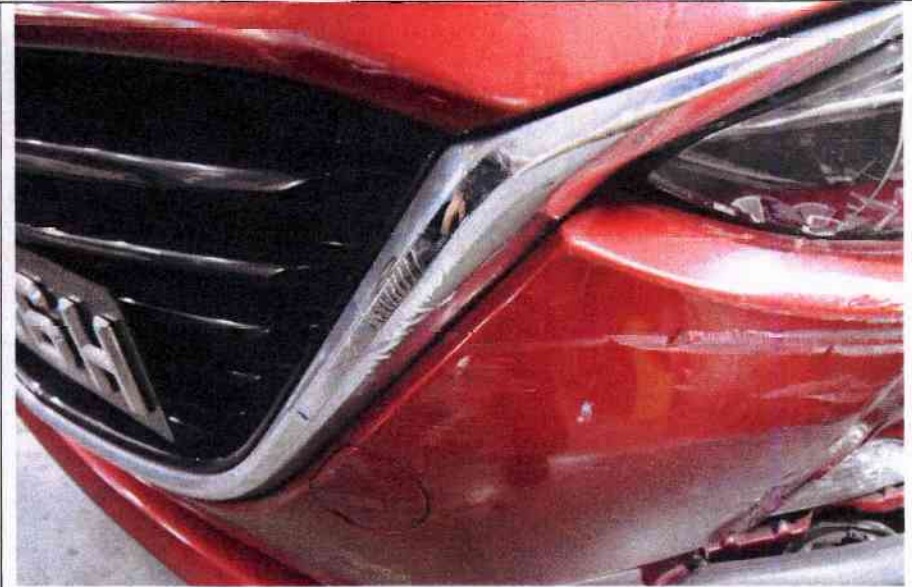
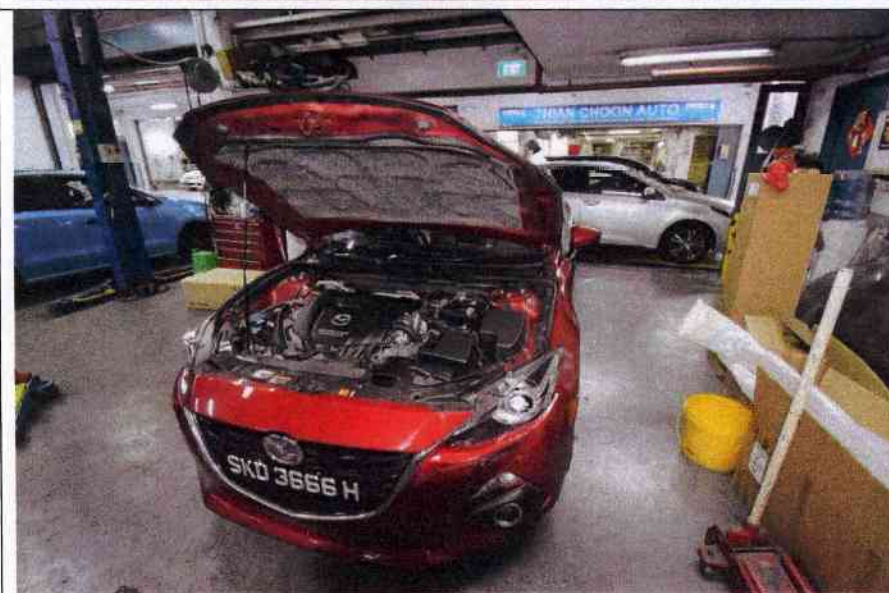
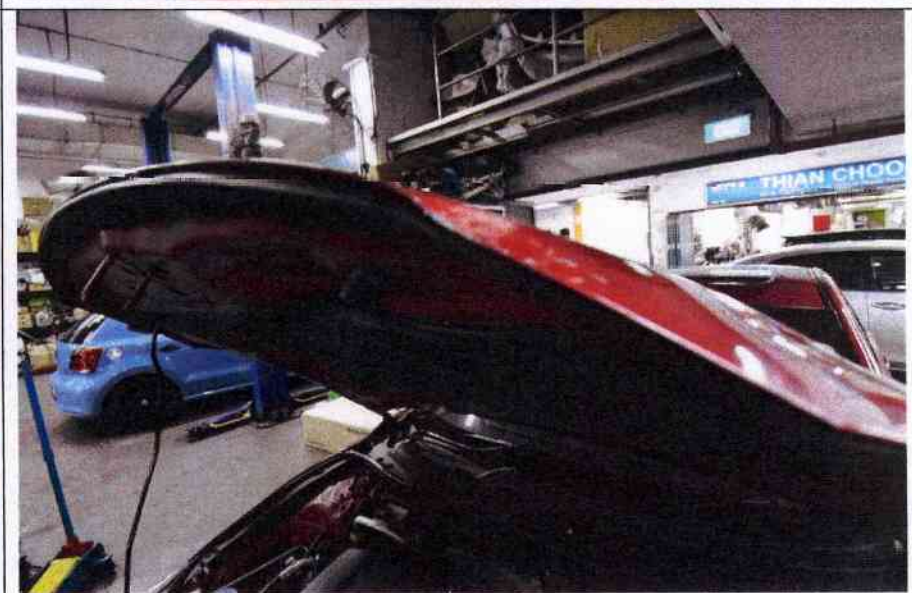
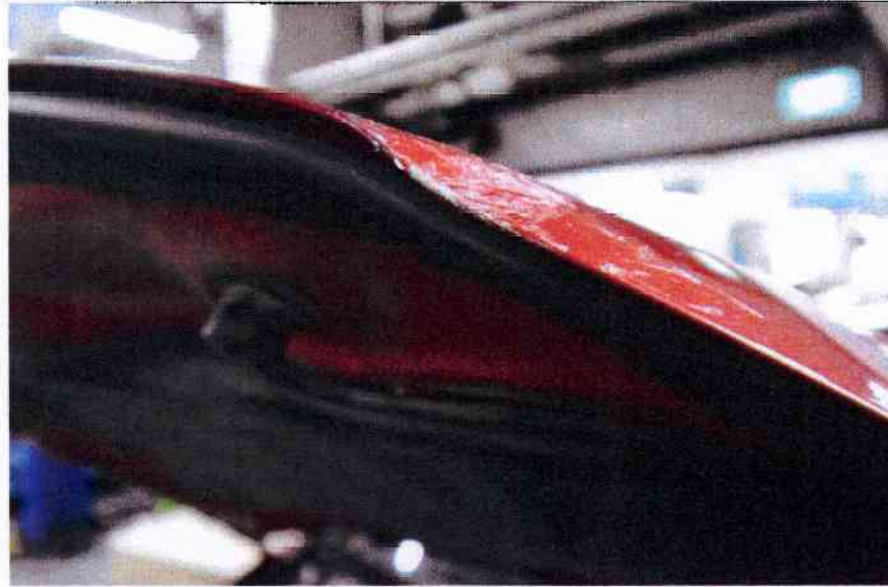
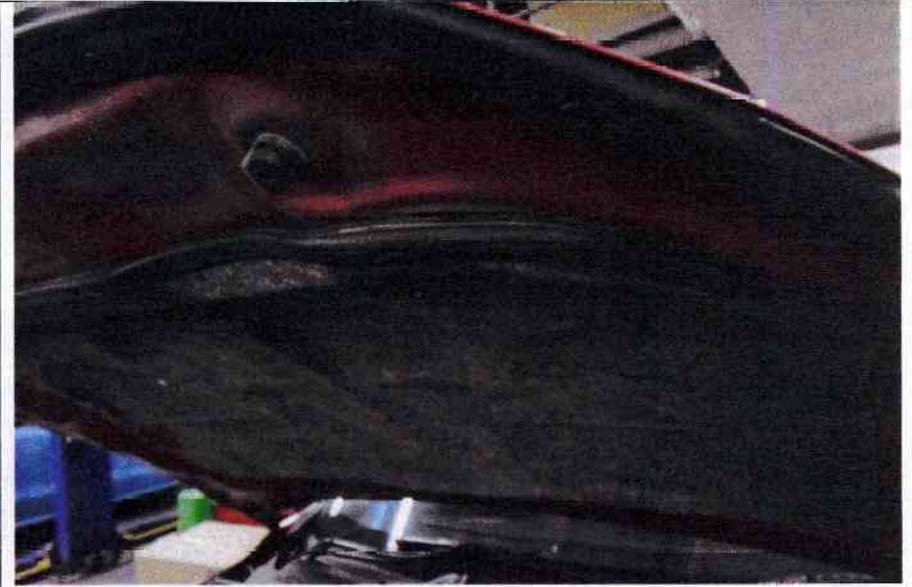
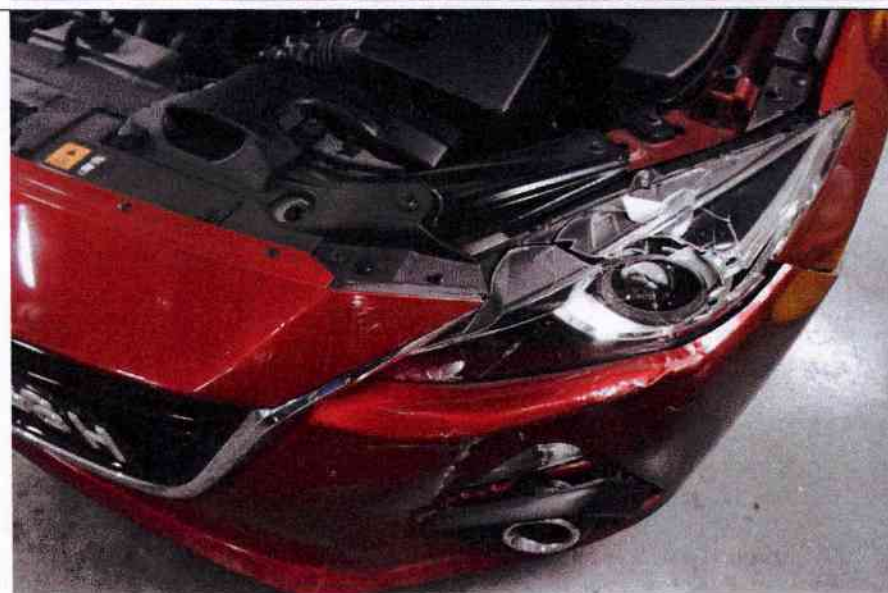
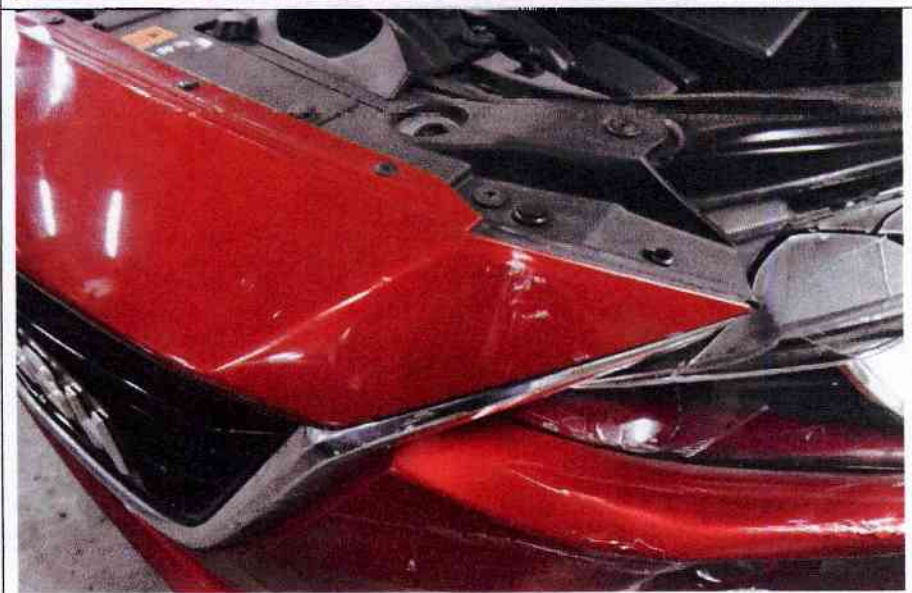
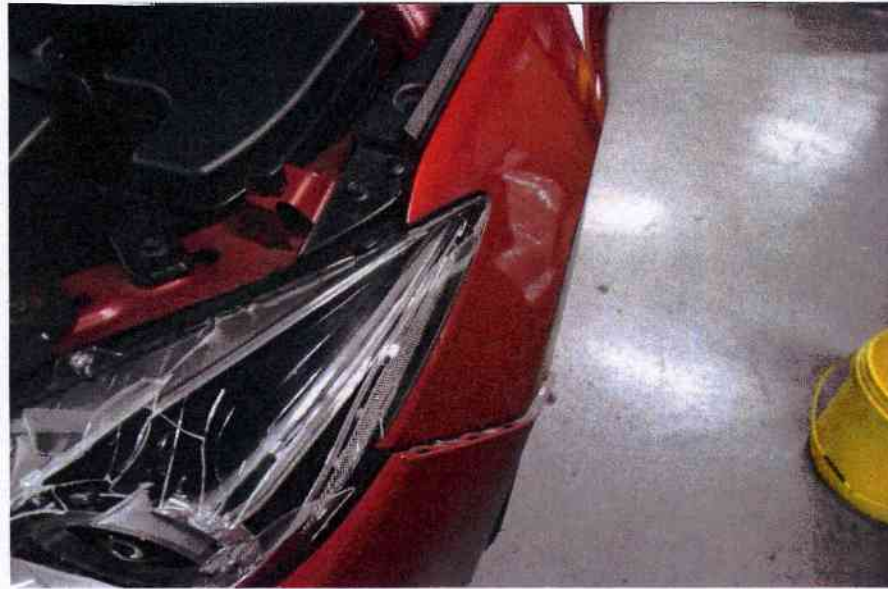
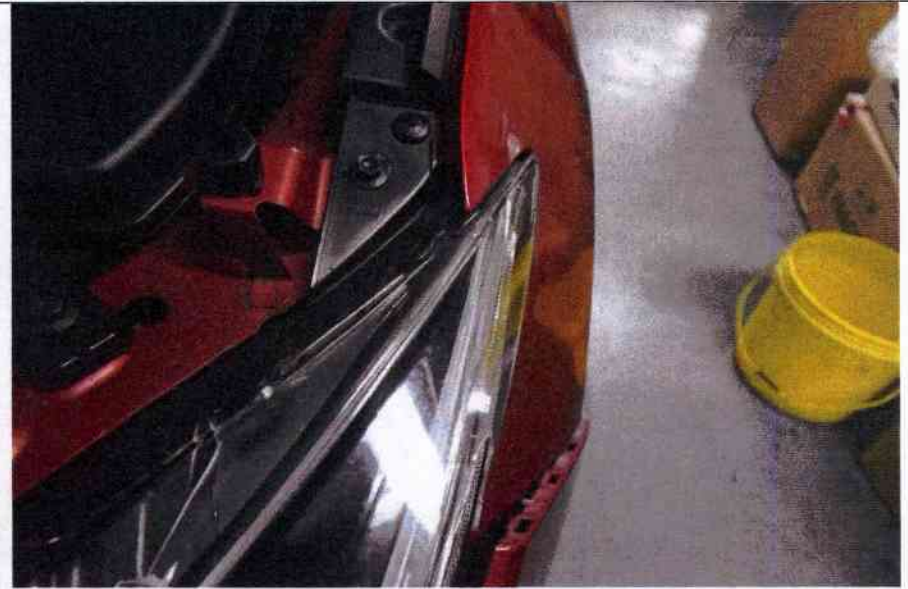
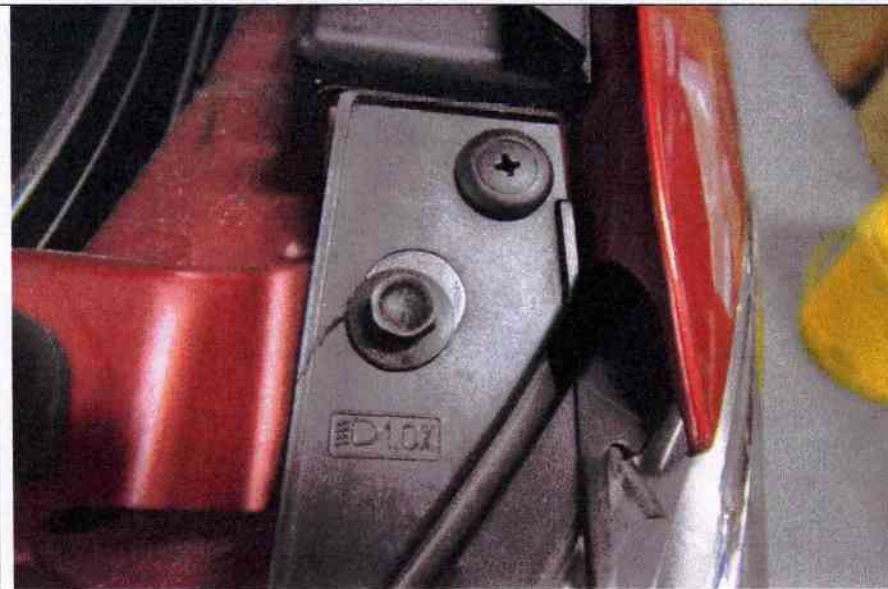
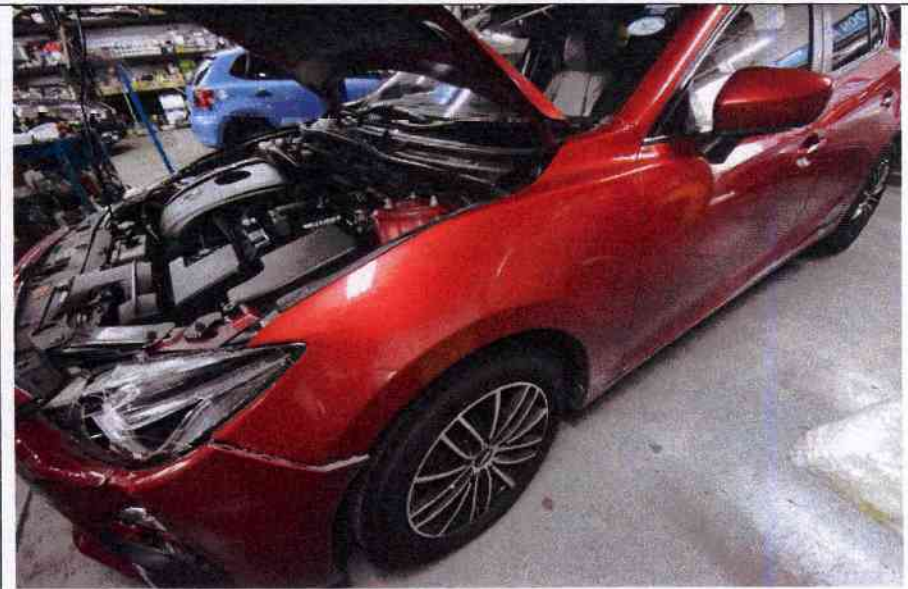
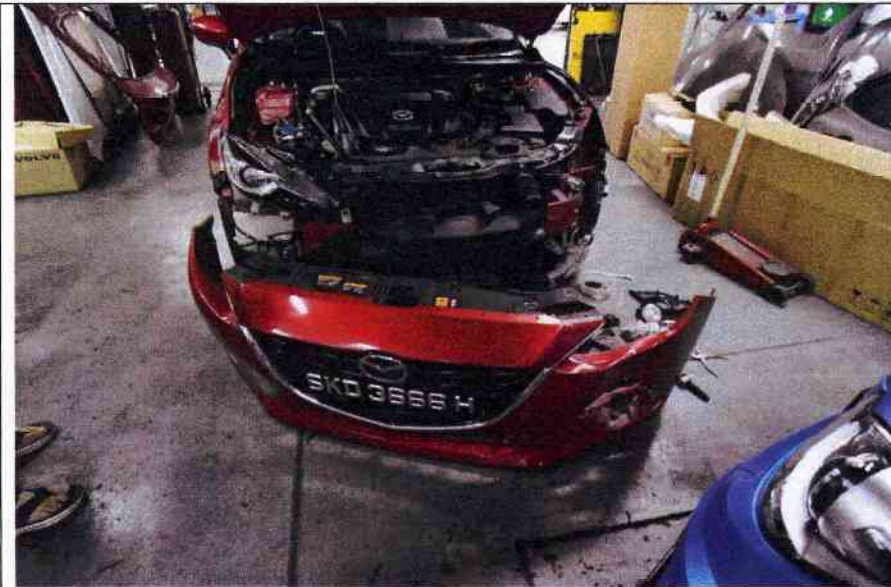
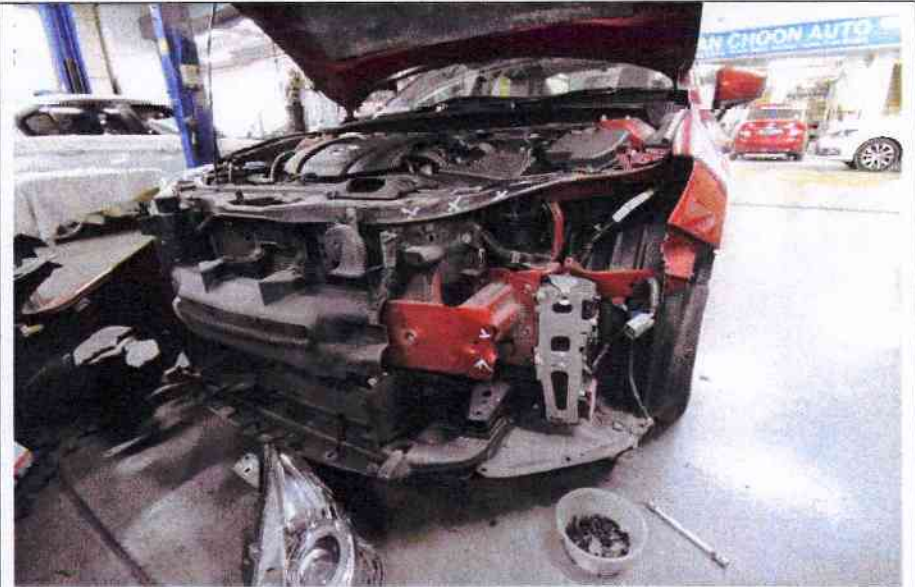
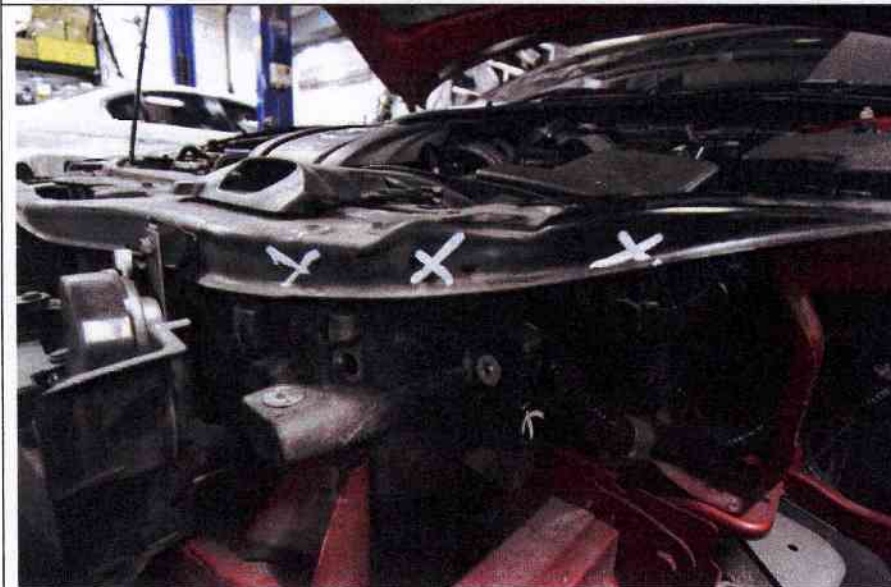
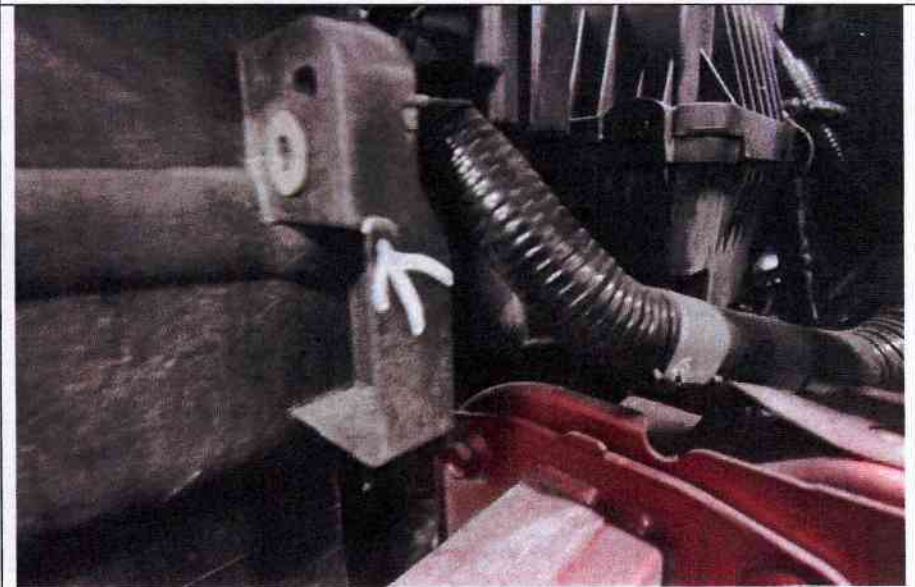
The vehicle sustained damages at front left hand portion.  
(For information of damages please refer to Parts/Labour/Photographs attached)

The repairer has agreed to undertake the repair on a lump sum basis of \$6,300.00, with a repair period of 6 working days.
