Vehicle No. SML 7907X
Insured Veh. PD 7700G
Claim No. SNM22D205768/C02
Policy No. DMB1SNW00010722202
Accident Date 15/08/2022
Inspection Date 18/08/2022

ADJUSTMENT ON REPAIR COST FOR VEHICLE NO. SML 7907X

PHOTOGRAPHS FOR VEHICLE NO. SML 7907X

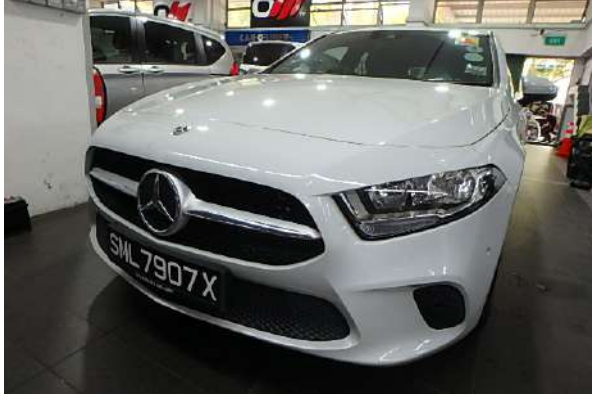
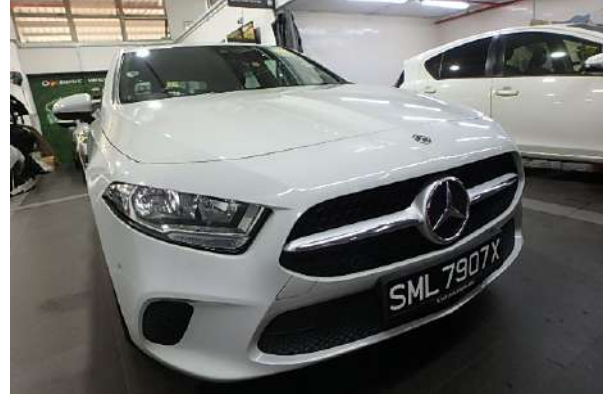
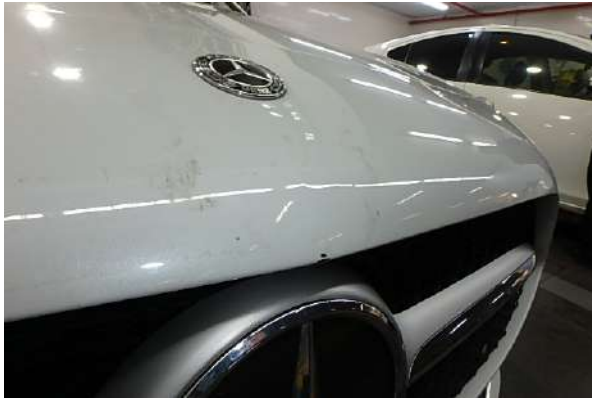
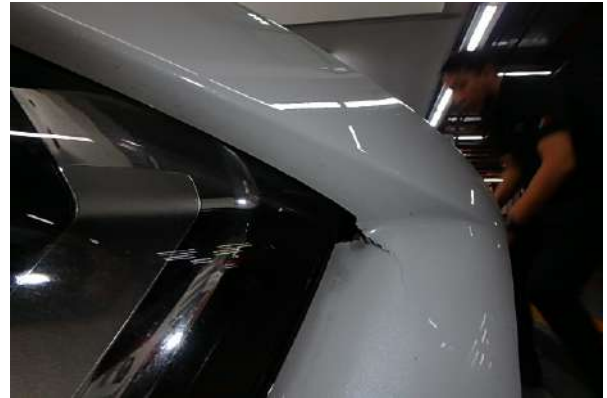
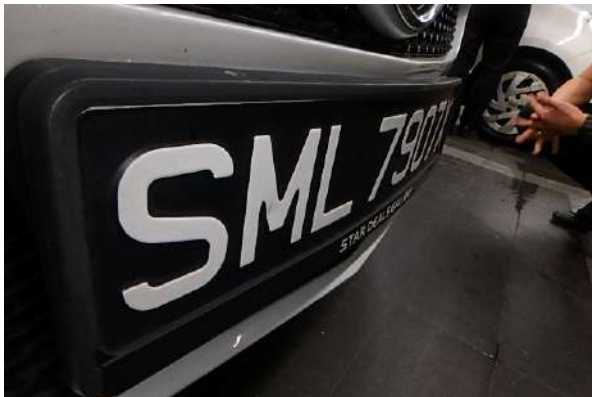
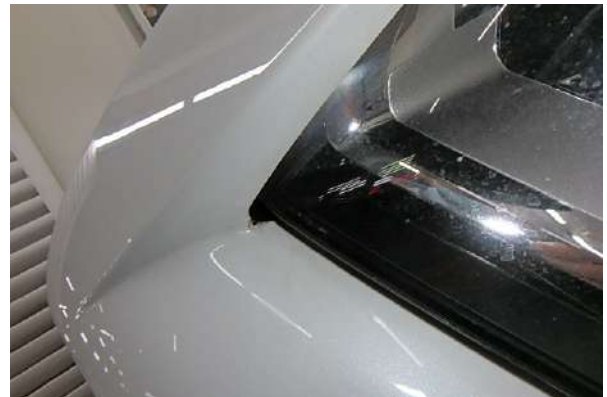
4. Description of Damages				
THE VEHICLE SUSTAINED DAMAGES AT THE FRONT PORTION. DAMAGES SEE DETAILS.				
5. General Information				
Accident Date	15/08/2022	Inspection Date	18/08/2022	
Survey held at	OPTIMA WERKZ PTE LTD 10 ANG MO KIO INDUSTRIAL PARK 2A #01-05 AMK AUTOPOINT SINGAPORE 568047			
5a. Remarks				
A)THE INSPECTION WAS CONDUCTED ON A"WITHOUT PREJUDICE" BASIS. B)IN ACCORDANCE TO YOUR INSTRUCTIONS, WE HAVE NOT AUTHORISED REPAIRS.				
5b. Estimate Days of Repair				
ESTIMATED NORMAL PERIOD FOR REPAIR:			3 Working Days
