SINGAPORE ACCIDENT STATEMENT

Automobile Inspection Report

Registration No. : GBE 5150S
Accident Date : 29/06/2022

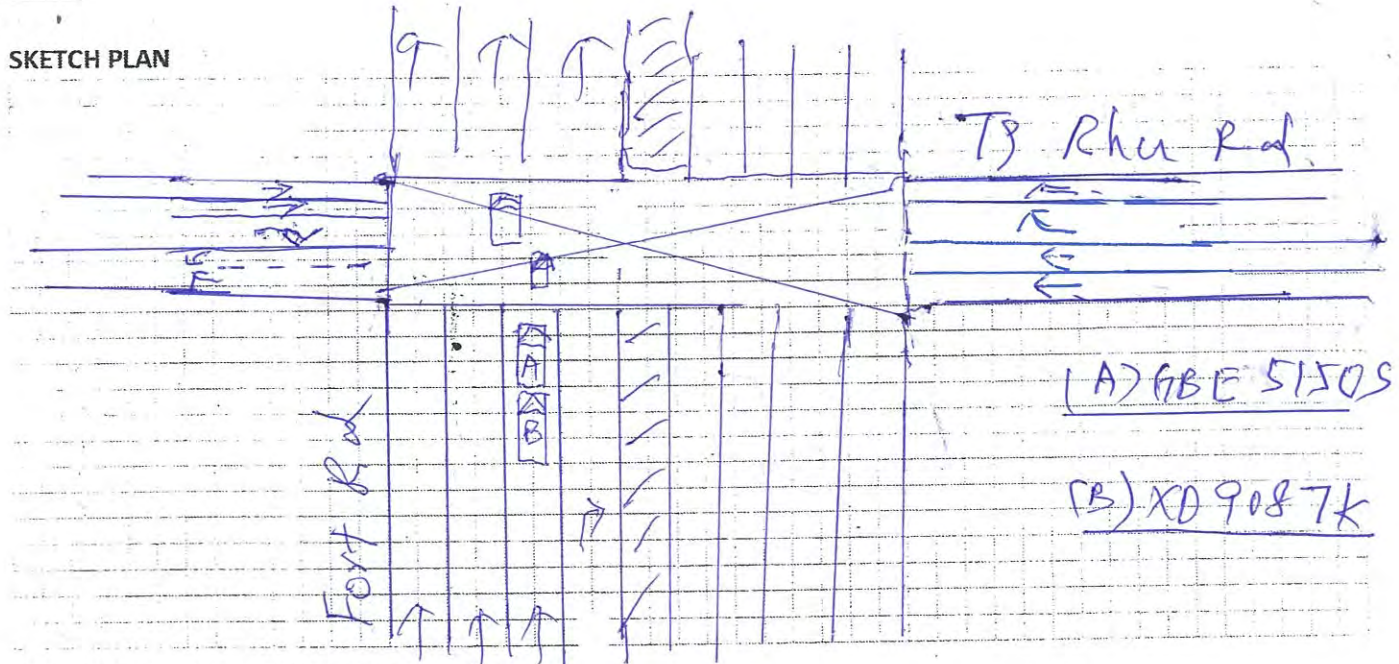
SKETCH PLAN

On 29/6/2022 at about 16.00pm. I drove my lorry no GRE 5150S along Fort Rd toward Marina Dr, when I reach the place of Fort Rd so I go straight at the traffic light junction Green light. The car and the motorcycle vehicle in front me slow down. I also slow down my lorry no GRE 5150S. Suddenly the Big lorry behind me with vehicle no XD 9087K and hit onto my lorry no GRE 5150S Rear Body and front portion Rear End panel and Diesel tank damaged.

(my lorry no GRE 5150S very damaged.)
