Affiliated to Federation Internationale Des Experts En Automobile			
CHINA TAIPING INSURANCE (S) PTE LTD 3 ANSON ROAD #16-00 SPRINGLEAF TOWERSINGAPORE 079909		Ref: CC3/CTI22008637/Tpa3q2 Date: 16/12/2022 Code: CTI

## ADJUSTMENT ON REPAIR COST FOR VEHICLE NO. SHB 6646S

## PHOTOGRAPHS FOR VEHICLE NO. SHB 6646S

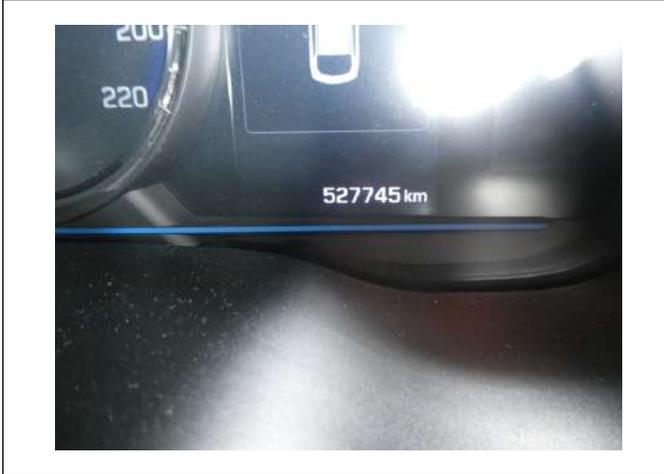
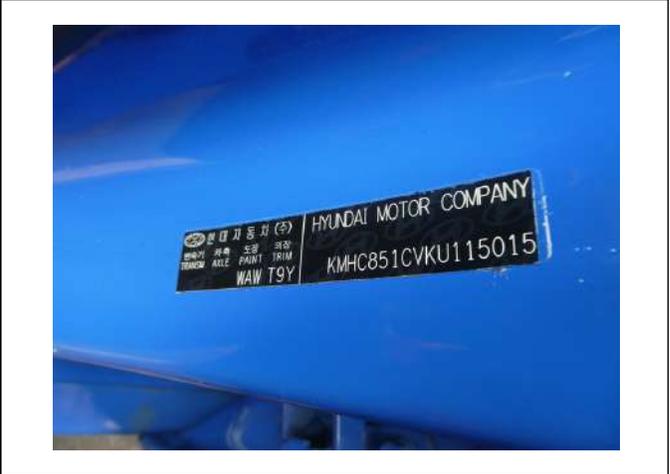
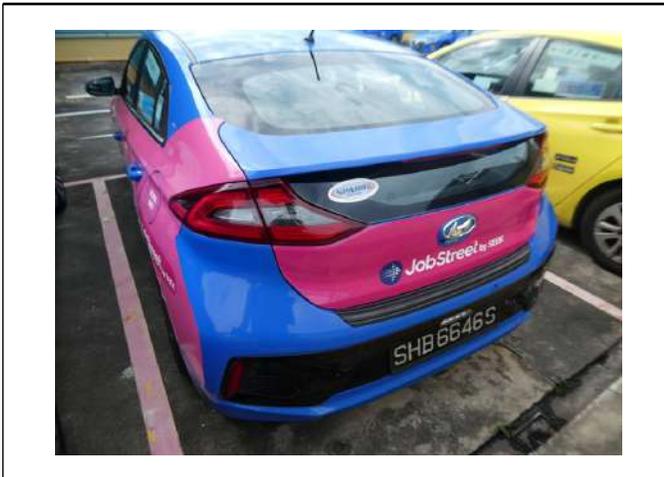
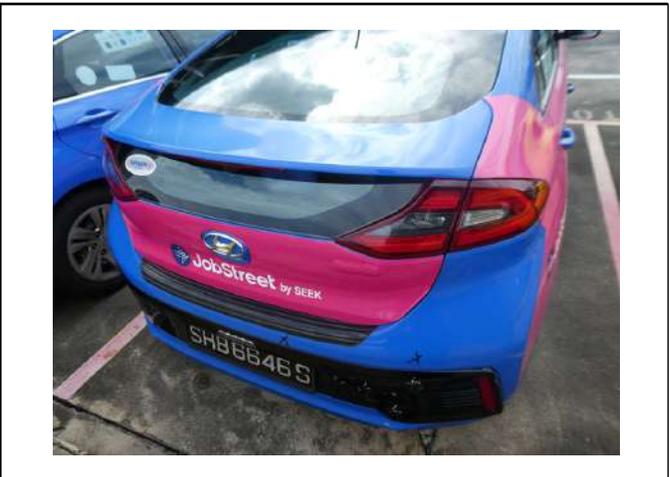
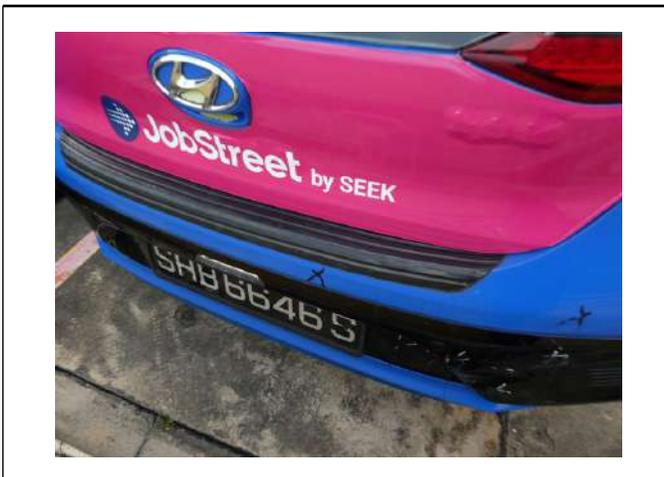
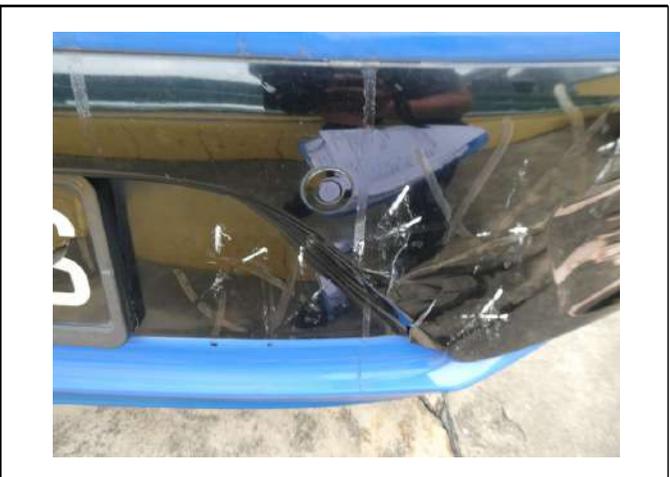
## INSPECTION

4. Description of Damages			
THE VEHICLE SUSTAINED DAMAGES AT THE REAR PORTION. DAMAGES SEE DETAILS.			
5. General Information			
Accident Date	24/08/2022	Inspection Date	24/08/2022
Survey held at	COMFORTDELGRO ENGINEERING PTE LTD 59 LOYANG DRIVE SINGAPORE 508969		
5a. Remarks			
A)THE INSPECTION WAS CONDUCTED ON A"WITHOUT PREJUDICE" BASIS. B)IN ACCORDANCE TO YOUR INSTRUCTIONS, WE HAVE NOT AUTHORISED REPAIRS.			
5b. Estimate Days of Repair			
ESTIMATED NORMAL PERIOD FOR REPAIR:		2 Working Days

Qty	Description of Parts	Condition	Estimate By Workshop (\$)	Our Adjusted (\$)
<b>REPLACEMENT OF PARTS</b>				
1	REAR BUMPER	DEFORMED	459.40	459.40
2	REAR BUMPER SIDE BRACKET LH/RH @\$55.80	NOT NECESSARY	111.60	-
1	REAR BUMPER CENTRE MOULDING	DEFORMED	451.25	451.25
2	REAR BUMPER REINFORCEMENT STAY LH/RH @\$138.10	NOT NECESSARY	276.20	-
1	REAR BUMPER REINFORCEMNT	NOT NECESSARY	394.80	-
1	REAR FOG LAMP	NOT NECESSARY	201.50	-
2	REAR BUMPER REFLECTOR LH/RH @\$41.45	NOT NECESSARY	82.90	-
1	TOWING COVER	NOT NECESSARY	98.80	-
2	REAR NUMBER PLATE LAMP LH/RH @\$85.30	NOT NECESSARY	170.60	-
10	REAR BUMPER CLIPS @\$2.20	NECESSARY	22.00	22.00
	LESS 20% DISCOUNT		-453.81	-186.53
			1,815.24	746.12
<b>SPECIAL NETT ITEMS</b>				
2	REAR FENDER ADVERTISEMENT LH/RH @\$100.00 (SN)	NECESSARY	200.00	200.00
1	REAR NUMBER PLATE W/HOLDER (SN)	CRACKED	55.00	55.00
1	REAR REVERSE SENSOR (SN)	NOT WORKING	180.00	180.00
