4.		Description	on of Damages	
	THE VEHICLE SUS	STAINED DAMAGES AT THE REA	AR PORTION.	
	DAMAGES SEE DE	ETAILS.		
5.		General	Information	
	Accident Date	21/09/2022	Inspection Date	26/09/2022
	Survey held at	CYCLE & CARRIAGE.FULCO M	OTOR DEALER PL	
		NO.330 UBI ROAD 3 SINGAPORE 408650		
5a.			emarks	
		N WAS CONDUCTED ON A"WIT E TO YOUR INSTRUCTIONS, W		
5b.		Estimate I	Days of Repair	
	ESTIMATED NORM	MAL PERIOD FOR REPAIR:	5 W	orking Days

ADJUSTMENT ON REPAIR COST FOR VEHICLE NO. SMJ 9007R

PHOTOGRAPHS FOR VEHICLE NO. SMJ 9007R

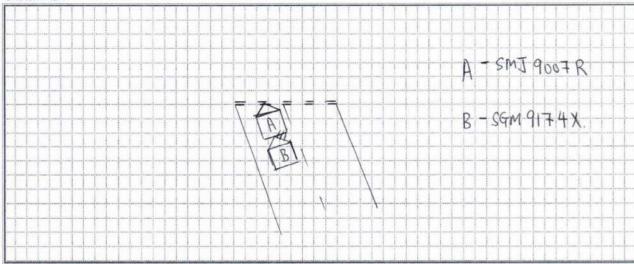
Sketch Plan

I was turning from Devonshire Road to Exeter Road near 111 Somerset. When I was approaching the Y junction, I stopped my vehicle to observe the incoming traffic. A few seconds later, a vehicle hit or collided against my vehicle from behind. We concluded to send my vehicle to workshop for repair. The quotation/invoice will be sent to the involved vehicle's driver (Mr Tan Yick Fung, S7902547Z, Vehicle No: SGM9174X) to make the payment. He will let me know whether he will want to settle outside (paid direct to the workshop) or claim from his insurance. We have exchanged contact numbers, NRIC and name, also took photos of the damaged vehicles.
