**ACCIDENT INVOLVING SMF 4959Y / SLU 786M ON 14.07.2022 ALONG BUKIT TIMAH ROAD
 TOWARDS WOODLANDS ROAD (BEFORE FOURTH AVE)**

VEHICLE APPRAISAL REPORT

Registration No.	: SMF 4959Y	Chassis Frame No.	: ZVW50-6144369
Make / Model	: Toyota Prius Hybrid 1.8S CVT	Engine No. (Logcard)	: 2ZR2B37174
Year of Manufacture/Reg	: 2018	Odometer Reading	: 323,420 KM
Colour	: Silver		
Class / Type	: Saloon

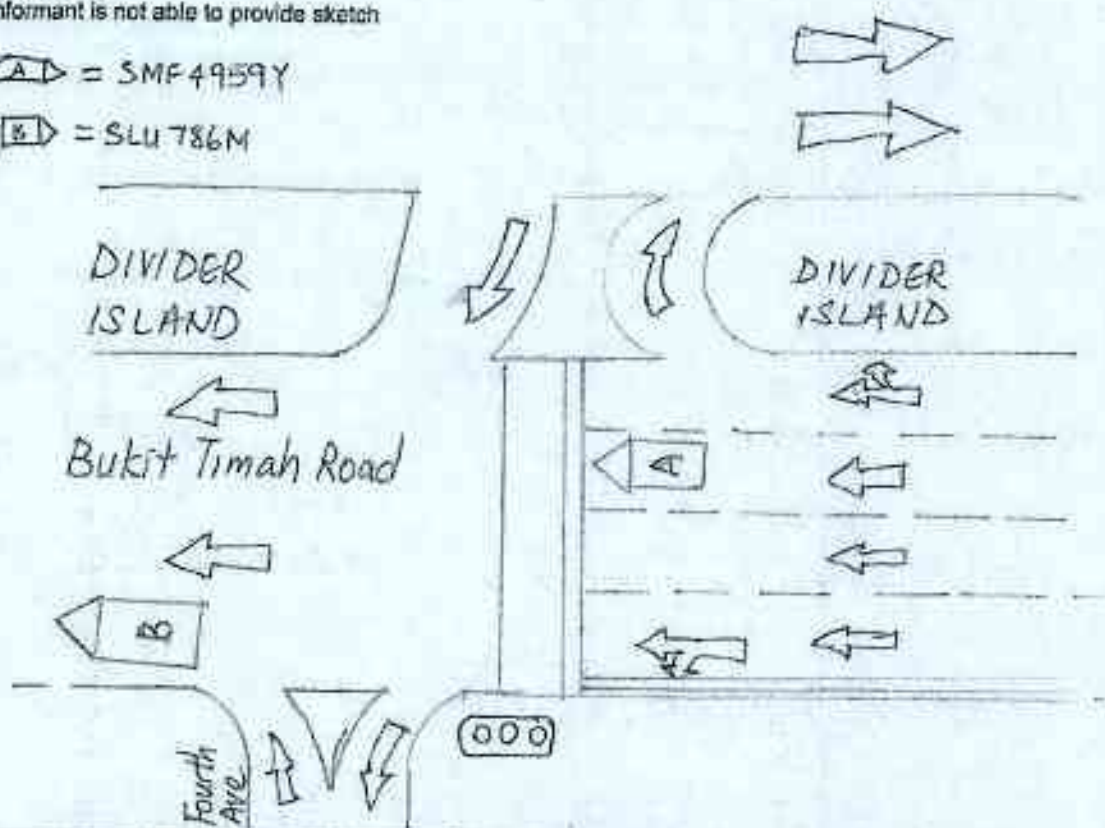
Sketch Plan

Informant is not able to provide sketch

A = SMF4959Y

B = SLU786M

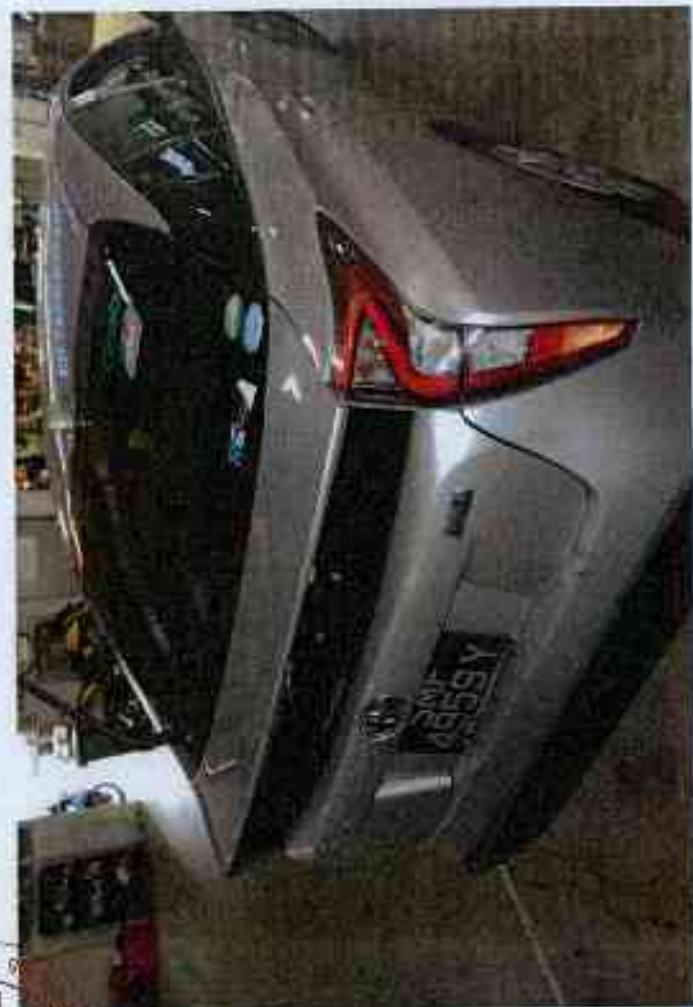
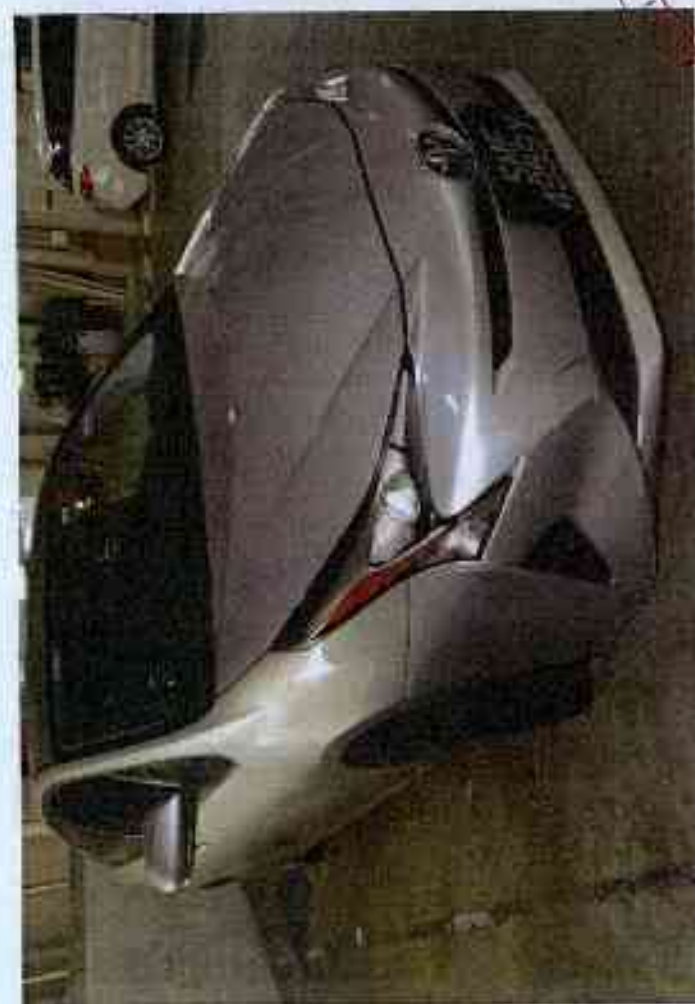
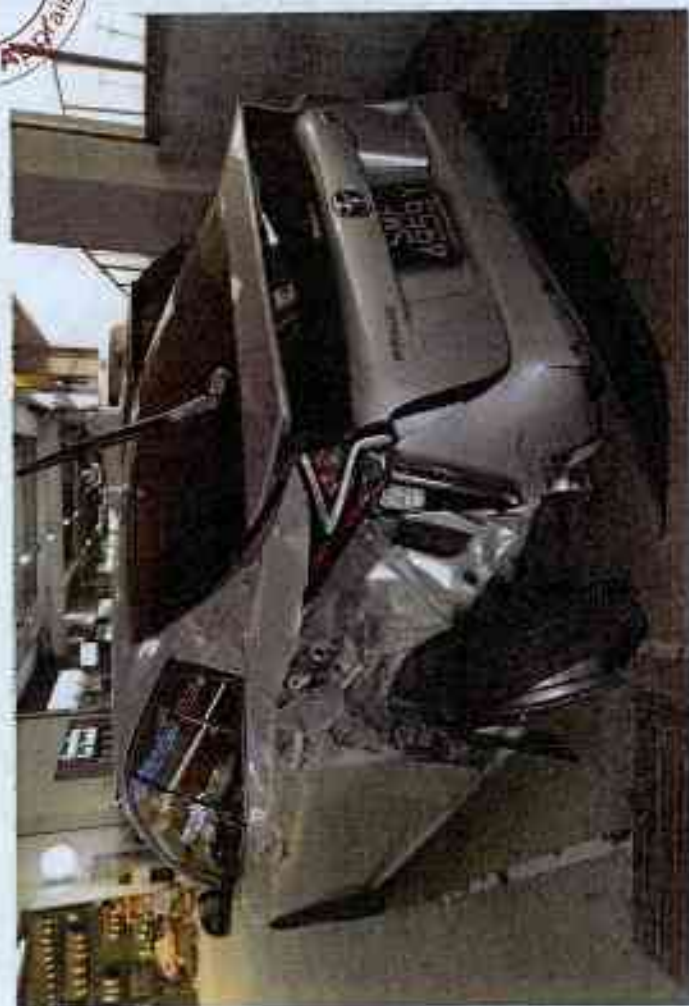
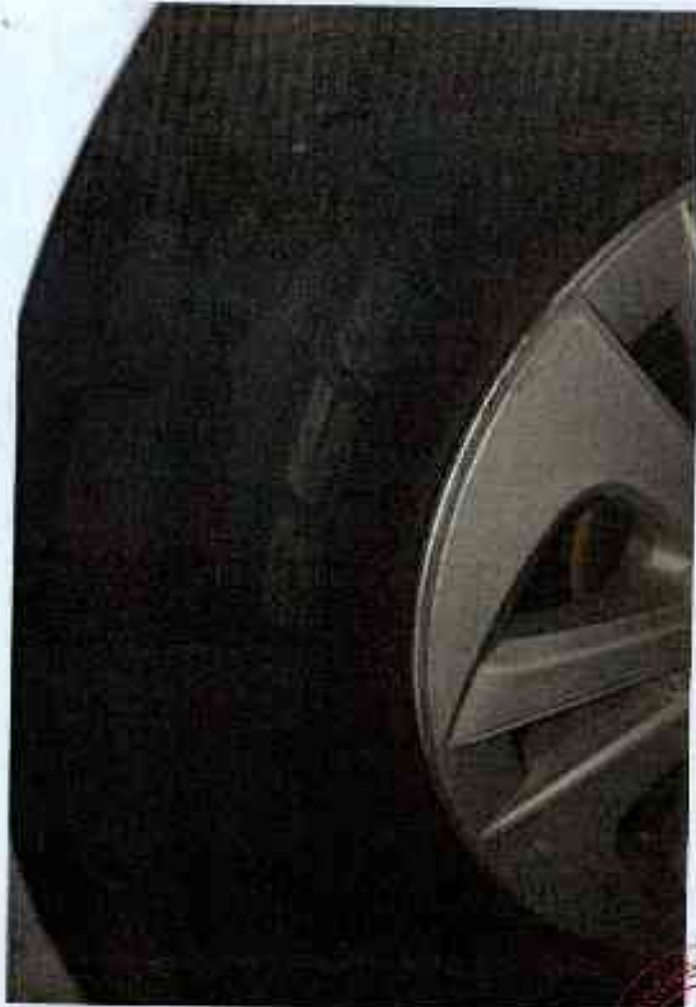
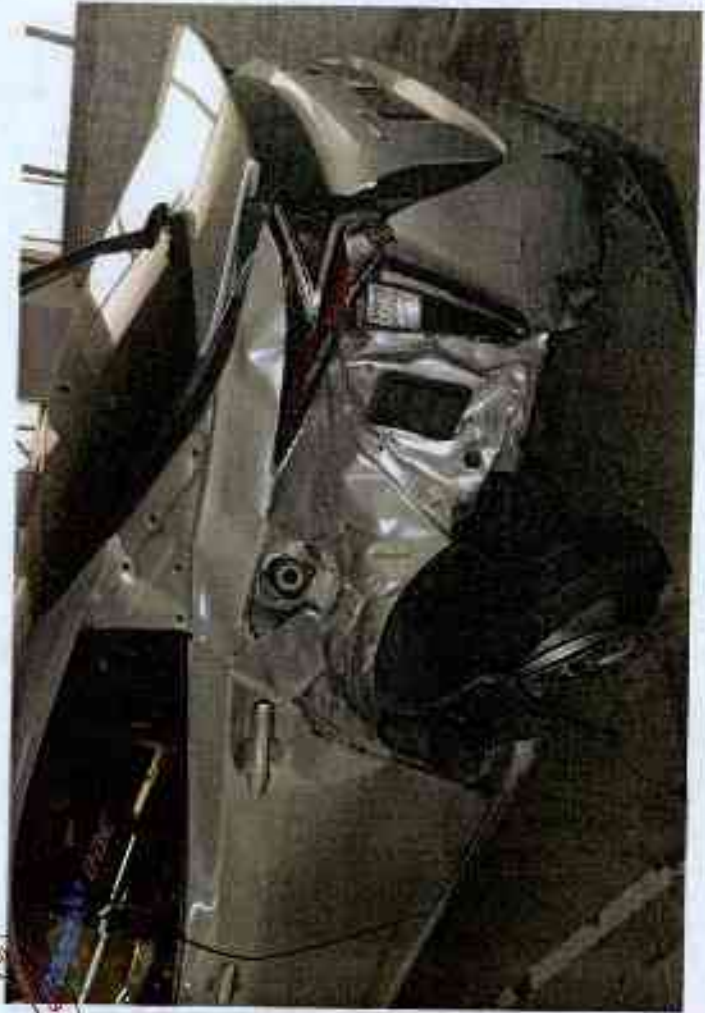
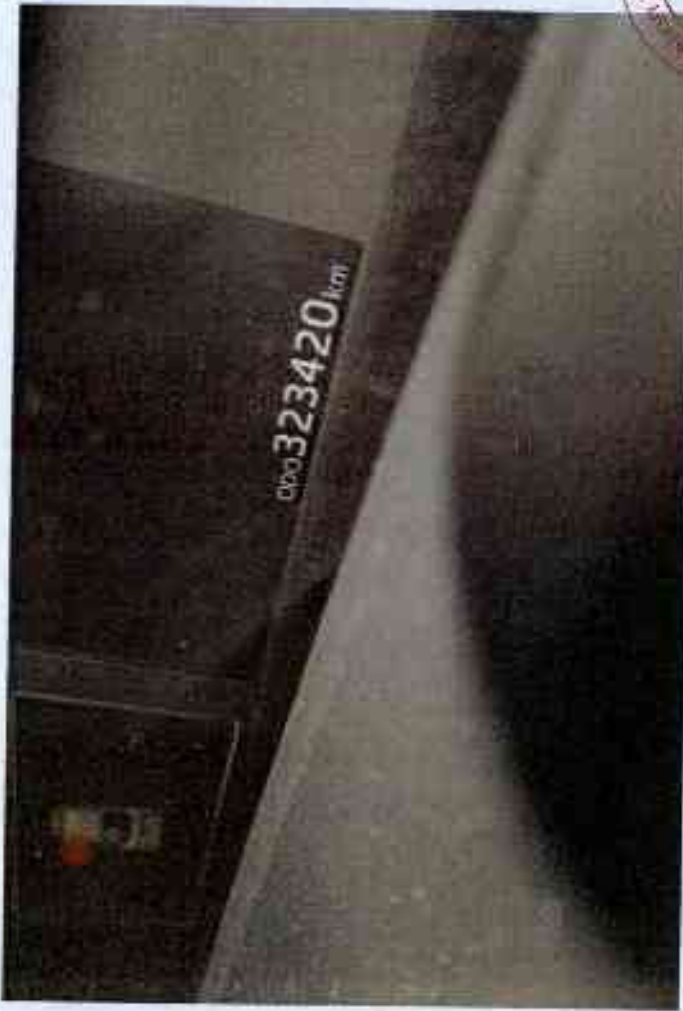
Damages sustained were consistent with the subject vehicle being involved in a collision with another vehicle and the impact was delivered

Squarely to the LH Rear

portion of the vehicle.

The general area of damages is at the
(Please refer to the parts list and photographs as attached for more information)

LH Rear portion

81 photographs were taken at the time of static inspection.

The estimated repair costs submitted by Messrs **Apex Motoring** is \$ 23,543.00 .
We have adjusted the cost to \$ 15,538.98 and the repairer has agreed to undertake the repairs at a
Contract Lump Sum of \$ 12,450.00 to a acceptable quality and standards.
However, we have not given authorization and instruction to the repairer to proceed with the repairs.

The repairs should be completed within a reasonable period of **12** working days.
