Vehicle No. YP 8389X  
Insured Veh. GBE 9410R  
Claim No. SNM22D207296/C02  
Policy No. DNCVSNW0040702201  
Accident Date 10/10/2022  
Inspection Date 11/10/2022

| Affiliated to Federation Internationale Des Experts En Automobile | | | | |
|---|---|---|---|---|
| | Make & Model | ISUZU NPR85 | c.c | 2999 |

## ADJUSTMENT ON REPAIR COST FOR VEHICLE NO. YP 8389X

### PHOTOGRAPHS FOR VEHICLE NO. YP 8389X

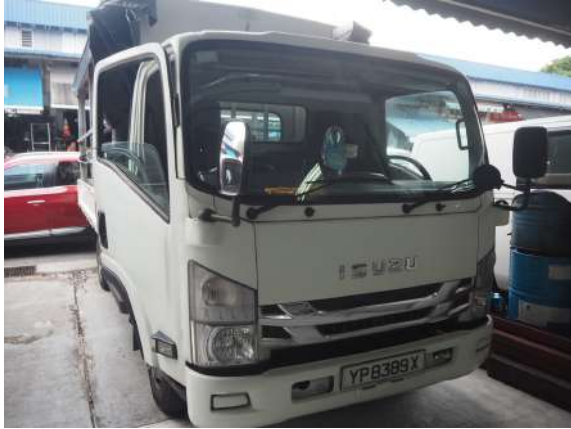
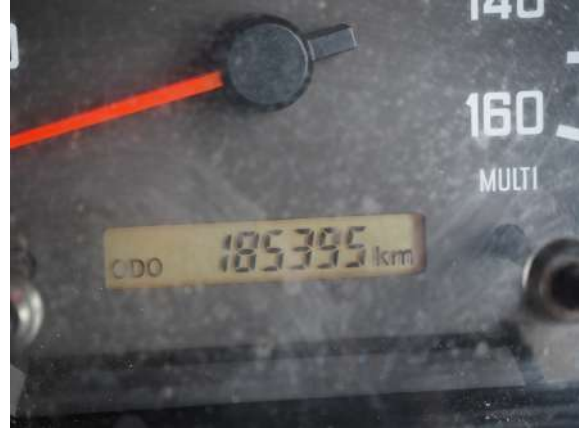
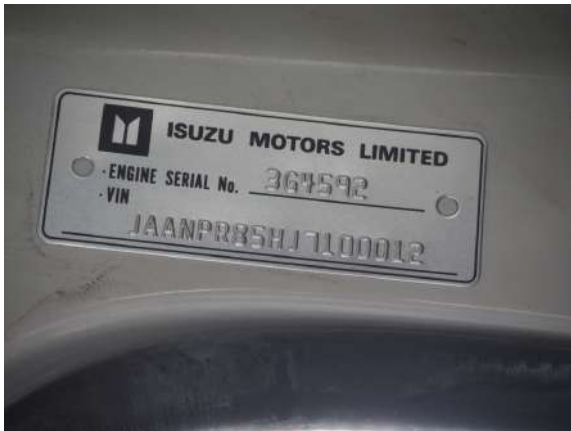
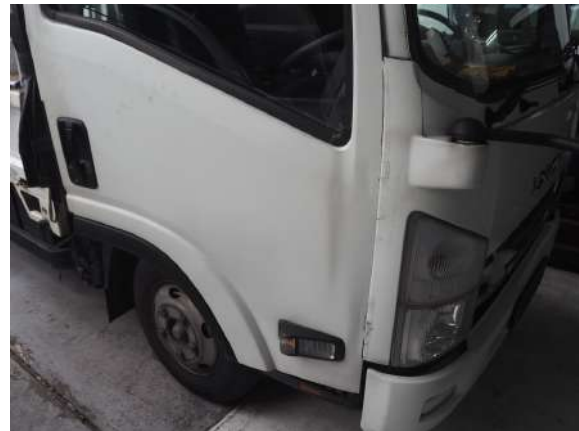
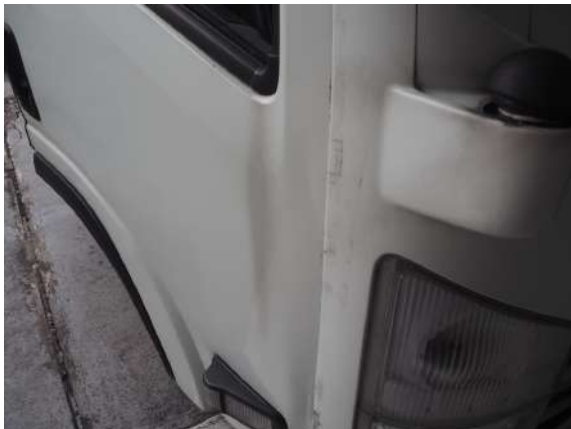
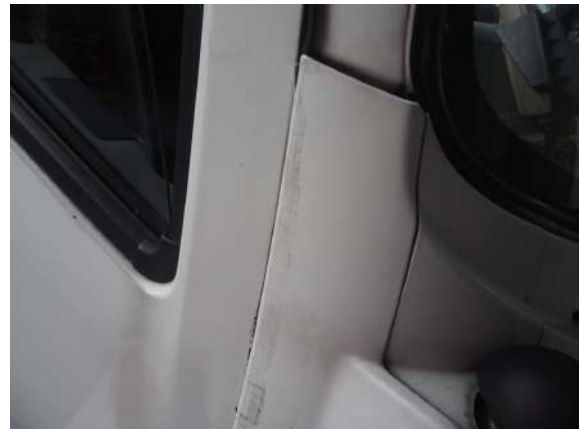
### INSPECTION

| Affiliated to Federation Internationale Des Experts En Automobile | | | | |
|---|---|---|---|---|
| | THE VEHICLE SUSTAINED DAMAGES AT THE O/S BODY.<br>DAMAGES SEE DETAILS. | | | |
