Estimate bill : TT 41 / 22 / TP / WT

Registration No : SMJ2578E

Make / model : Hyundai Avante

**TRAFFIC ACCIDENT INVOLVING VEHICLE BEARING REGISTRATION NO: SGV478G AND SMJ2578E ALONG  
EXIT FROM PUNGOL FIELD TOWARDS SUMANG WALK ON 21 NOVEMBER 2022 AT ABOUT 2014HRS.**

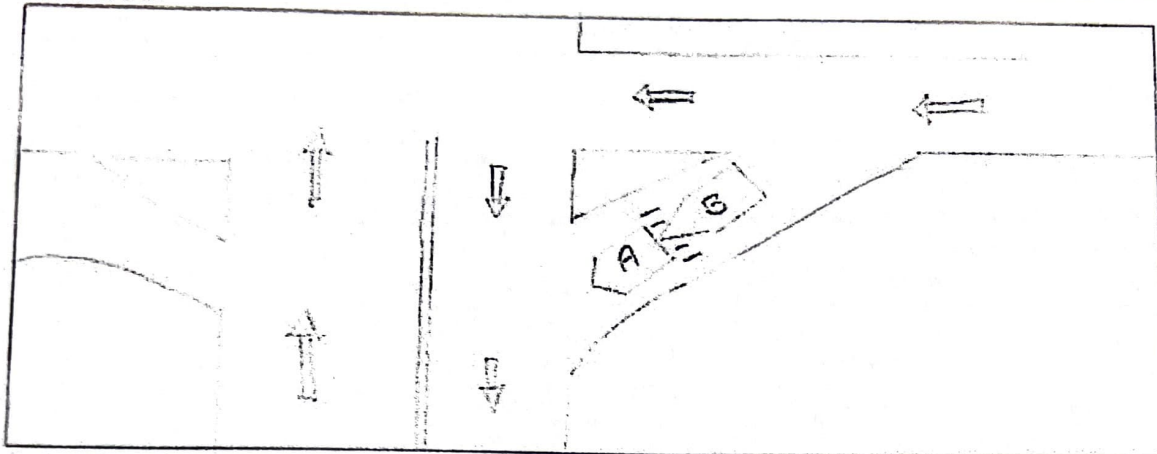
SKETCH PLAN

At Approximately 8.14pm, My vehicle SMJ 2578E was driving along Punggol Field road, preparing to turn into Sumang Walk through a filter lane that was directly situated in front of U-stairs Mega Mart.

As I slowed down my vehicle at the filter, coming to a complete stop to look to my right for any possible incoming traffic, the vehicle behind to ~~SGV 478G~~ SGV 478G hit the rear of my vehicle resulting in a boom sound.
