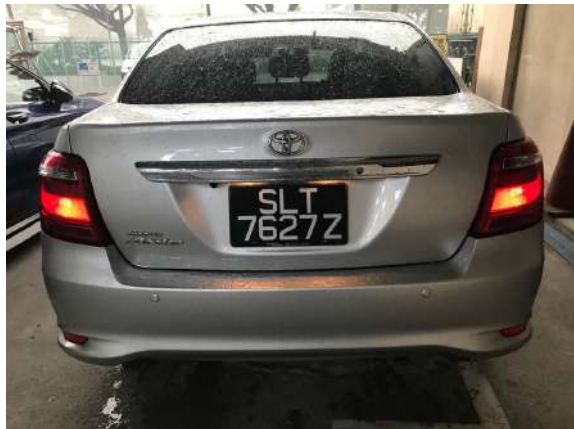
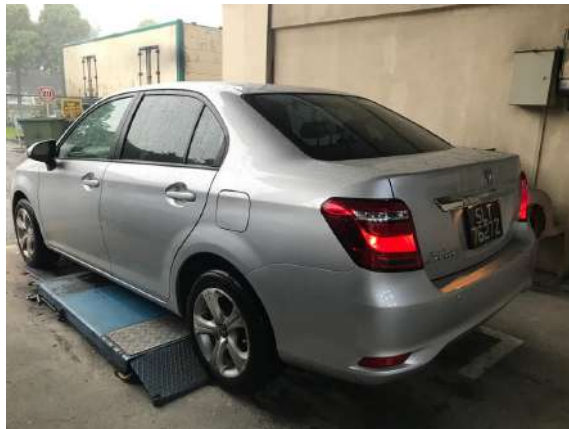
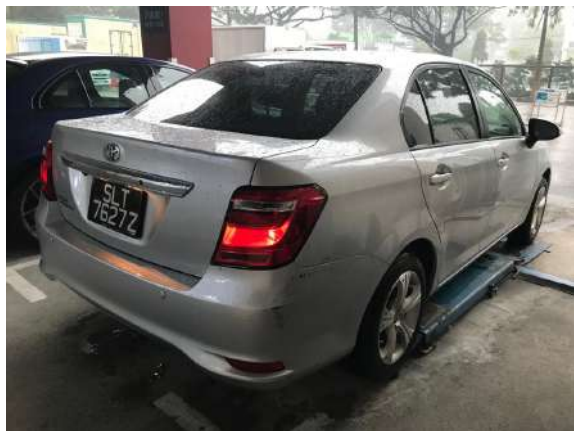
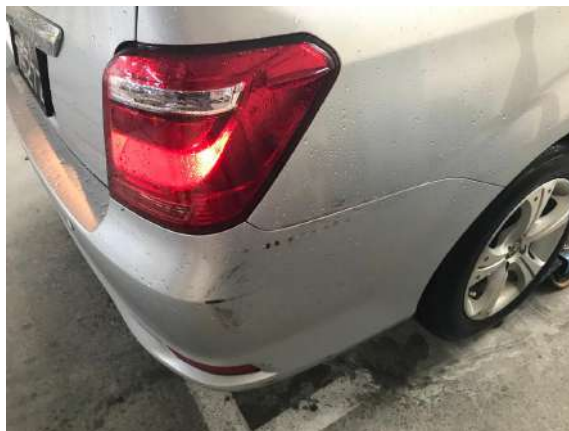
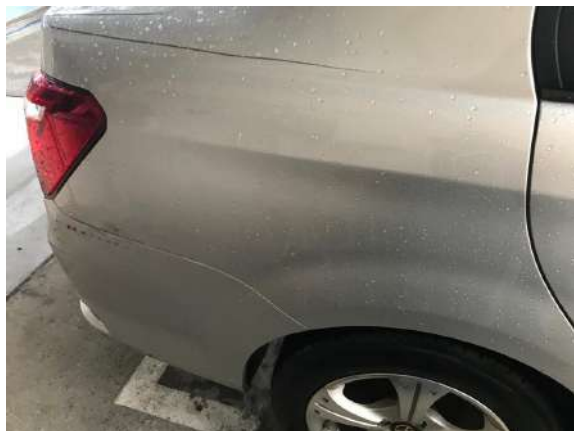
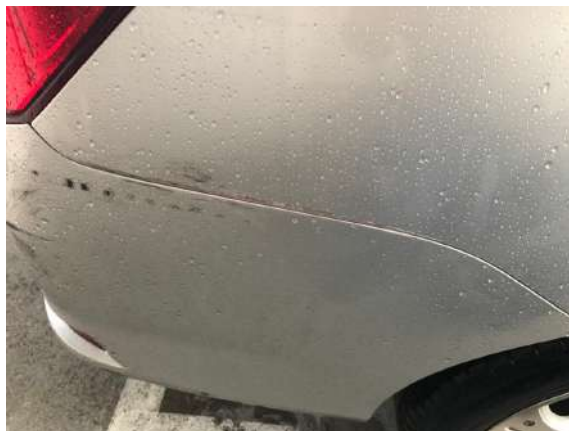
4. Description of Damages				
	THE VEHICLE SUSTAINED DAMAGES AT THE O/S BODY. DAMAGES SEE DETAILS.			
5. General Information				
	Accident Date	05/11/2022	Inspection Date	06/12/2022
	Survey held at	KT MOTORWERK 3012 BEDOK INDUSTRIAL PARK E, #01-2020, BEDOK INDUSTRIAL PARK E, SINGAPORE 489978		
5a. Remarks				
	A)THE INSPECTION WAS CONDUCTED ON A"WITHOUT PREJUDICE" BASIS. B)IN ACCORDANCE TO YOUR INSTRUCTIONS, WE HAVE NOT AUTHORISED REPAIRS.			
5b. Estimate Days of Repair				
	ESTIMATED NORMAL PERIOD FOR REPAIR:		3 Working Days

Qty	Description of Parts	Condition	Estimate By Workshop (\$)	Our Adjusted (\$)
	<u>REPLACEMENT OF PARTS</u>			
1	REAR BUMPER	DEFORMED	1,249.60	565.00
1	REAR BUMPER REFLECTOR	NOT NECESSARY	79.50	-
1	REAR BUMPER SIDE RETAINER	CRACKED	105.40	45.00
1	REAR BUMPER BRACKET	NOT NECESSARY	85.20	-
1	TAIL LAMP	CRACKED	589.30	452.00
1	TAIL LAMP LOWER BRACKET	NOT NECESSARY	98.70	-
1	TAIL LAMP PANEL	NOT NECESSARY	245.80	-
1	REAR FENDER	TO REPAIR SEE LABOUR	974.30	-
1	REAR FENDER INNER COWLING	NOT NECESSARY	147.60	-
1	REAR FENDER INNER TRIM	NOT NECESSARY	395.80	-
1	REAR FENDER AIR VENT	NOT NECESSARY	135.20	-
	LESS 25% DISCOUNT		-1,026.60	-265.50
			3,079.80	796.50
	<u>SPECIAL NETT ITEMS</u>			
1	REAR BUMPER CLIPS (SN)	NECESSARY	30.00	30.00
1	SET TAILLAMP CLIP (SN)	NOT NECESSARY	30.00	-
1	TAIL LAMP PANEL SEALANT (SN)	NOT NECESSARY	60.00	-
1	REAR FENDER SEALANT (SN)	NOT NECESSARY	60.00	-
1	SET REAR FENDER COWLING CLIPS (SN)	NOT NECESSARY	30.00	-

1	SET REAR FENDER INNER TRIM CLIPS (SN)	NOT NECESSARY	30.00	-
1	REAR END PANEL INSULATION SEAL (SN)	NOT NECESSARY	180.00	-
			420.00	30.00
	<u>LABOUR</u>			
	PANEL BEATING, REMOVAL AND REPLACING PARTS. INCLUSIVE OF THE REPAIR OF REAR FENDER.		1,200.00	250.00
	TO SPRAY PAINT AFFECTED AREA.		1,200.00	400.00
	TUFF COAT.		150.00	20.00
	WIRING CHECK ON TAILAMP.		100.00	30.00
	REMOVE AND REFIX INTERIOR UPHOLSTERY.	NOT NECESSARY	200.00	-
