Our Reference : KAAS/TA/6439/9985/TP/07.22
 Date : 11 September 2022

VEHICLE APPRAISAL REPORT

Registration No. : **SNE 9985G** Chassis Frame No. : VF1RFB00655649392
 Make / Model : Renault Megane GT 1.6 TCE AT EU6 Engine No. (Logcard) : M5MB450N011154
 Year of Manufacture/Reg : 2017 Odometer Reading : 105,949 KM
 Colour : Blue
 Class / Type : Hatchback

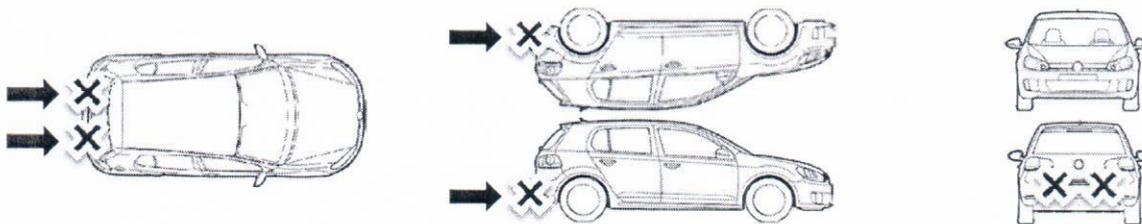
Damages sustained were consistent with the subject vehicle being involved in a collision with another vehicle and the impact was delivered **Squarely to the Rear** portion of the vehicle.

The general area of damages is at the **Rear portion**
 (Please refer to the parts list and photographs as attached for more information)

The estimated repair costs submitted by Messrs **Garage Star Pte Ltd** is \$ 20,386.00 .
 We have adjusted the cost to \$ 17,445.40 and the repairer has agreed to undertake the repairs at a **Contract Lump Sum of \$ 14,000.00** to a acceptable quality and standards.
