LKK Auto Consultants Pte Ltd

4. Description of Damages			
THE VEHICLE SUSTAINED DAMAGES AT THE REAR O/S PORTION. DAMAGES SEE DETAILS.			
5. General Information			
Accident Date	20/11/2022	Inspection Date	06/12/2022
Survey held at	154 GUL CIRCLE, 629611 Tuas		
Repairer	BOXFRESH PTE LTD		
5a. Remarks			
A)THE INSPECTION WAS CONDUCTED ON A"WITHOUT PREJUDICE" BASIS. B)IN ACCORDANCE TO YOUR INSTRUCTIONS, WE HAVE NOT AUTHORISED REPAIRS.			
5b. Estimate Days of Repair			
ESTIMATED NORMAL PERIOD FOR REPAIR:		2 Working Days

ADJUSTMENT ON REPAIR COST FOR VEHICLE NO. SBS 3448Z

PHOTOGRAPHS FOR VEHICLE NO. SBS 3448Z

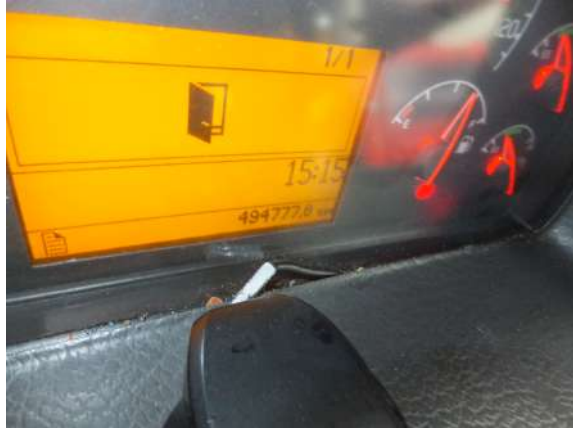
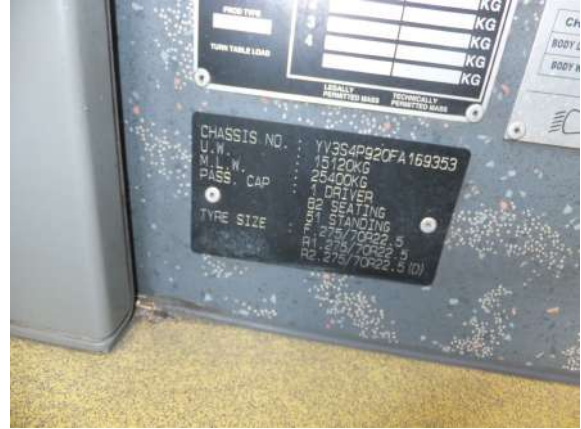
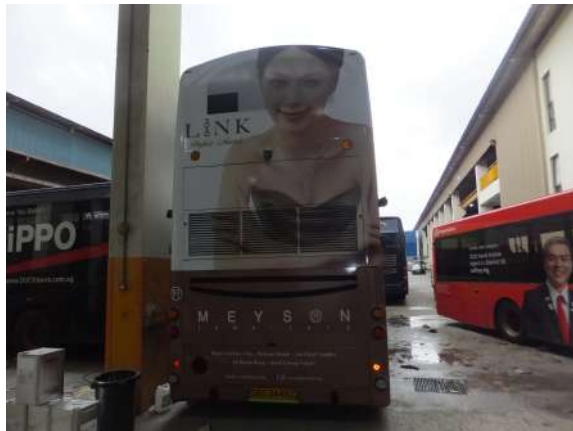
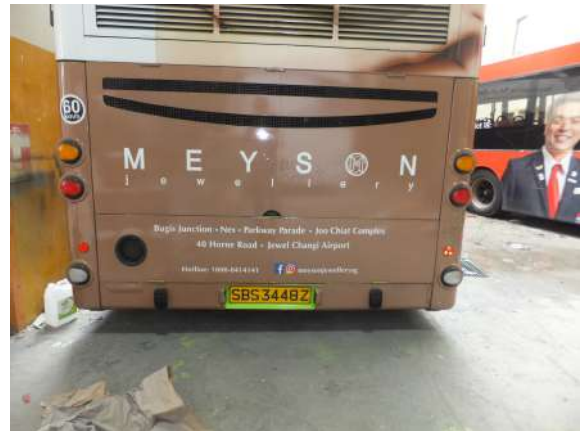
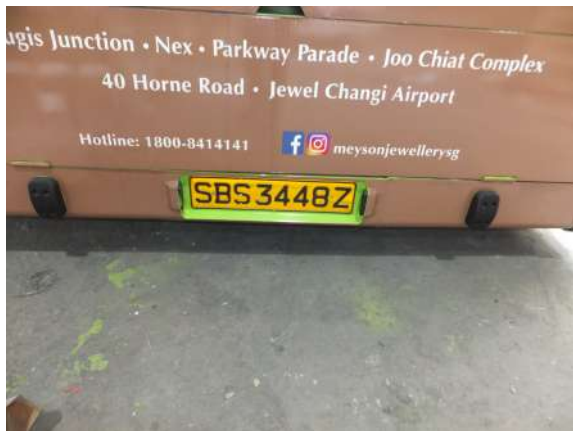
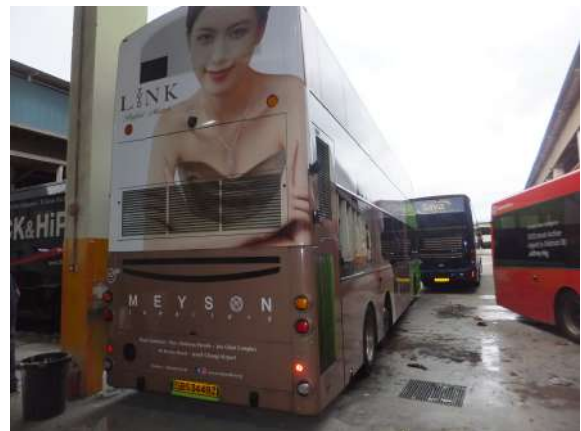
INSPECTION

BC Hassan was driving service 43 [SBS3448Z] on the above-mentioned date & time. While stationary at the above-mentioned location, the front left corner bumper & h/lamp of a dark blue BMW X4 [SKJ9928G] rear-ended SBS3448Z's rear right corner panel & reverse light

Qty	Description of Parts	Condition	Estimate By Workshop (\$)	Our Adjusted (\$)
	<u>REPLACEMENT OF PARTS</u>			
1	O/S REAR SIGNAL LIGHT P/N: ELU-00300	SCRATCHED	259.40	259.40
1	RED REFLECTOR LAMP P/N: ELU 0430	CRACKED	10.00	10.00
			269.40	269.40
	<u>LABOUR</u>			
	REMOVAL OF OS REAR PANEL STICKERS. }		600.00	500.00
	REPAIR O/S REAR PANEL. }		-	-
	PANEL BEATING OF REAR BUMPER. }		-	-
	SAND, PUTTY AND MAKE GOOD SURFACE OF AFFECTED PARTS. }		-	-
	PAINTING OF AFFECTED PARTS. }		-	-
			600.00	500.00
	GRAND TOTAL		869.40	769.40
	RECOMMENDED COST OF REPAIRS			769.40
