ASSIGNMENT

SKW 4952A  
2nd Anln

Volkswagen Golf

The U/C / Chassis frame / Body Structure affected due to collision.

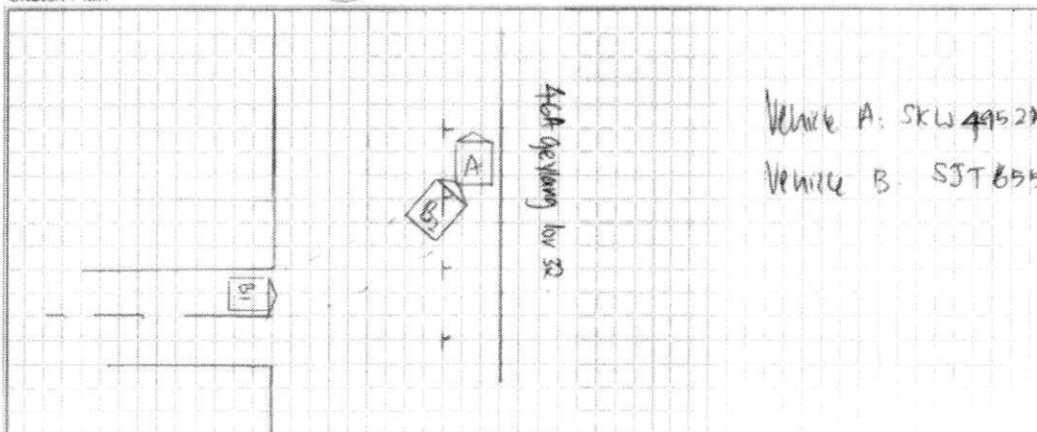
Sketch Plan

On the stated date and time, my vehicle was parked parallel stationary at the carpark lot of 46A Geylang Lor 32, as I just live nearby, I did hear a loud bang and was informed by my landlord that vehicle B has collided onto my stationary vehicle's rear left portion.
