## ASSIGNMENT

SKX 1568R

SH/2022/330/12/014/OD

Estimated cost of repair for vehicle no : SKX1568R Audi A3  
Policy no: Z22VP05032269 Accident Date: 10.12.2022

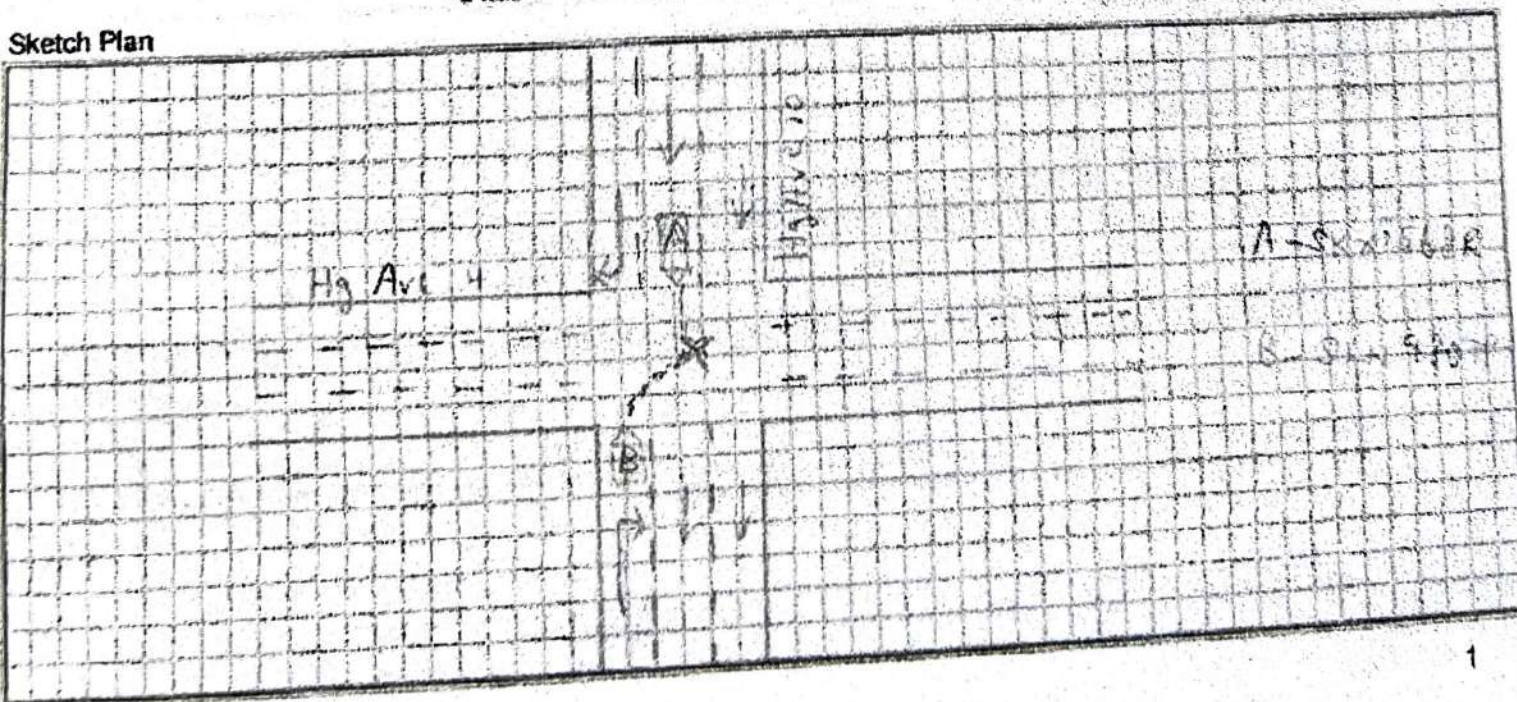
## Sketch Plan

Date of Submission ..... 12/12/2022 12:02 (SGT)  
Reported by ..... Driver  
Date of Accident ..... 10/12/2022 11:25 (SGT)  
Exact Location of Accident ..... Hougang Ave 10, Singapore  
Additional Location Information ..... Hougang Ave 10 & Hougang Ave 4 junction towards Hougang Ave 2  
Country/State of Loss ..... Singapore
