### ASSIGNMENT

To Inspect Vehicle No:

SJM 4045H

Hyundai Avante

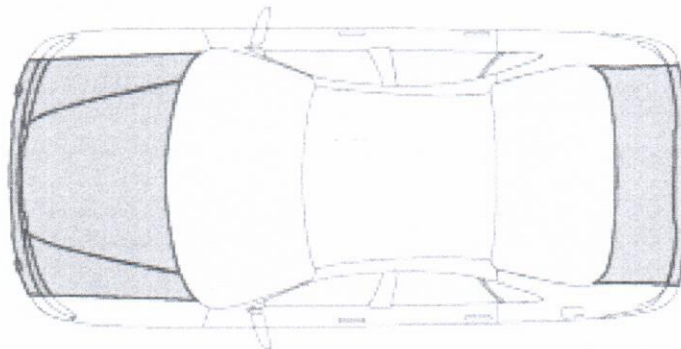
### Damage Areas

Des. of Damages: Frt / Rear / O/S / N/S / U/C / Rooftop or

Rear & Frt

The U/C / Chassis frame / Body Structure affected due to collision.

Code	Description	Time Base 10 WU/h	Price = 42.00 SGD/h	
			WU	Price SGD
86510R00	RENEW COMPLETE FRONT BUMPER INCLUDES: FRONT BUMPER, FRONT BUMPER REINFORCEMENT AND REQUIRED ATTACHED PARTS R + R AND IF NECESSARY RENEW.		6.0	25.20
92000R0B	REMOVE/REFIT BOTH HEADLIGHT UNITS INCLUDES: SET HEADLIGHT BEAMS		3.0	12.60
NO NUMBER	R + R FRONT PANEL		20.0	84.00
86520R00	RENEW REAR BUMPER CPL INCLUDES: REAR BUMPER, REAR LAMPS, REINFORCEMENT REAR BUMPER AND REQUIRED TRIMS REMOVE AND REFIT ATTACHED PARTS ASSEMBLE IF NECESS RENEW		8.0	33.60

Code	Description	WU	Price SGD
NO NUMBER	RENEW REAR END PANEL	63.0	264.60
97606R00	R + R AIR CONDITIONING CONDENSER	10.0	42.00
85731R00)	R + R LEFT BOOT TRIM	1.0	4.20
85731R0R)	R + R RIGHT BOOT TRIM	1.0	4.20
85710R00	R + R LUGGAGE COMP FLOOR CARPET	2.0	8.40
25300R00)	R + R RADIATOR	7.0	29.40
	INCLUDES: R + R COMPLETE RADIATOR SHROUD		
NO NUMBER	DRAIN/REFILL COOLING SYSTEM	3.0	12.60
09760A00	DRAIN + REFILL AIR CONDITIONING	5.0	21.00
<b>Labour Cost</b>		<b>Hrs</b>	<b>WU</b>
<b>Panel / Mechanical Labour</b>		<b>12.90</b>	<b>129.0</b>
<b>Total of Labour</b>			<b>541.80</b>
