SINGAPORE ACCIDENT STATEMENT

VEHICLE INSPECTION REPORT

ASSESSMENT REPORT FOR VEHICLE NO: SMD8924G

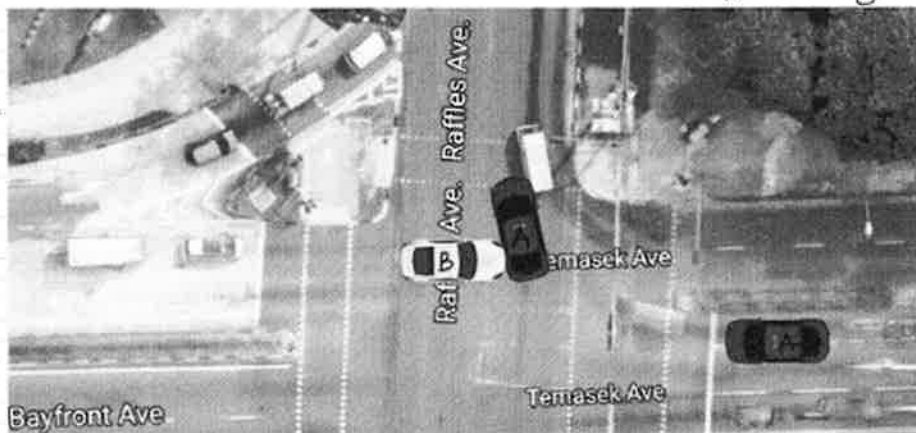
Sketch Plan

A - SHIA 3960J
B - SMD 89246

ON 27.09.2022 AT ABOUT 2155HRS I WAS DRIVING MY VEHICLE A SHA3960J FROM TEMASEK AVE TURNING RIGHT TO RAFFLES AVE. VEHICLE B SMD8924G COMING AT A FAST SPEED FROM BAYFRONT AVE COLLIDED HER VEHICLE B FRONT RIGHT ONTO MY VEHICLE A LEFT REAR. NO ONE WAS INJURED. PARTICULARS EXCHANGED BUT NO HANDPHONE
