ACCIDENT INVOLVING MOTOR VEHICLES NO. SML7016S AND SNG9293J (SCL8668Y) ALONG
CTE TOWARDS TOWN ON 08.09.2022 AT ABOUT 1056 HOURS.

ACCIDENT DAMAGED VEHICLE INSPECTION REPORT

Registration No : SML7016S
Make : AUDI
Model : A4 SEDAN 2.0 TFSI S TRONIC (NAV)
Year : 2018

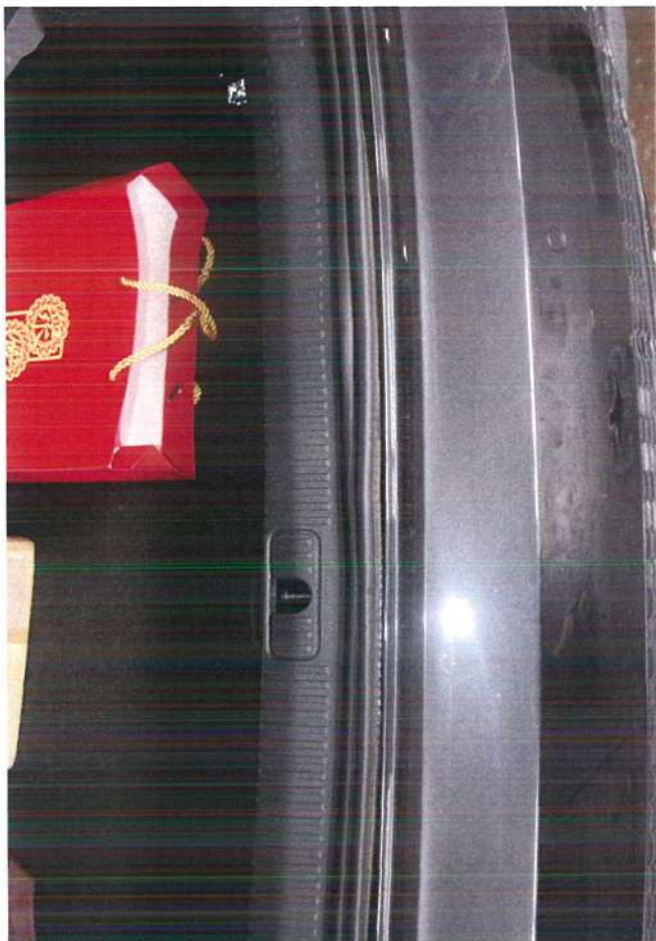
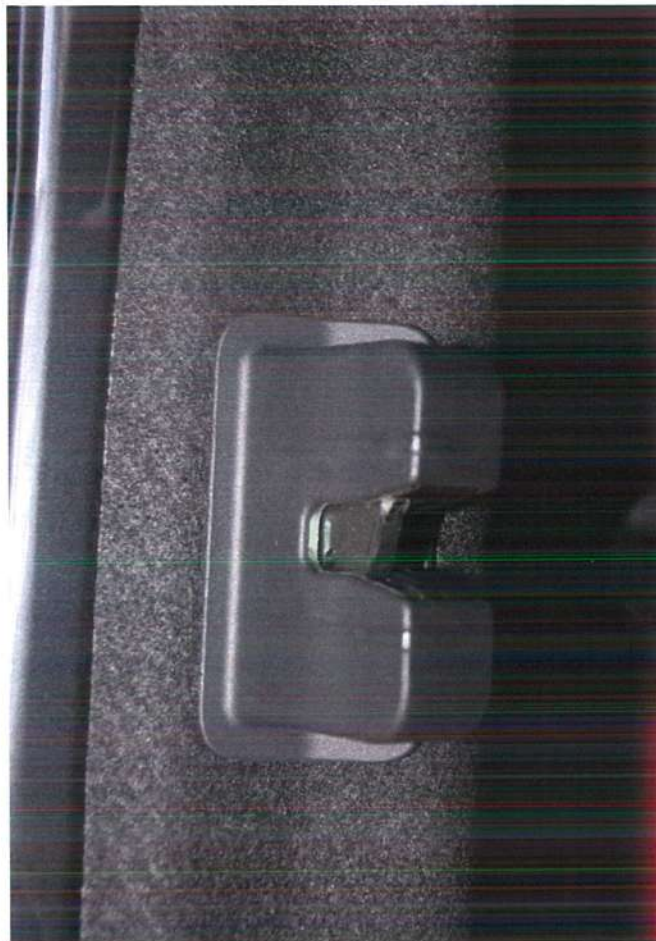
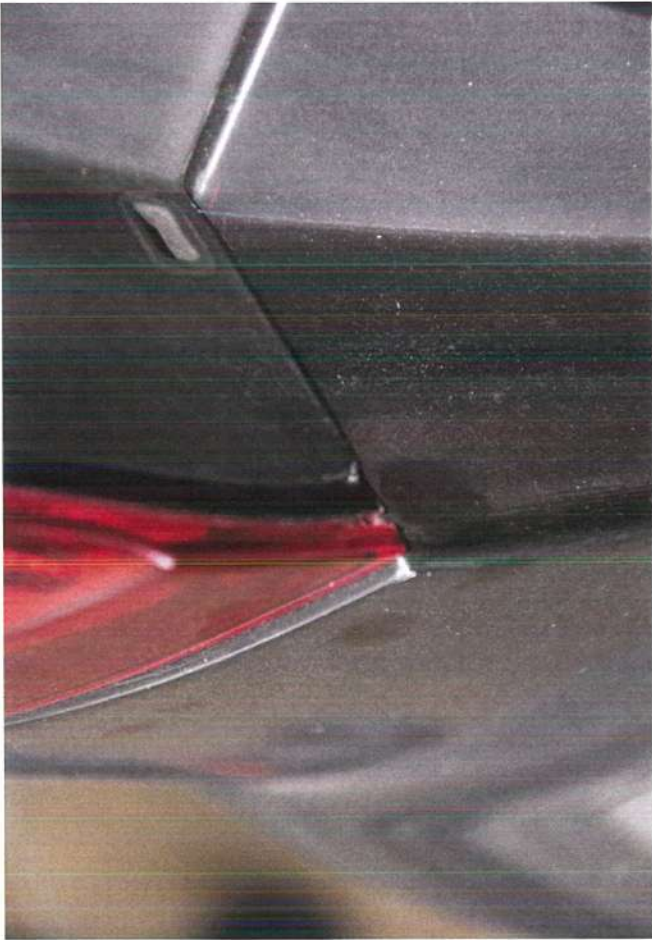
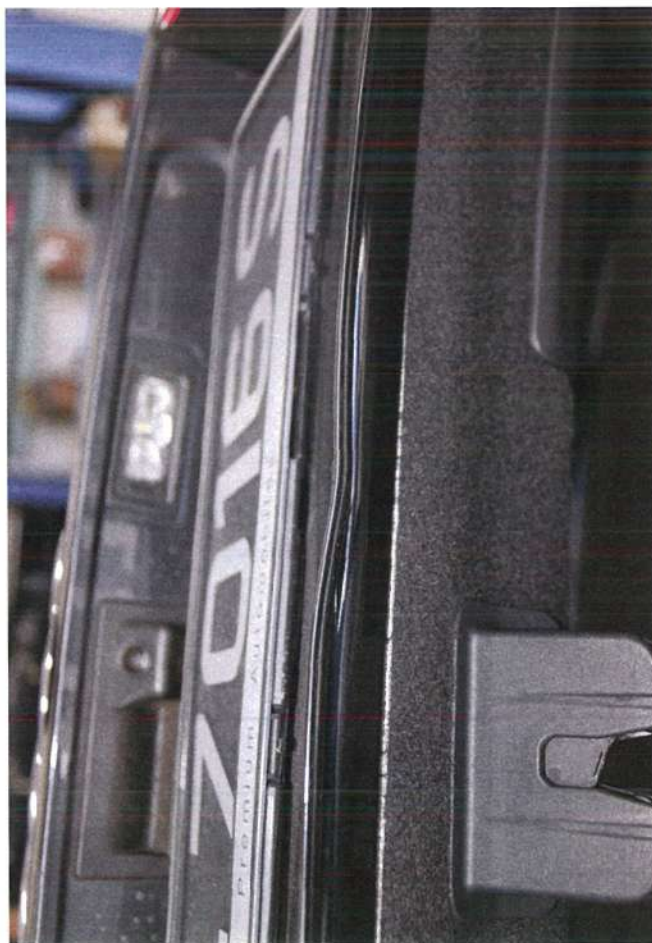
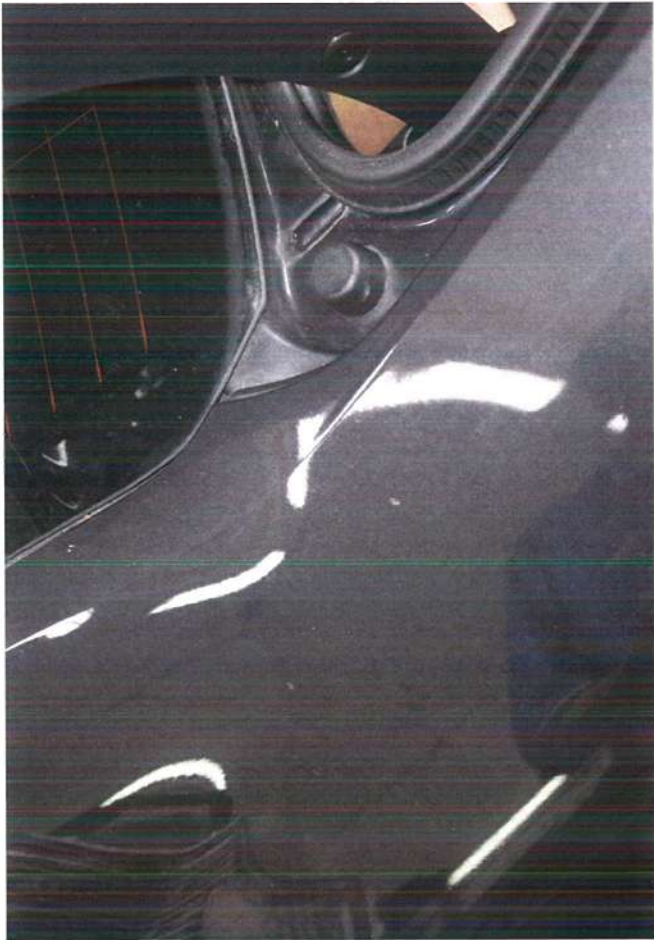
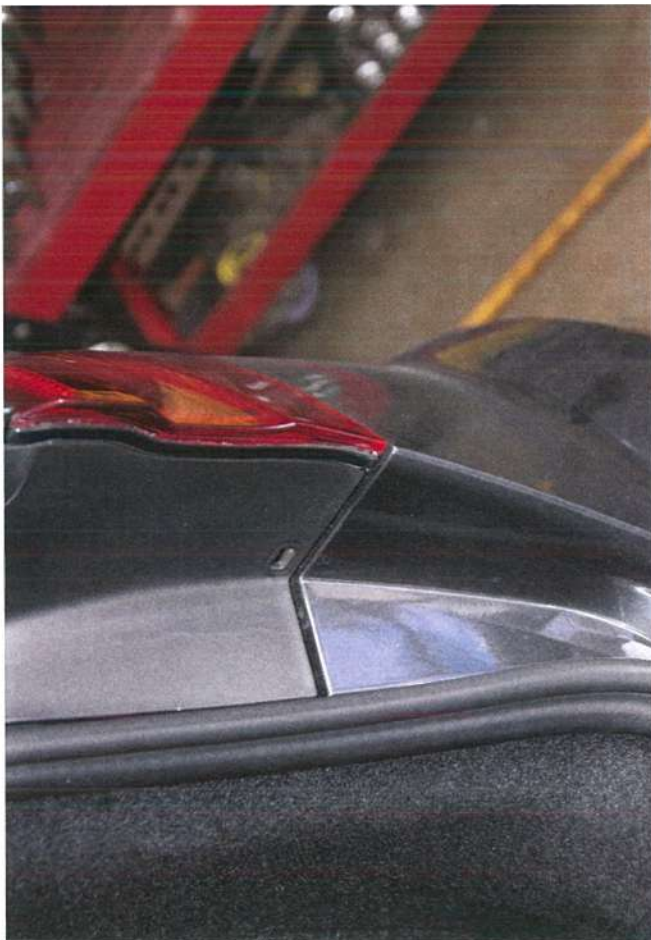
The vehicle sustained damage at the rear portions.
For details, refer to assessment for repairs and photographs attached.

The damages appeared to be consistent as per the accident report statement.

Our assessment of the repair costs to pre-accident condition was **SS\$12,050.00** nett at lump sum basis.(Subject to GST if applicable)

QTY	ASSESSED	ORIGINAL		REVISED
A) SPARE PARTS		PC/SET	CONDITION	QUOTATION		QUOTATION
01	REAR BUMPER	1	DEFORMED/CRACKED	\$	1,910.00	\$ 1,910.00
02	REAR BUMPER CENTRE PAD	1	DEFORMED/CRACKED	\$	211.00	\$ 211.00
03	REAR BUMPER LOWER PAD	1	DEFORMED/CRACKED	\$	215.00	\$ 215.00
04	REAR BUMPER LOWER PAD BRACKET LH	1	NECESSARY	\$	62.00	\$ 62.00
05	REAR BUMPER LOWER PAD BRACKET RH	1	NECESSARY	\$	62.00	\$ 62.00
06	REAR BUMPER REFLECTOR LH	1	GRAZED	\$	32.00	\$ 32.00
07	REAR BUMPER REFLECTOR RH	1	NOT NECESSARY	\$	32.00	\$ -
08	REAR BUMPER PARKING SENSOR	4	MALFUNCTION	\$	1,020.00	\$ 1,020.00
09	REAR BUMPER TOP BRACKET HOLDER	1	CRACKED	\$	389.00	\$ 389.00
10	REAR BUMPER BRACKET LH	1	NECESSARY	\$	98.00	\$ 98.00
11	REAR BUMPER BRACKET RH	1	NECESSARY	\$	98.00	\$ 98.00
12	REAR BUMPER REINFORCEMENT	1	NOT NECESSARY	\$	804.00	\$ -
13	REAR BOOTLID	1	DENTED	\$	2,585.00	\$ 2,585.00
14	REAR BOOTLID LOCK	1	JAMMED	\$	189.00	\$ 189.00

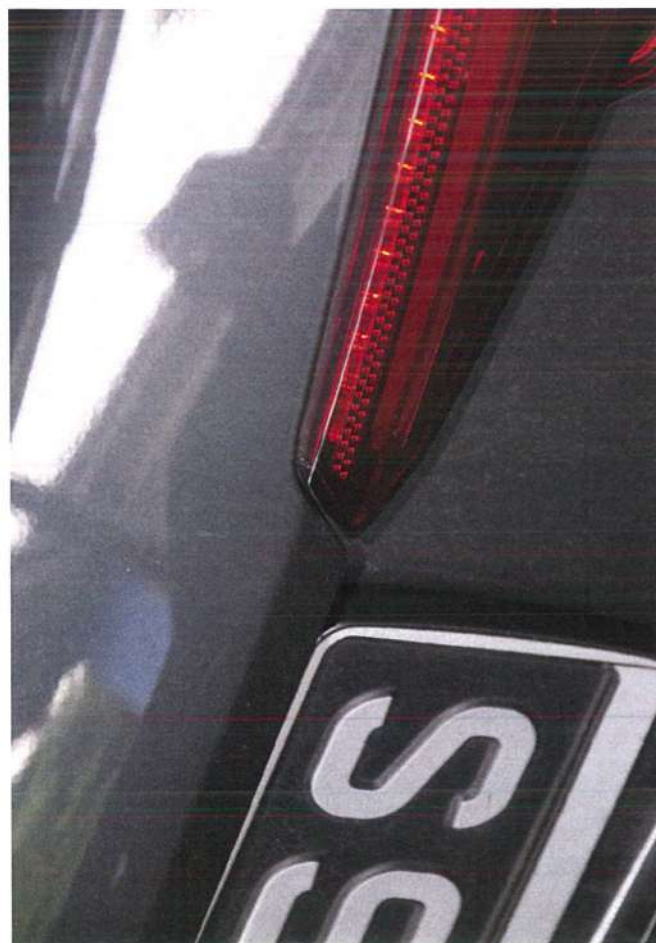
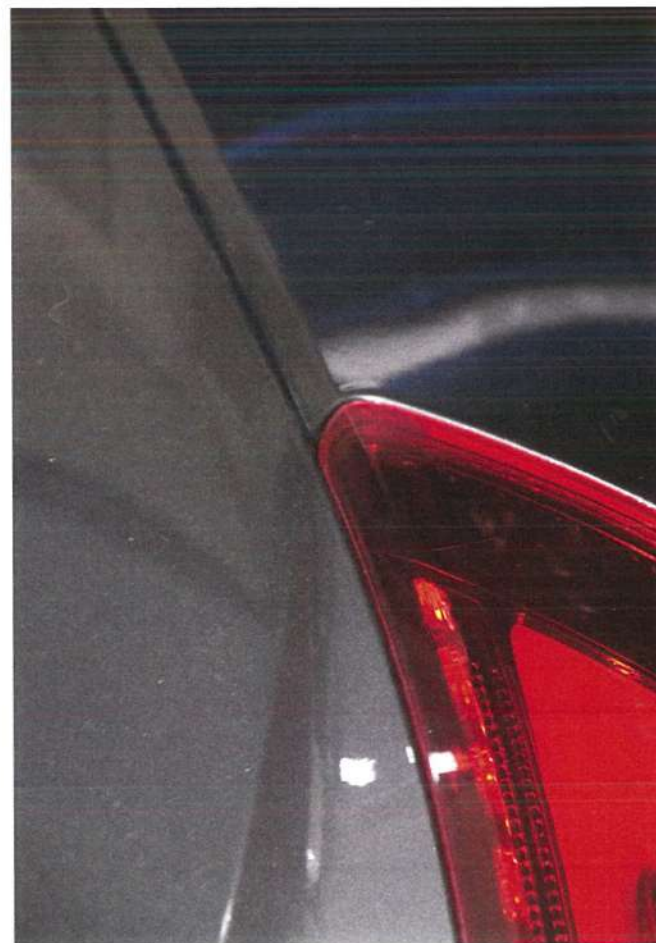
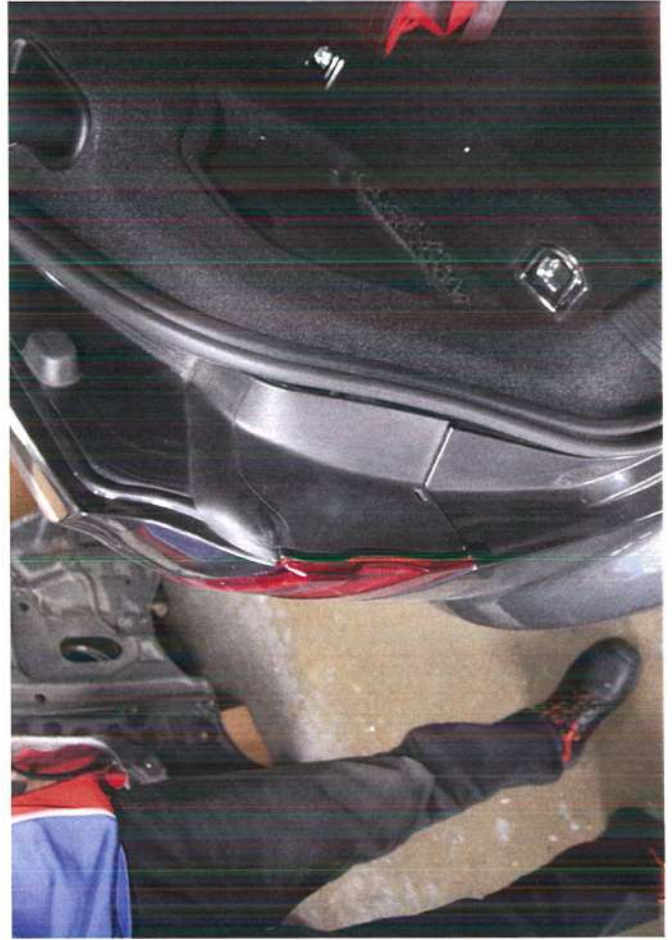
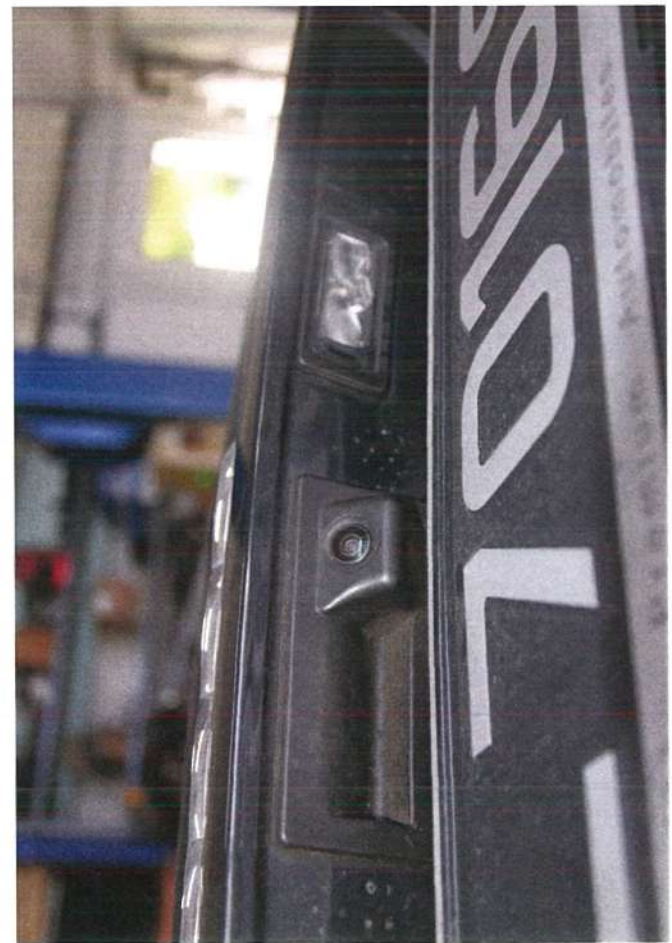
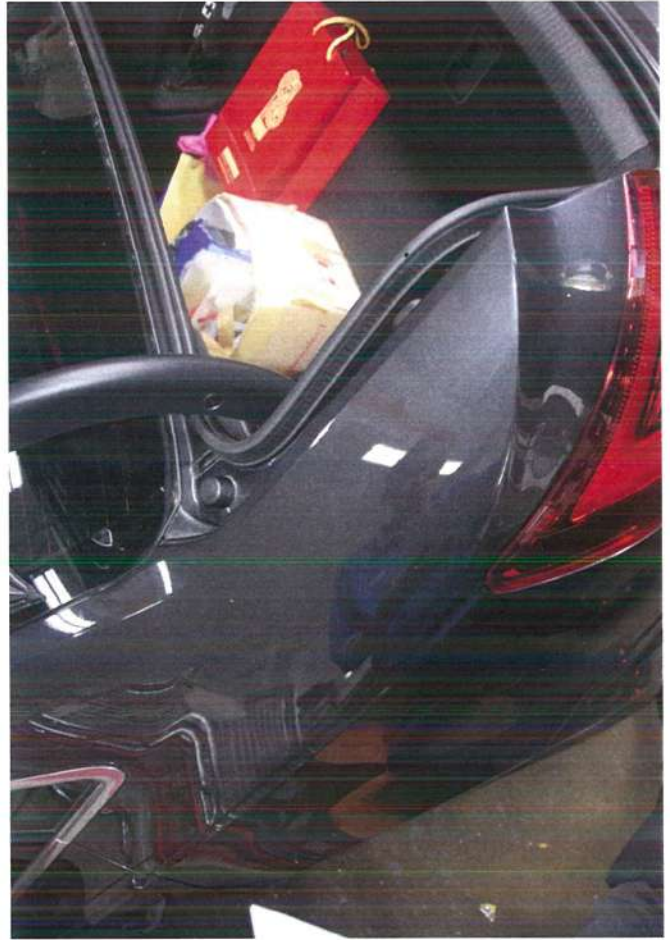
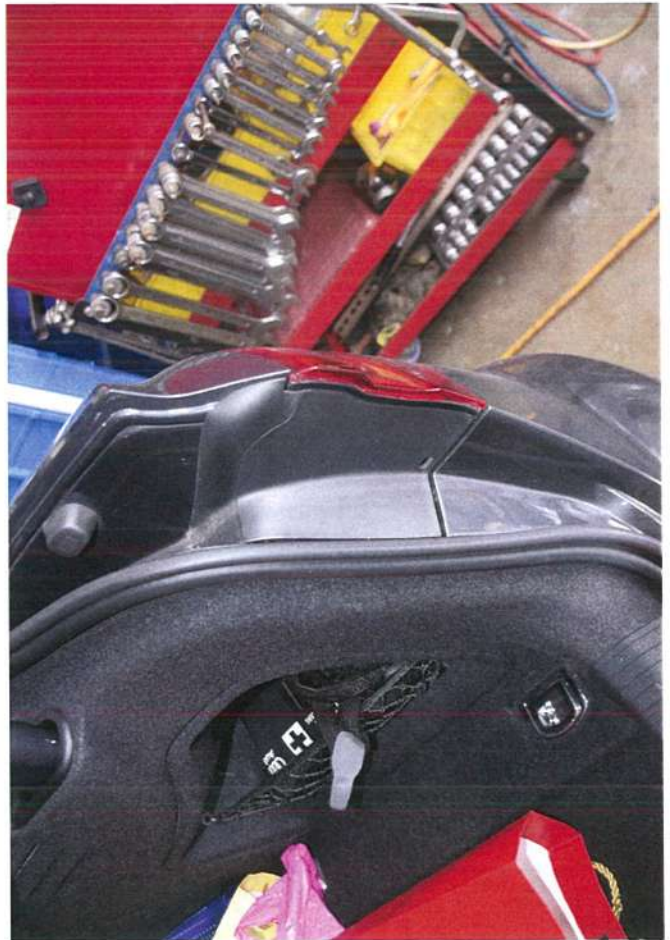
The impact was confined to the rear portion of the vehicle.

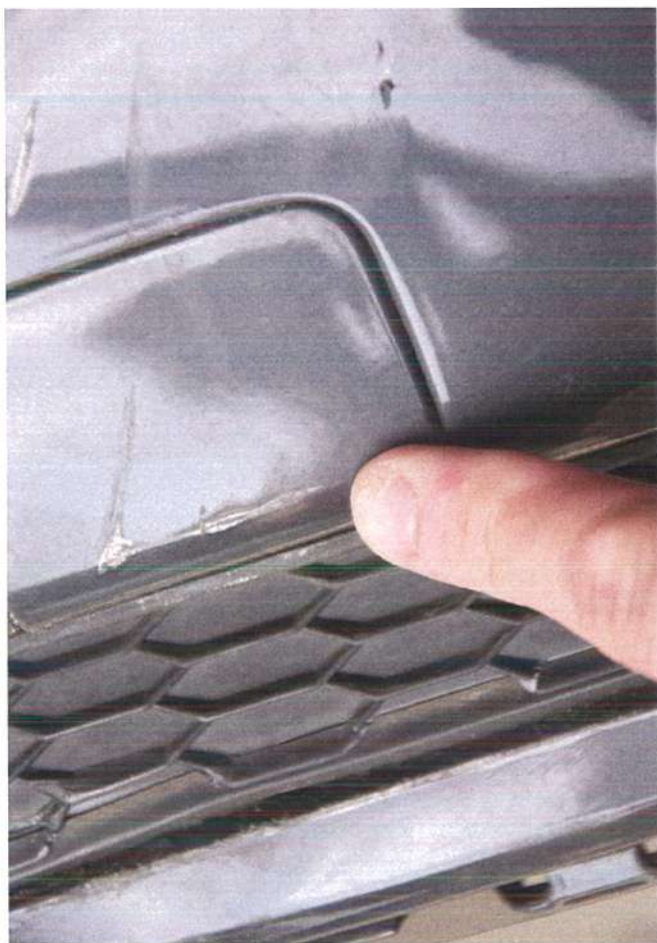
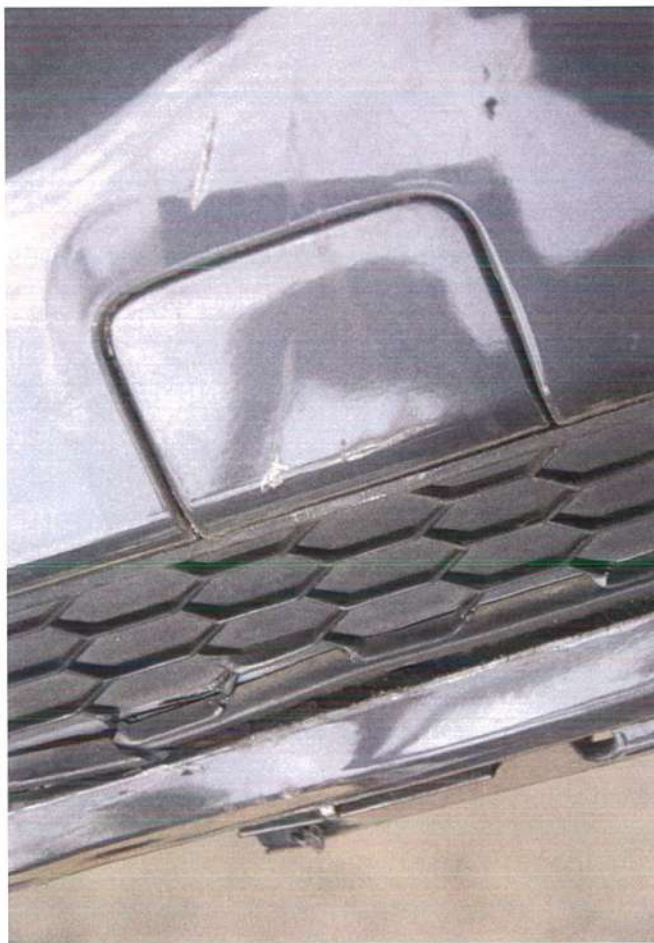
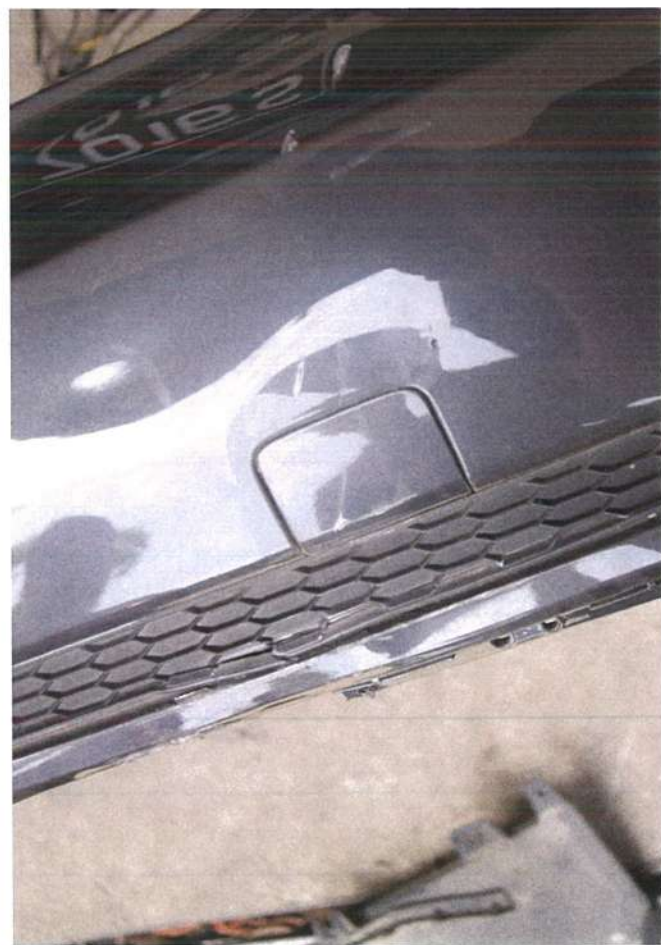
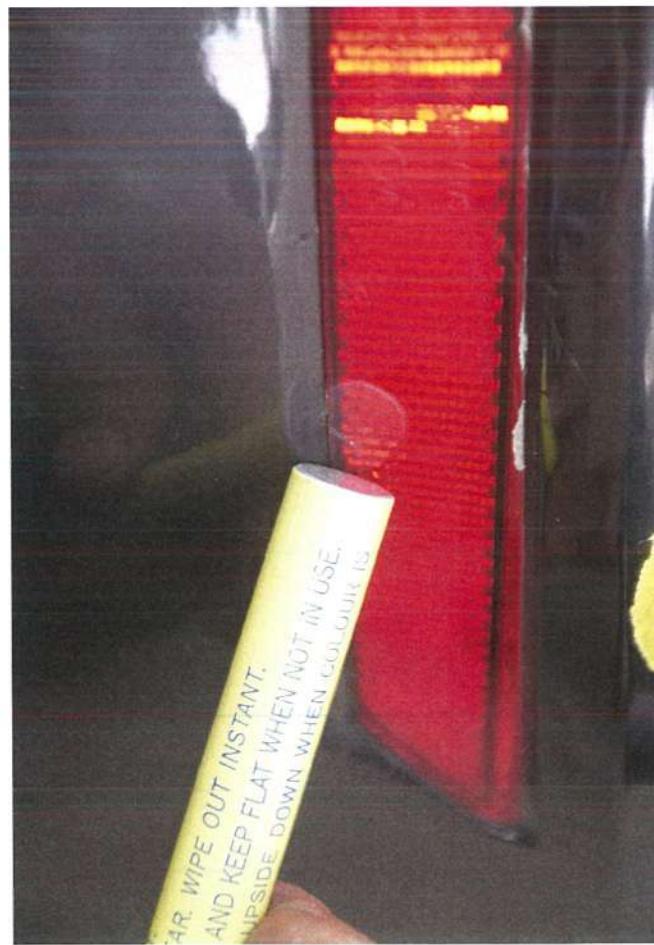
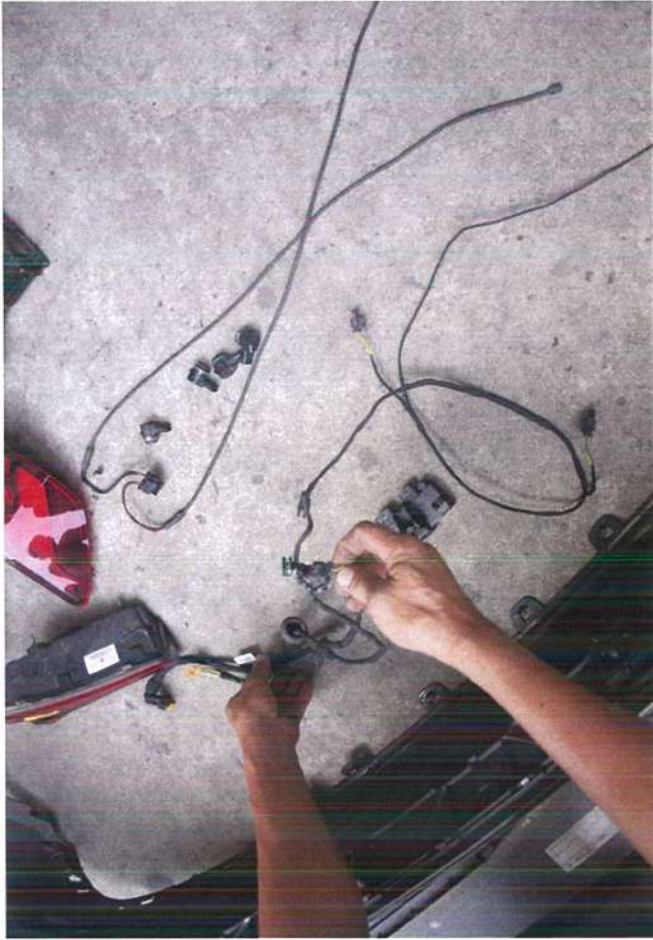
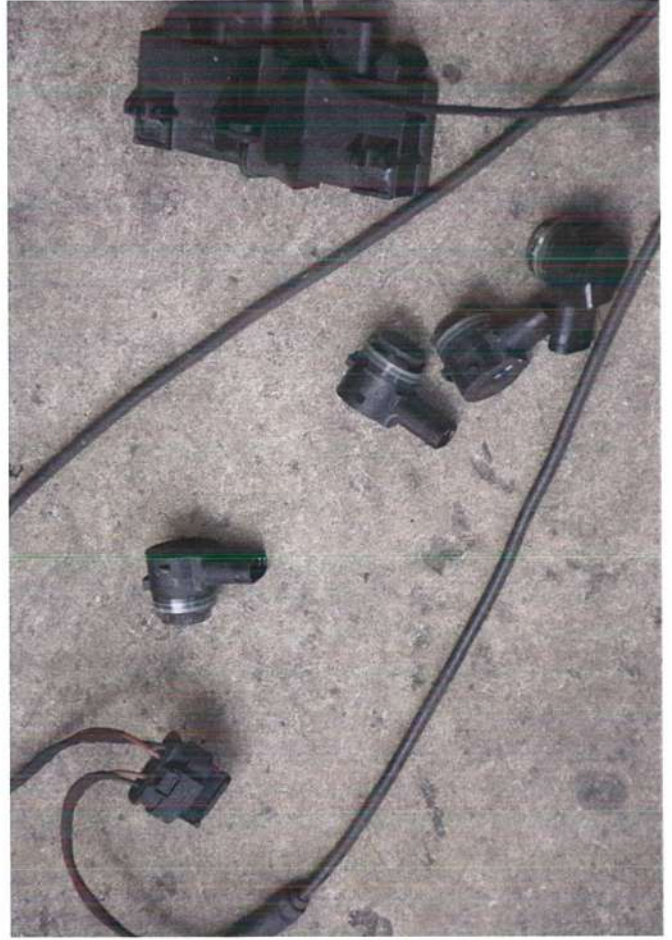
15	REAR BOOTLID LOCK COVER	1	GRAZED	\$	57.00	\$ 57.00
16	REAR BOOTLID WEATHERSTRIP	1	DEFROMED	\$	175.00	\$ 175.00
17	TAILLAMP LH	1	CRACKED	\$	955.00	\$ 955.00
18	TAILLAMP RH	1	NOT NECESSARY	\$	955.00	\$ -
19	TAILLAMP SIDE COVER LH	1	CRACKED	\$	45.00	\$ 45.00
20	TAILLAMP SIDE COVER RH	1	NOT NECESSARY	\$	45.00	\$ -
21	END PANEL OUTER	1	DENTED	\$	1,451.00	\$ 1,451.00
22	END PANEL INNER	1	REPAIR	\$	1,599.00	\$ 1,599.00
23	END PANEL TOP GARNISH	1	NOT NECESSARY	\$	235.00	\$ -
24	KEYLESS ANTENA	1	MALFUNCTION	\$	119.00	\$ 119.00
25	EXHAUST CHROME CUTTER - LH	1	GRAZED	\$	198.00	\$ 198.00
26	EXHAUST CHROME CUTTER - RH	1	GRAZED	\$	198.00	\$ 198.00
				\$	13,739.00	\$ 11,668.00
				Less 10%	\$ 1,373.90	\$ 1,166.80
				\$	12,365.10	\$ 10,501.20

The repairer has agreed to undertake repair the vehicle at a lump sum basis of **S\$12,050.00 nett** corresponding to replacement of parts, spray painting and labour charges. We now revert for your decision on the above claim.
