## LKK Auto Consultants Pte Ltd

Vehicle No. SHA 9592Z  
Insured Veh. GBG 8717C  
Claim No. SNM23D200761/C02  
Policy No. DMCVSNA00146052201  
Accident Date 27/01/2023  
Inspection Date 30/01/2023

## ADJUSTMENT ON REPAIR COST FOR VEHICLE NO. SHA 9592Z

PHOTOGRAPHS FOR VEHICLE NO. SHA 9592Z

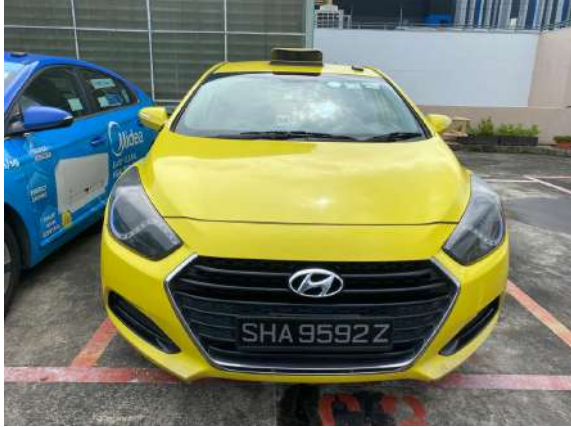
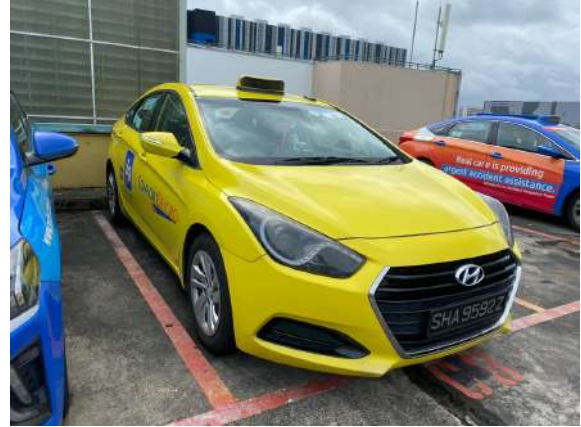
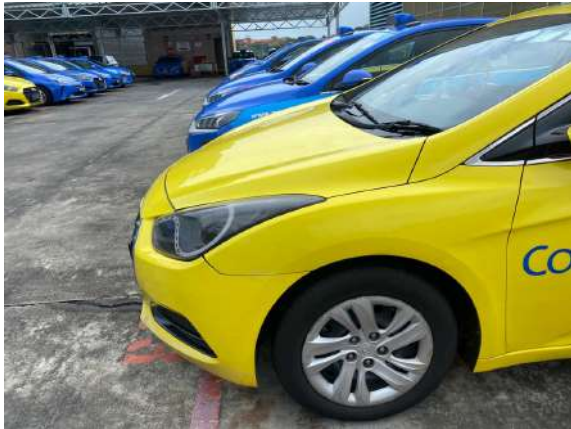
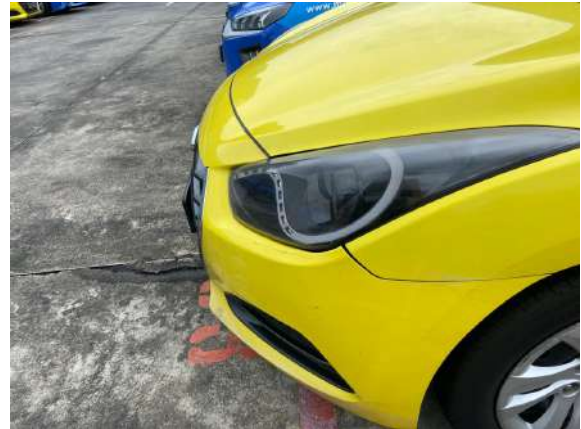
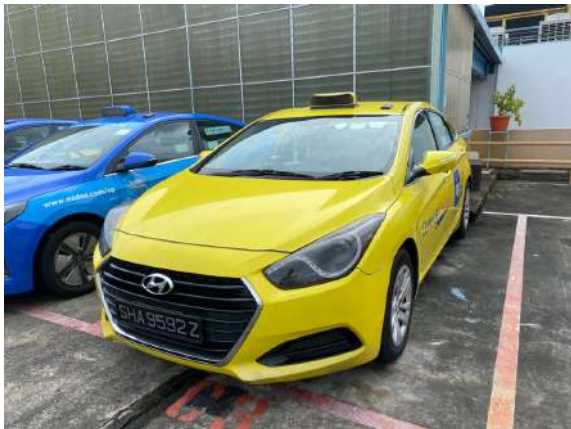
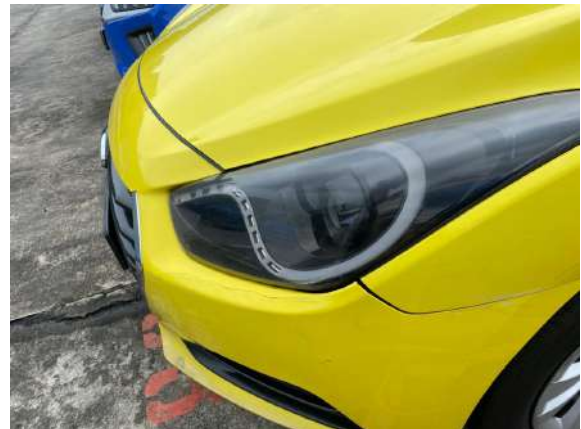
INSPECTION

| Affiliated to Federation Internationale Des Experts En Automobile | | | | |
|---|---|---|---|---|
| | THE VEHICLE SUSTAINED DAMAGES AT THE N/S BODY.<br>DAMAGES SEE DETAILS. | | | |
