## LKK Auto Consultants Pte Ltd

| Affiliated to Federation Internationale Des Experts En Automobile | | | | |
|---|---|---|---|---|
| <b>1. Policy Particulars :- THIRD PARTY CLAIM</b> | | | | |

### ADJUSTMENT ON REPAIR COST FOR VEHICLE NO. GBJ 7335L

### PHOTOGRAPHS FOR VEHICLE NO. GBJ 7335L

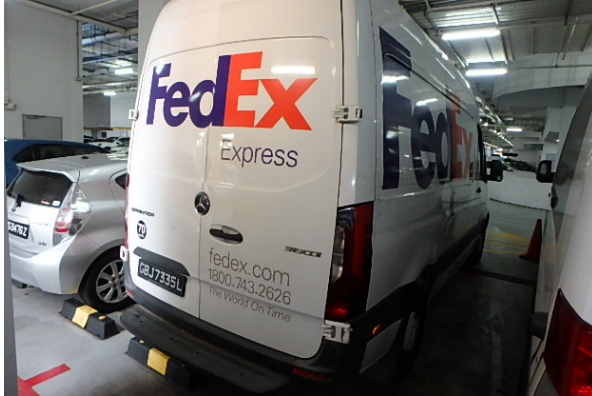
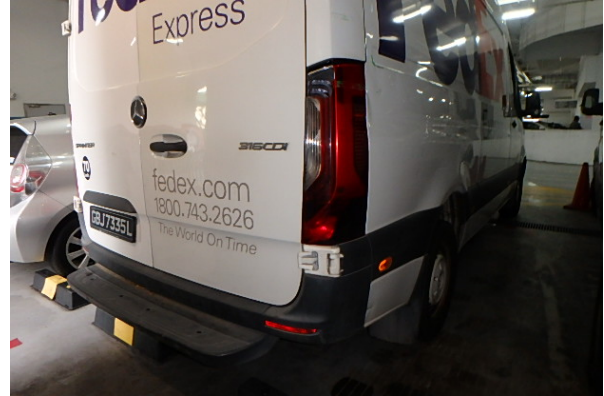
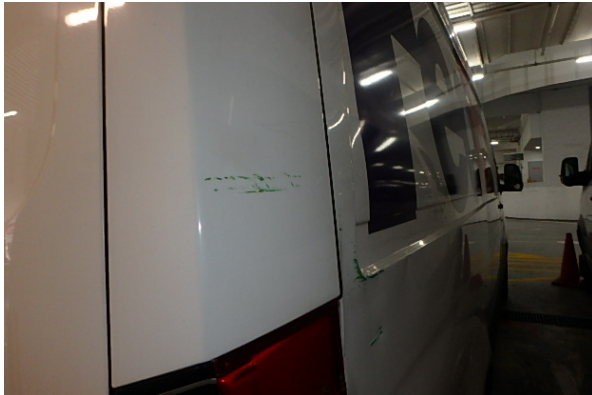
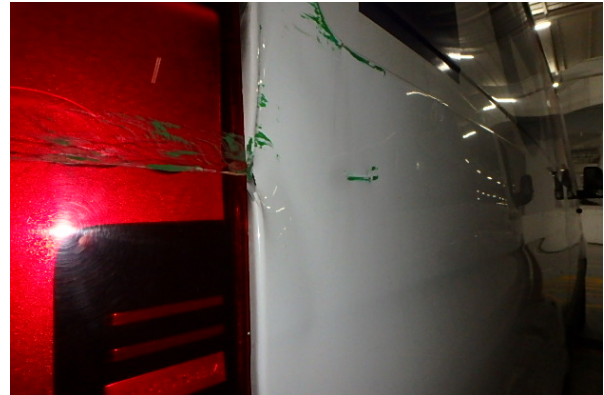
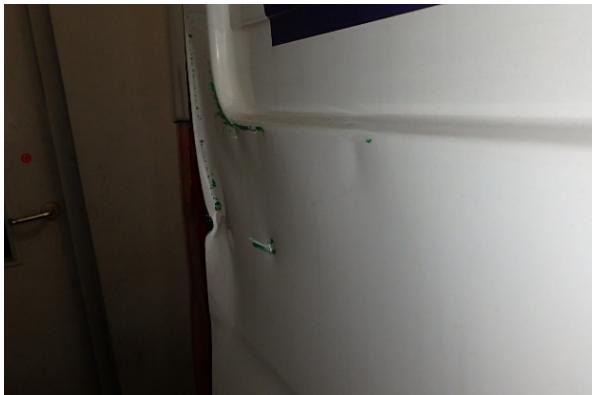
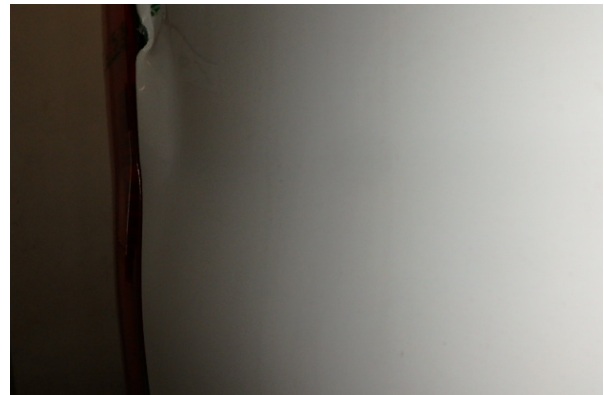
### INSPECTION

| Affiliated to Federation Internationale Des Experts En Automobile | | | | |
|---|---|---|---|---|
| | THE VEHICLE SUSTAINED DAMAGES AT THE O/S REAR PORTION.<br>DAMAGES SEE DETAILS. | | | |

| Qty | Description of Parts | Condition | Estimate By Workshop (\$) | Our Adjusted (\$) |
|---|---|---|---|---|
| 1 | TAILLAMP RH | CRACKED | 1,200.00 | 920.00 |
| 1 | REAR FENDER RH | TO REPAIR SEE LABOUR | 1,850.00 | - |
| 1 | REAR FENDER STICKER RH (SN) | NECESSARY | 450.00 | 300.00 |
| | STRAIGHTEN & PANEL BEAT ACCIDENT AREA.INCLUSIVE OF THE REPAIR OF REAR FENDER RH | | 850.00 | 400.00 |
| | RESPRAY ACCIDENT AREA. | | 750.00 | 300.00 |
